**Technology Evaluation for Environmental Risk
Mitigation Principal Center**

NASA-DoD Lead-Free Electronics Project

Joint Test Report - Final

December 2011

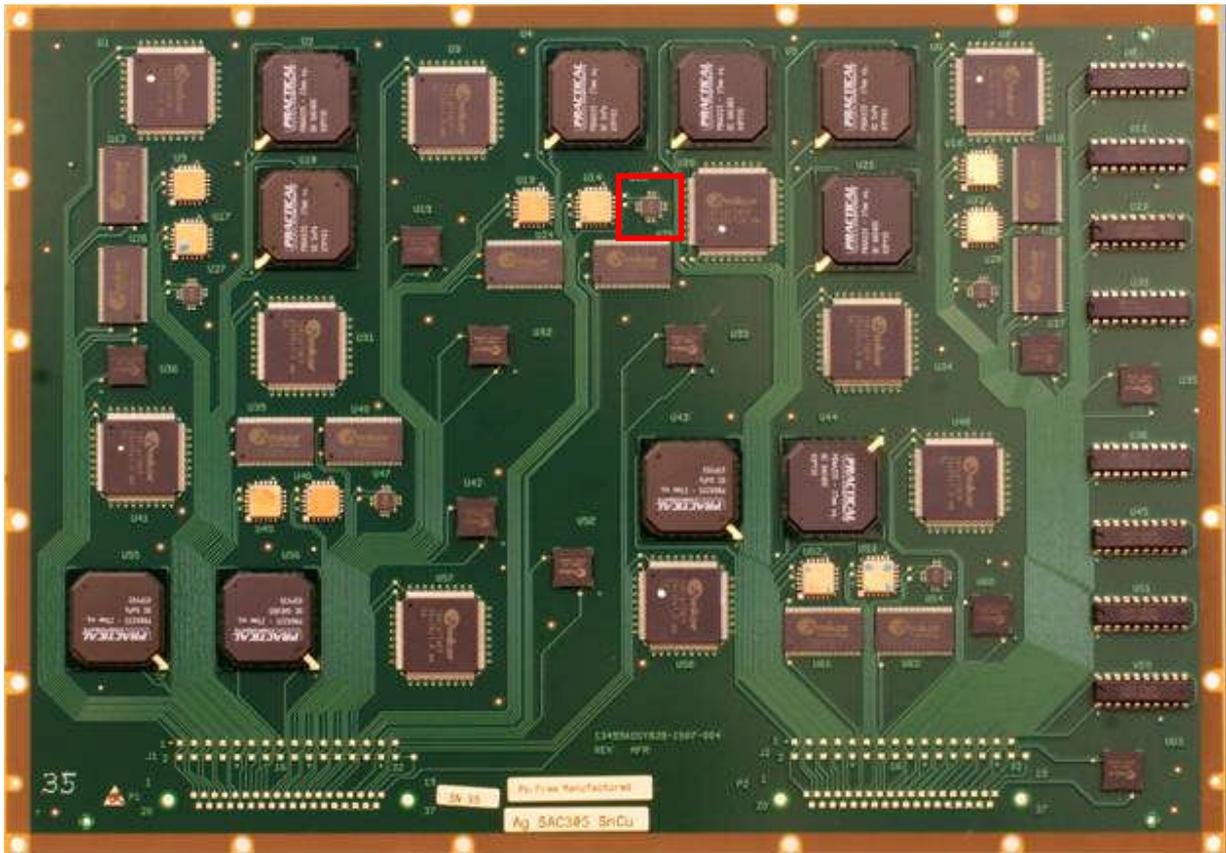
Figure 6 - Quad Flat No leads (QFN), Component Location U15

Component location U15, a QFN, is missing a wire trace, Figure 6. During drafting, the trace was not included in the test vehicles drawing, Figure 7. Test data cannot be collected for this component unless a jumper wire is used in-place of the missing trace. Jumper wires were used for the thermal cycle test vehicles. For vibration, drop, mechanical shock and combined environments testing, it was determined that a jumper wire is not feasible. For the NSWCR Crane rework test vehicles, QFN U15 is an active rework component. For drop and vibration testing, a jumper wire was attached to each U15 location to permit collection of test data (see Figure 8).

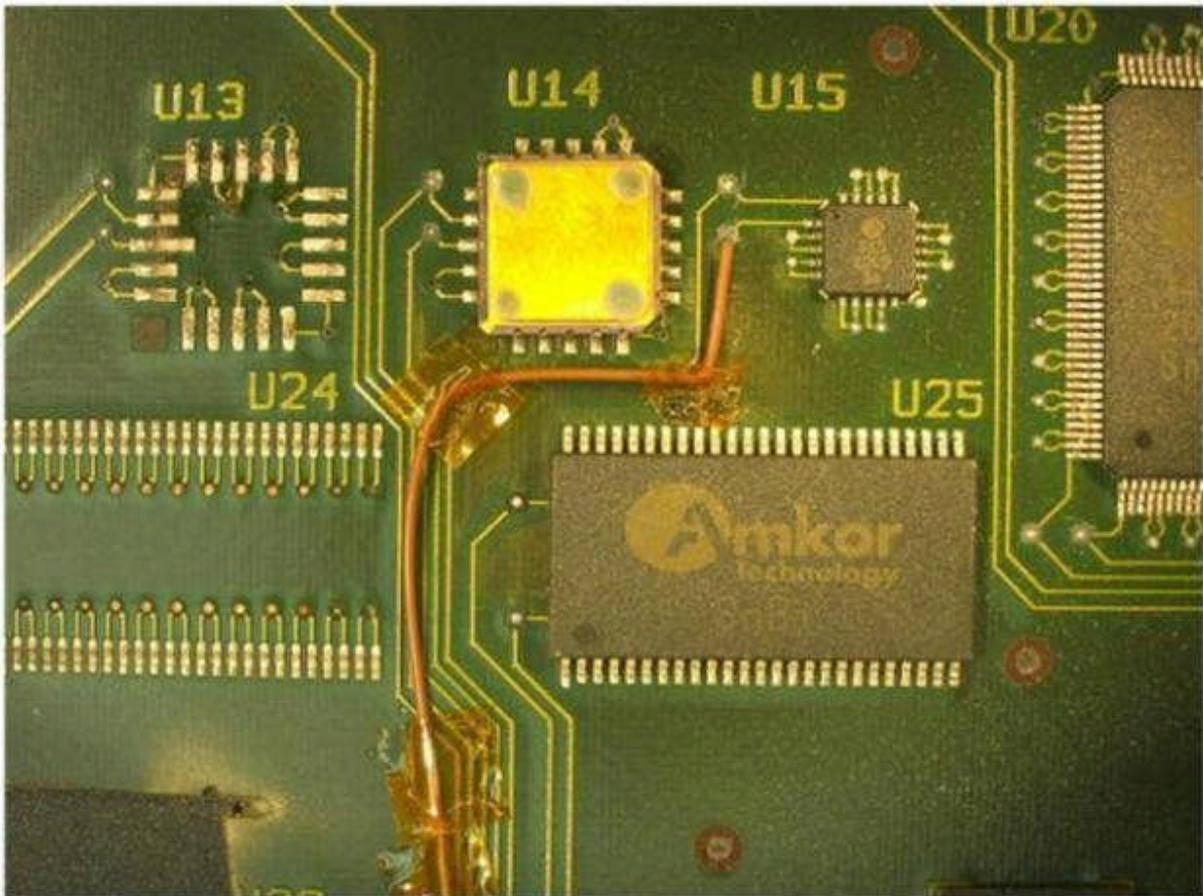
Figure 8 - Jumper Wire Attached to U15 Location to Permit Collection of Test Data

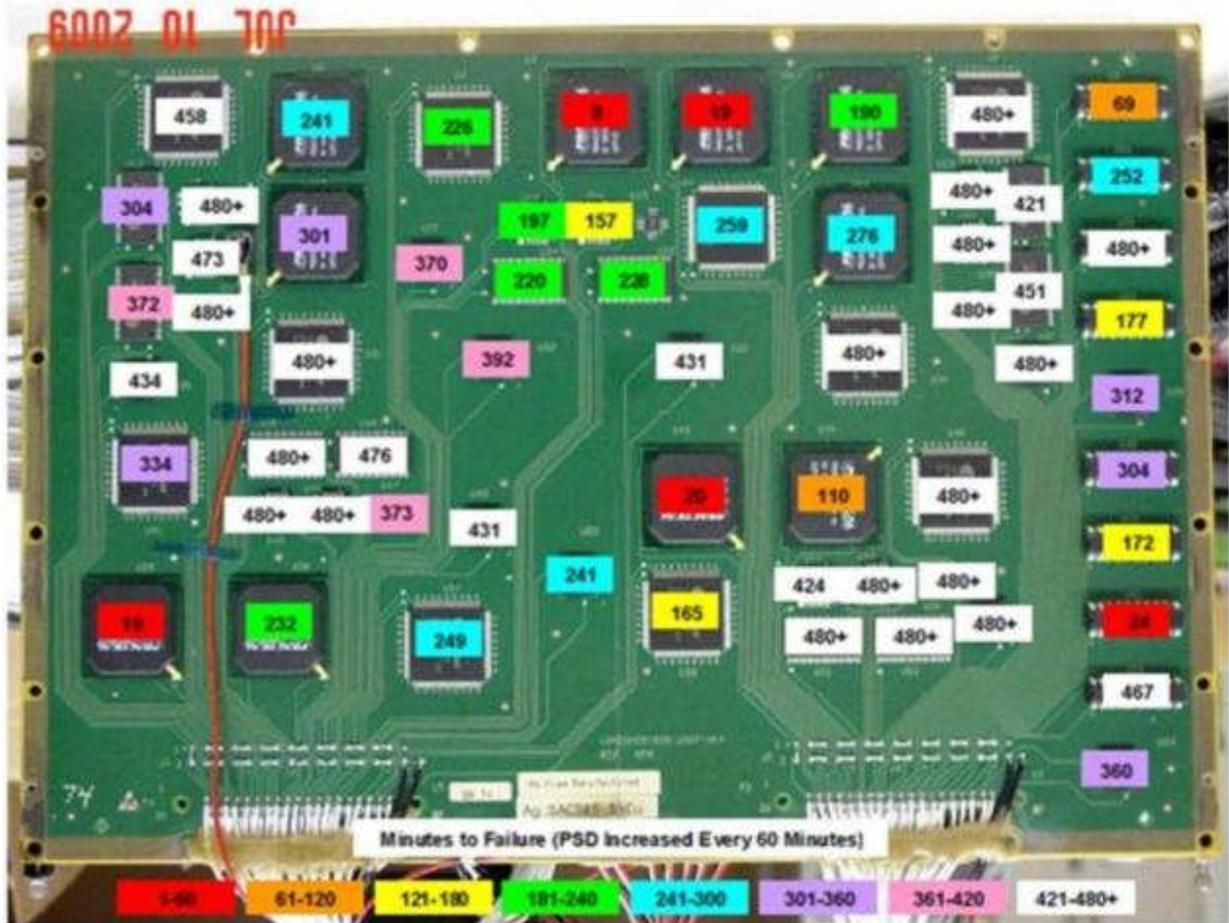
421 to 480+ minutes). In general, the components tended to fail first down the centerline and along the edges of the test vehicle (near the wedgelocks). Therefore, the first component failures coincide with the regions of highest strain as shown in Figure 12.

Figure 11 - Test Minutes Required for Components to Fail (Test Vehicle 74 Data)

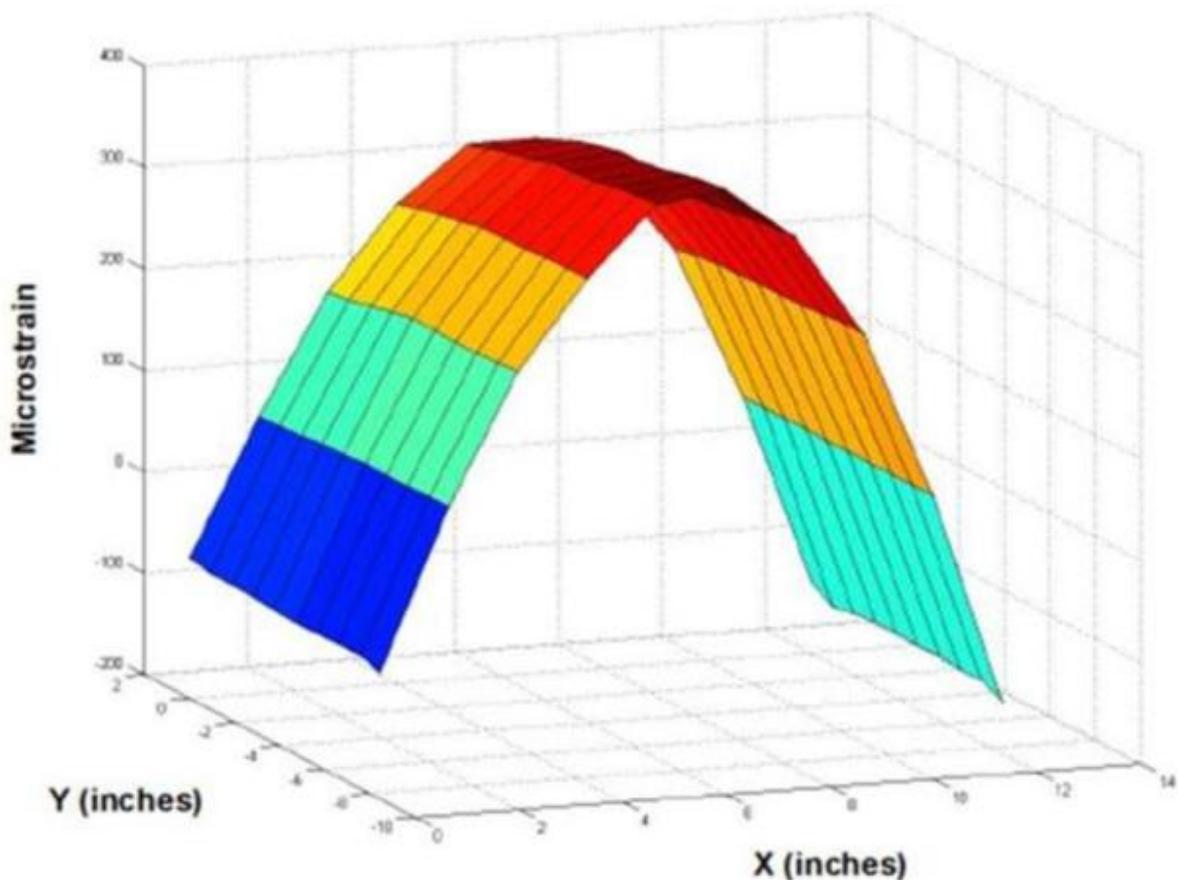
Figure 12 - Full Field Peak Strains at 65 Hz (1G Sine Dwell, Test Vehicle 74)

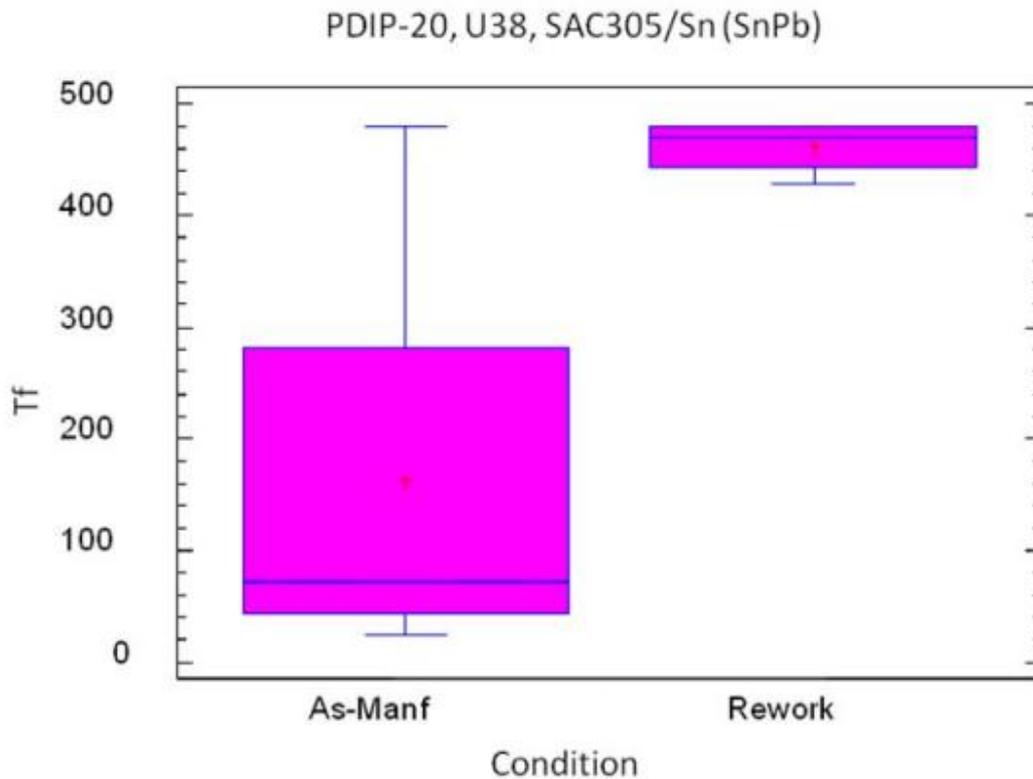
In two cases, the reworked samples lasted much longer than as-manufactured samples. The most extreme example was a test run where PDIP-20, U38, lasted 300 minutes longer after rework. A graph of the results is shown in Figure 15.

Figure 15 - Results of PDIP-20, U38 in As-Manufactured Condition and after Rework

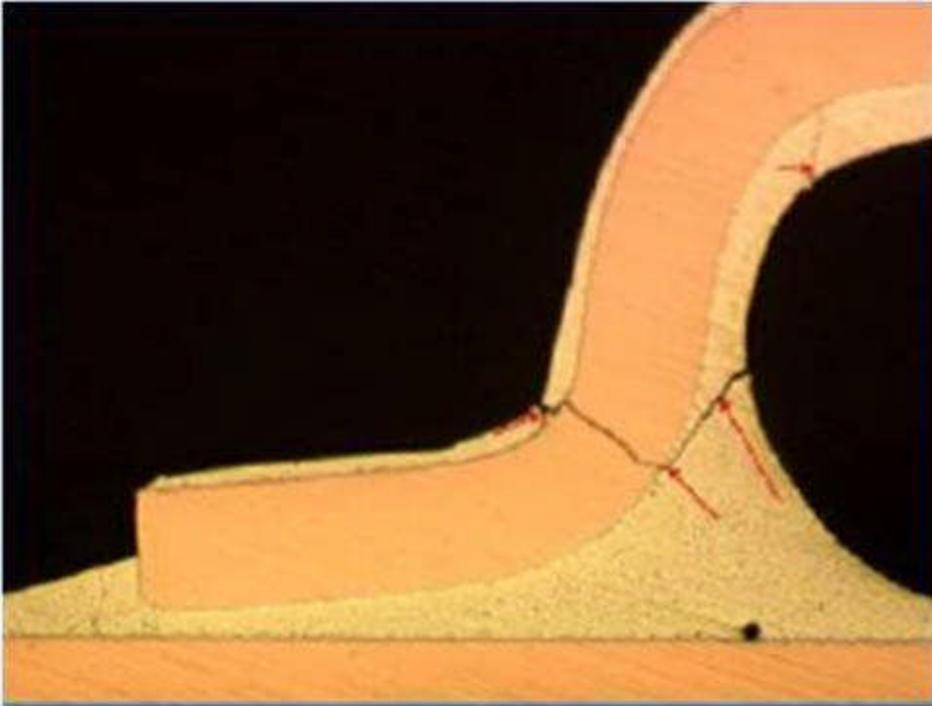
Figure 21 - SN63 U41. Left Lead

Cross-sectioning revealed cracks in the actual copper leads of the TQFP-144 packages. This damage was observed only on parts which were not reworked and therefore the solder joint was Pb-free. This is to be expected as the Pb-free solder is stiffer than the SnPb solder and transfers the stress to the weaker copper leads. Figure 21 and Figure 22 illustrate TQFP-144 packages which were not reworked and therefore contain only Pb-free solders.

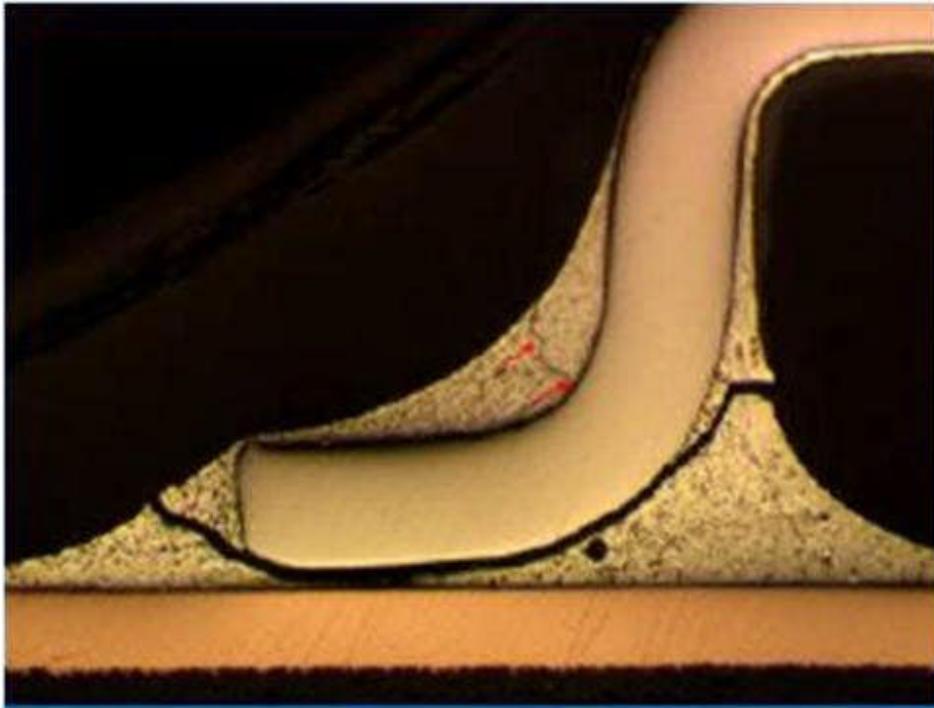
Figure 29 - SN63 U16, Left Lead

SN63 U16 (Figure 29) and SN68 U29 (Figure 30) were both re-worked twice with SnPb solder. SN63 U16 is finished with SnBi and SN68 U29 is finished with Sn. The SnBi part experienced extensive solder cracking through-out. The Sn finished part experienced solder cracking at one side of the component.

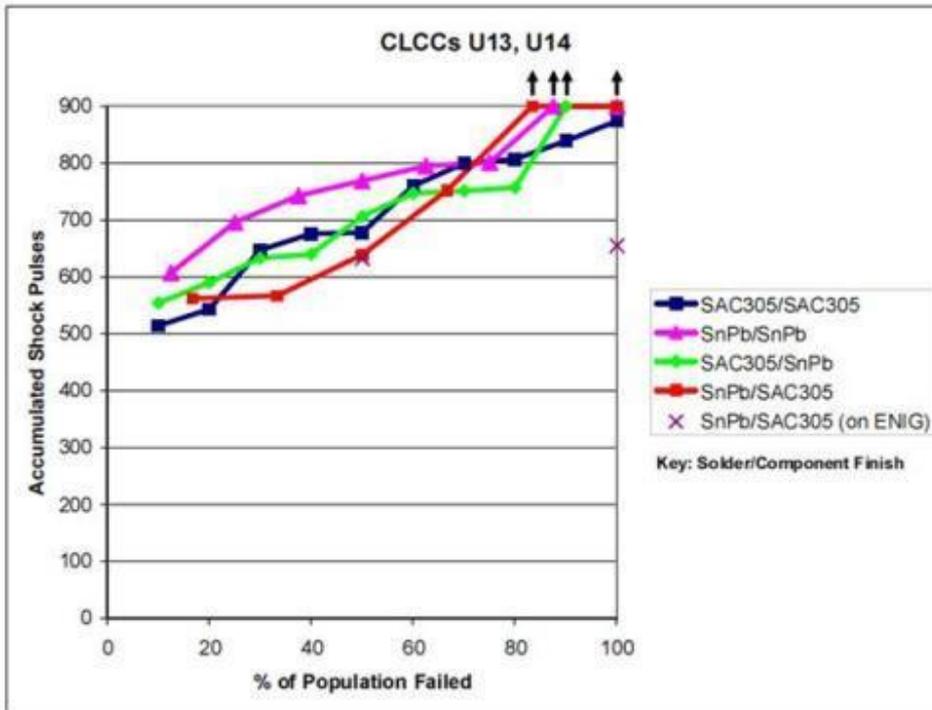
For the CLCC-20 components, the SnPb/SnPb controls outperformed the combinations of SAC305/SAC305, SnPb/SAC305, and SAC305/SnPb (Figure 38).

Figure 38 - Combined Data from CLCC's U13 and U14

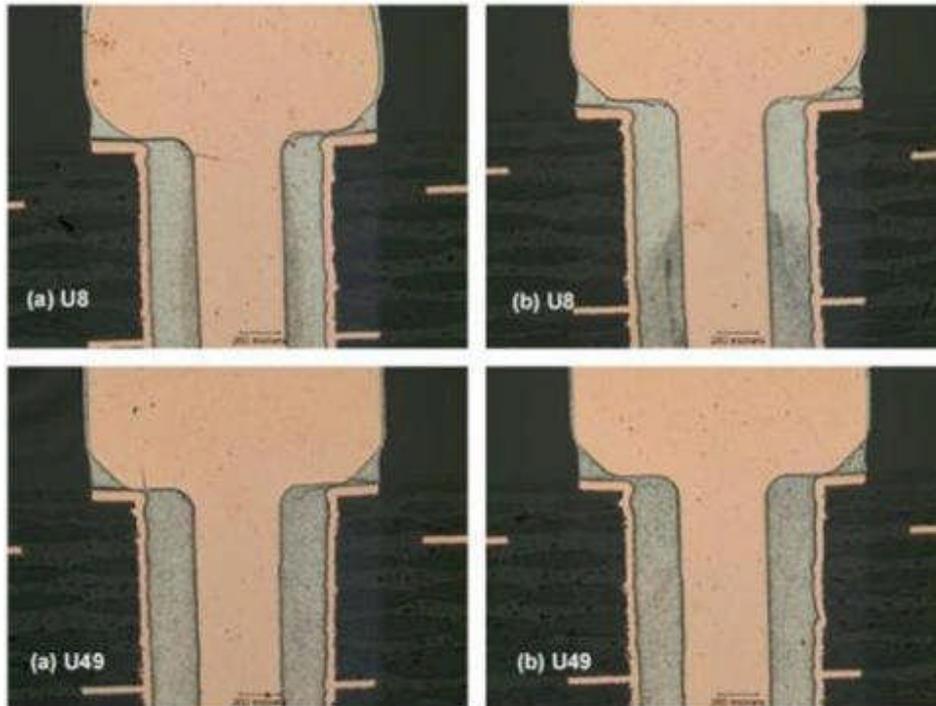
The combination of SN100C solder/Sn component finish generally performed as well as the SnPb/SnPb controls in mechanical shock although some of the SN100C/Sn solder joints failed early. Microsections made at the end of the test showed that the corner solder joints failed before the other solder joints. The topside solder fillet would crack first followed by cracking of the lead where it necks down at the top of the PTH (Figure 43 and Figure 44).

Figure 43 - Test Vehicle 34 – PDIPs U8 and U49 (a) Corner Lead, (b) Lead Adjacent to Corner Lead (SnPb Solder/SnPb Finish)

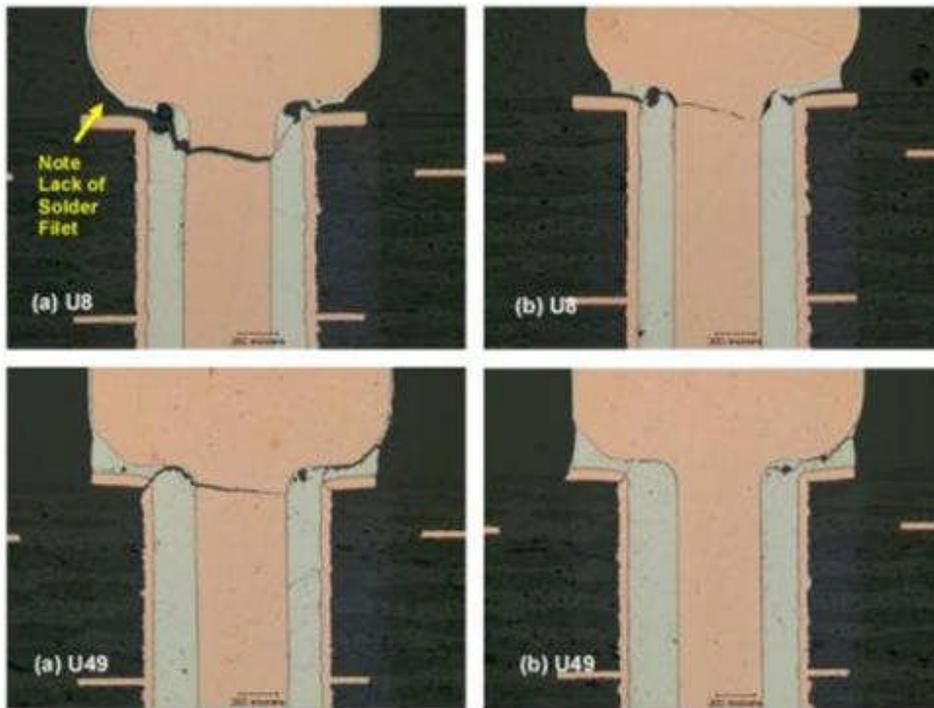
Figure 44 - Test Vehicle 89 – PDIPs U8 and U49 (a) Corner Lead, (b) Lead Adjacent to Corner Lead (SN100C Solder/Sn Finish)

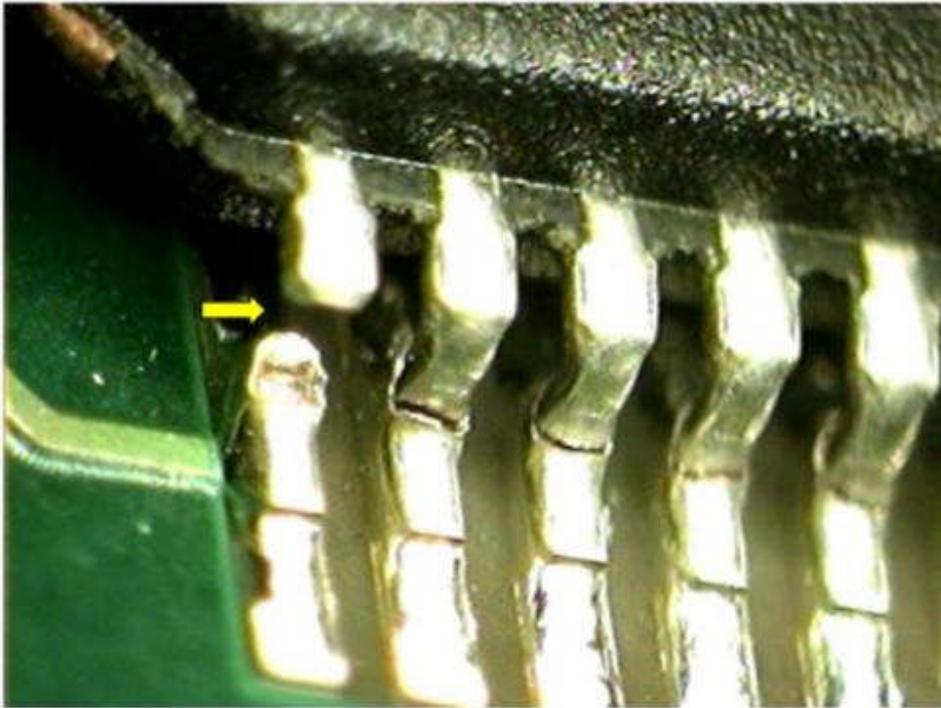
Most of the TQFP-144’s had broken and/or missing leads at the end of the test (Figure 48). Since most of the failures appeared to be due to broken leads, the scatter in the test data for all of the TQFP solder/finish combinations was small. SAC305/Sn was equivalent in performance to SnPb/Sn, SnPb/NiPdAu (on immersion Ag), and SnPb/NiPdAu (on ENIG). SAC305/NiPdAu was superior to the SnPb/Sn controls in performance.

Figure 48 - Test Vehicle 89 TQFP U3 (Cracked Leads, Missing Lead)

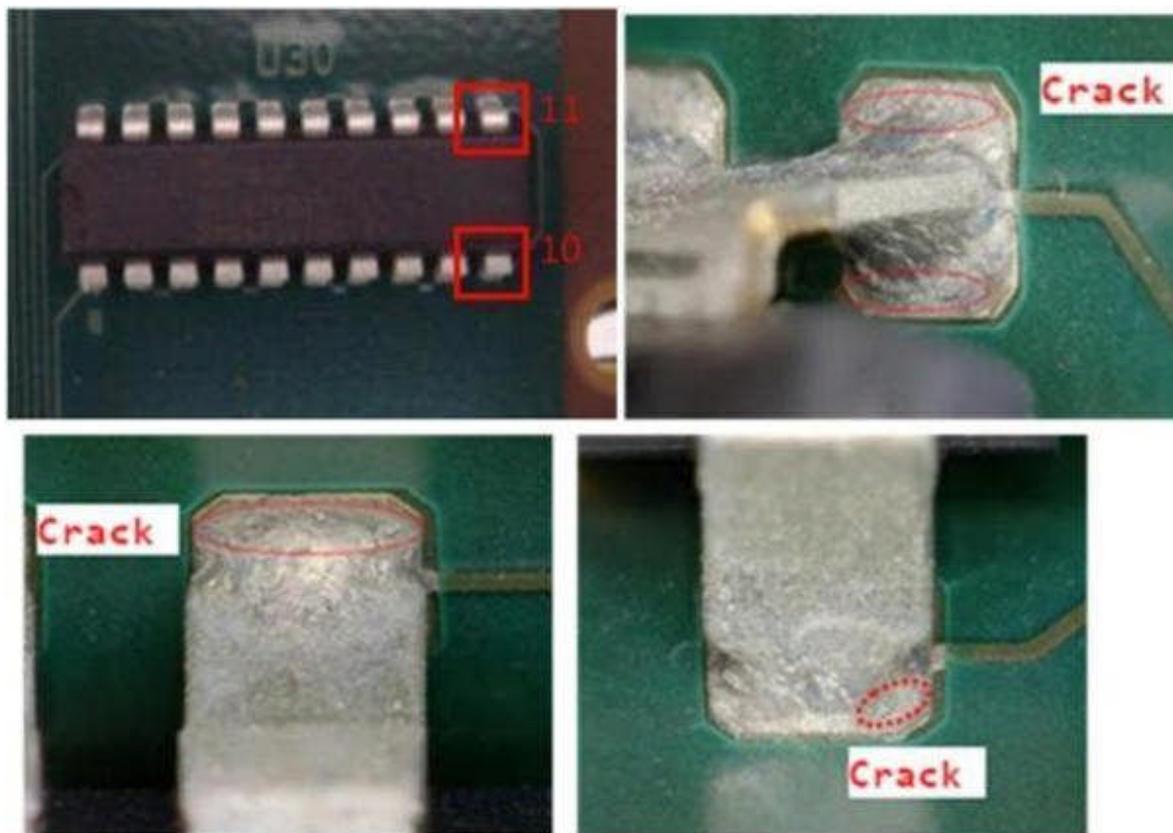
Component location U30 is a PDIP-20 from the SnPb manufactured (Batch C), soldered with SnPb on tin plated component finish. This component survived all 650 cycles of combined environments testing and it was surrounded by components that fell off during testing. Figure 57, the red boxes highlight the two leads that were magnified to indicate observed cracking in the solder joints. The image in the upper right is of lead 11, which indicates two areas with cracking. The image in the bottom left is the top portion of lead 11 and the bottom right image is of lead 10 showing a small crack near the pad. Crack has not caused an electrical failure, yet.

Figure 57 - TV23 U30; Optical Micrograph, PDIP-20

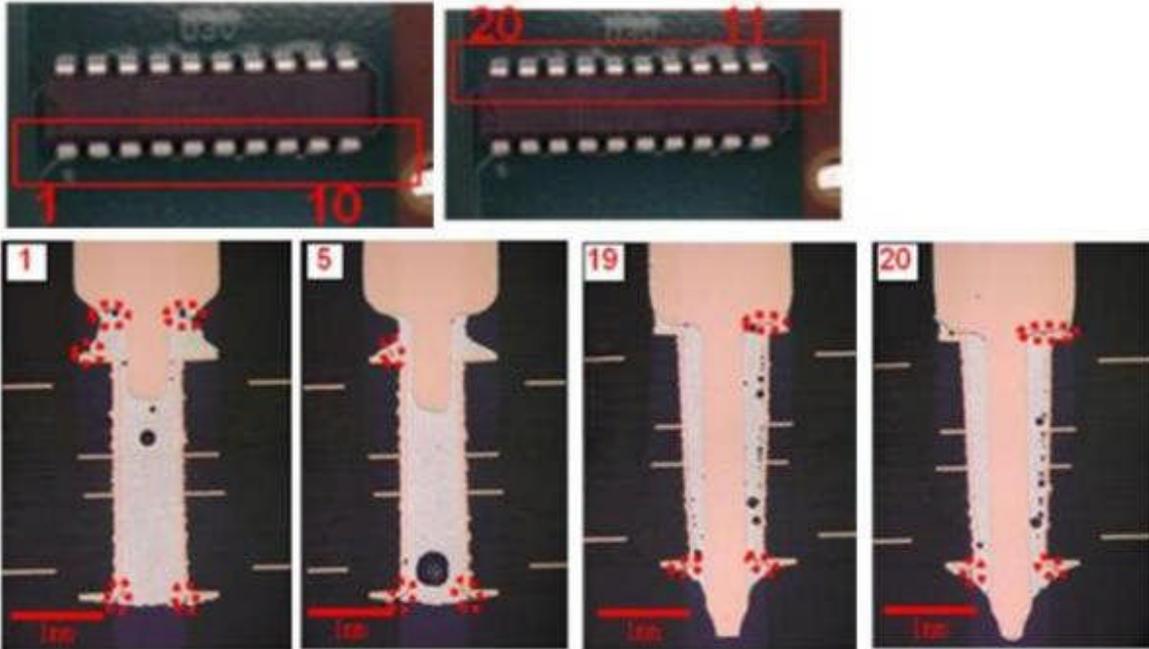
Figure 58 shows cross-sectional micrographs of PDIP-20 leads where the two images on the top are indicating the lead numbering. The cross-sections of leads 1, 5, 19 and 20 were selected as an example of the leads that had large quantities of voids, relative to the other component leads. The dotted lines indicate solder cracks that were found; no break off solder was found during failure analysis.

Figure 58 - TV23 U30; Cross-Sectional Micrographs of PDIP-20 Leads

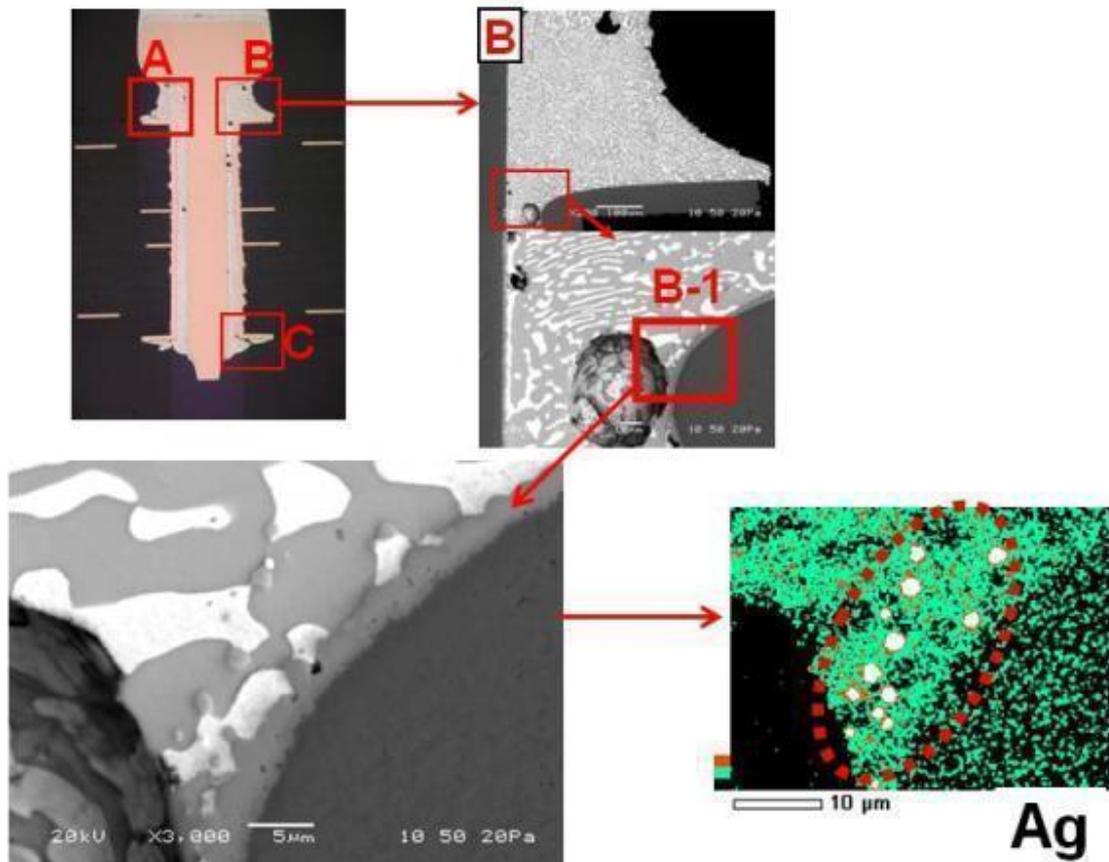
The micrographs in Figure 59 show progression of analysis for lead 9 of PDIP-20 component beginning with upper left and following the arrows to the image on the bottom right. This analysis found silver (bottom right) within the solder joint. The source of the silver may have been the immersion silver board finish.

Figure 59 - TV23 U30; Micrographs, Lead 9 of PDIP-20

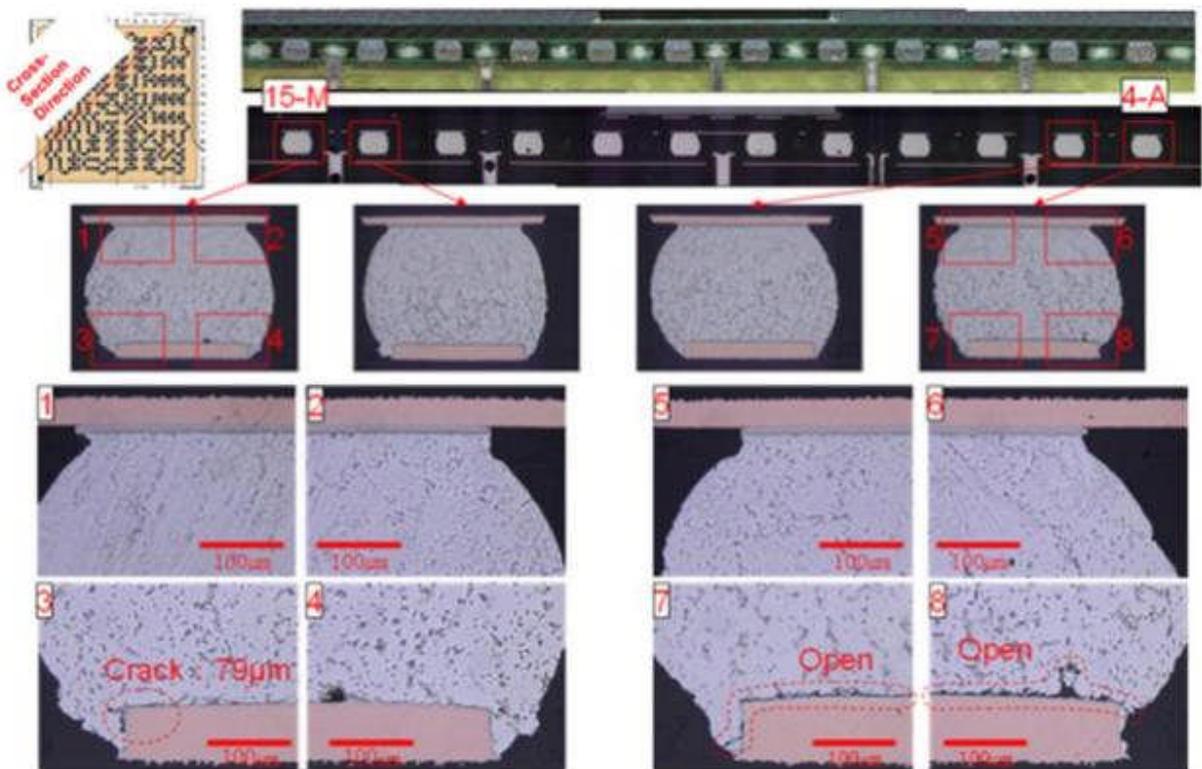
Cross-sectional micrographs in Figure 61 show different solder structure in lands on board (3, 4, 7, 8) and lands on component (1, 2, 5, 6). Cracking to open along land on board observed at 3-A.

Figure 61 - TV23 U43; Cross-Sectional Micrographs

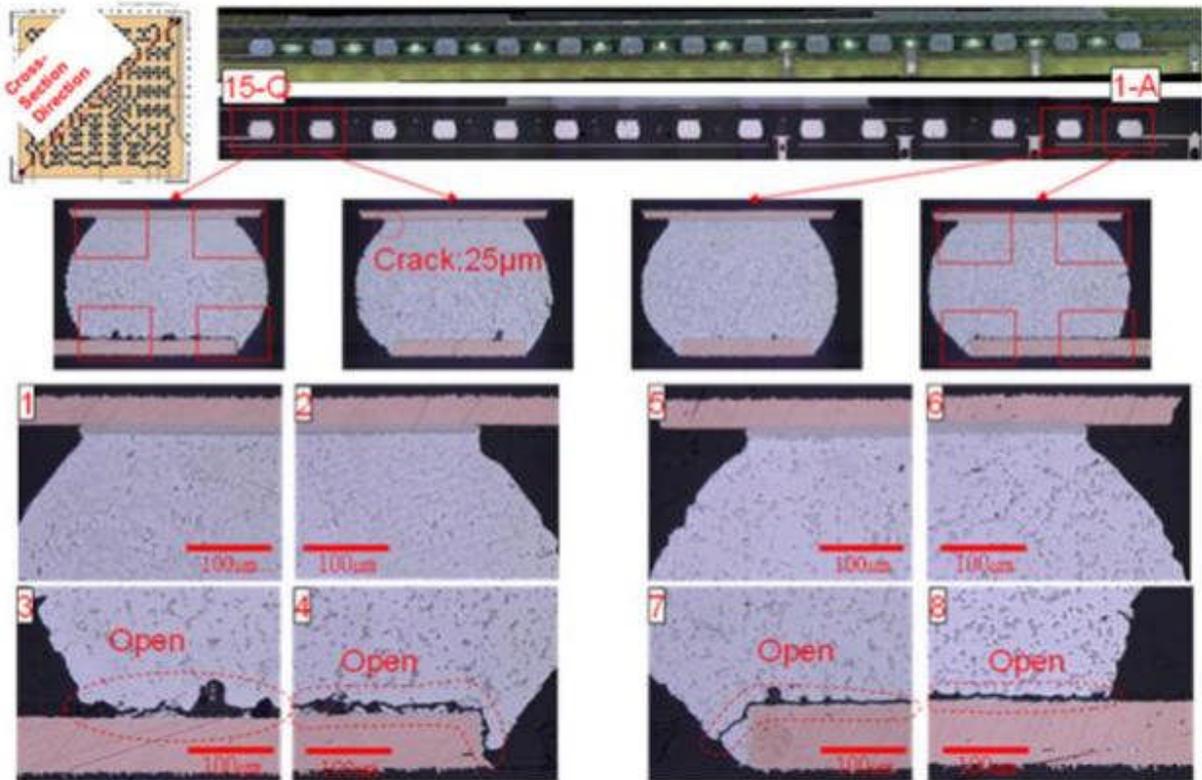
Cross-sectional micrographs in Figure 62 show different solder structure in lands on board (3, 4) and lands on component (1, 2). Cracking to open along land on board observed at 1-A and 15-Q.

Figure 62 - TV23 U43; Cross-Sectional Micrographs

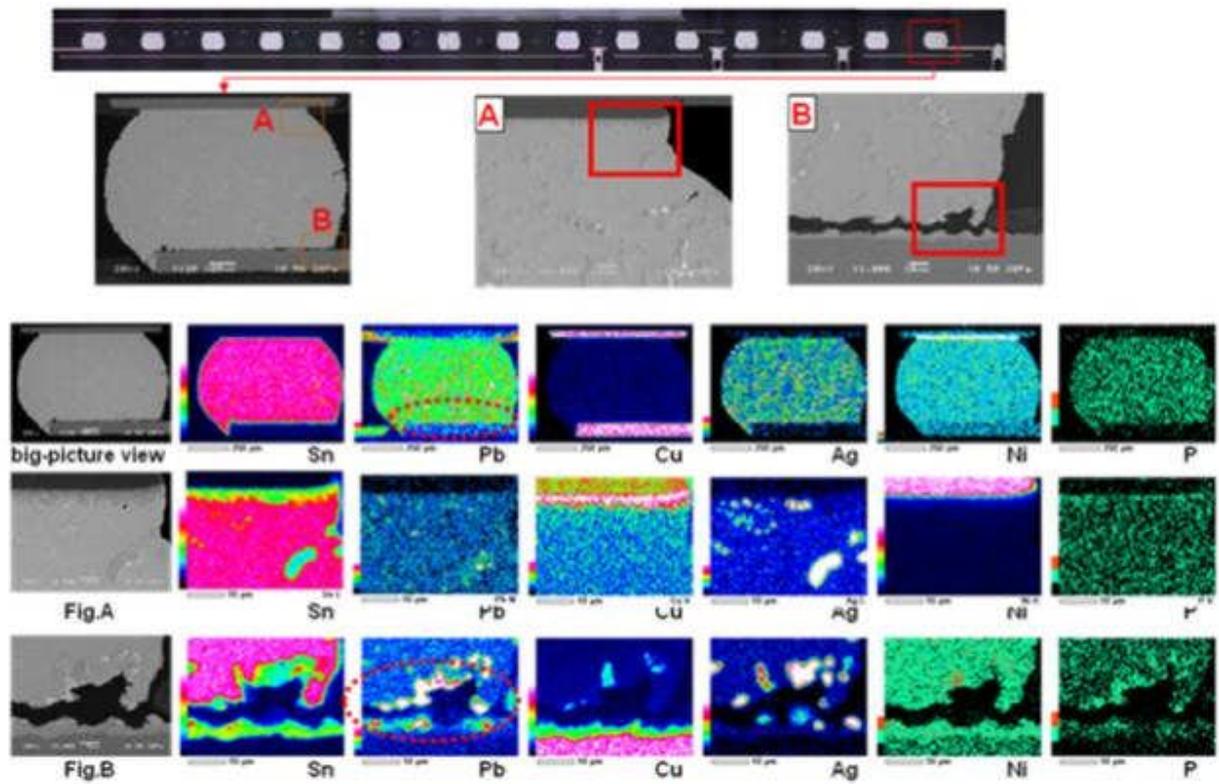
In Figure 63 SEM mapping shows segregation of Pb around land on board. Cracking found in the part Pb segregated.

Figure 63 - TV23 U43; SEM Mapping

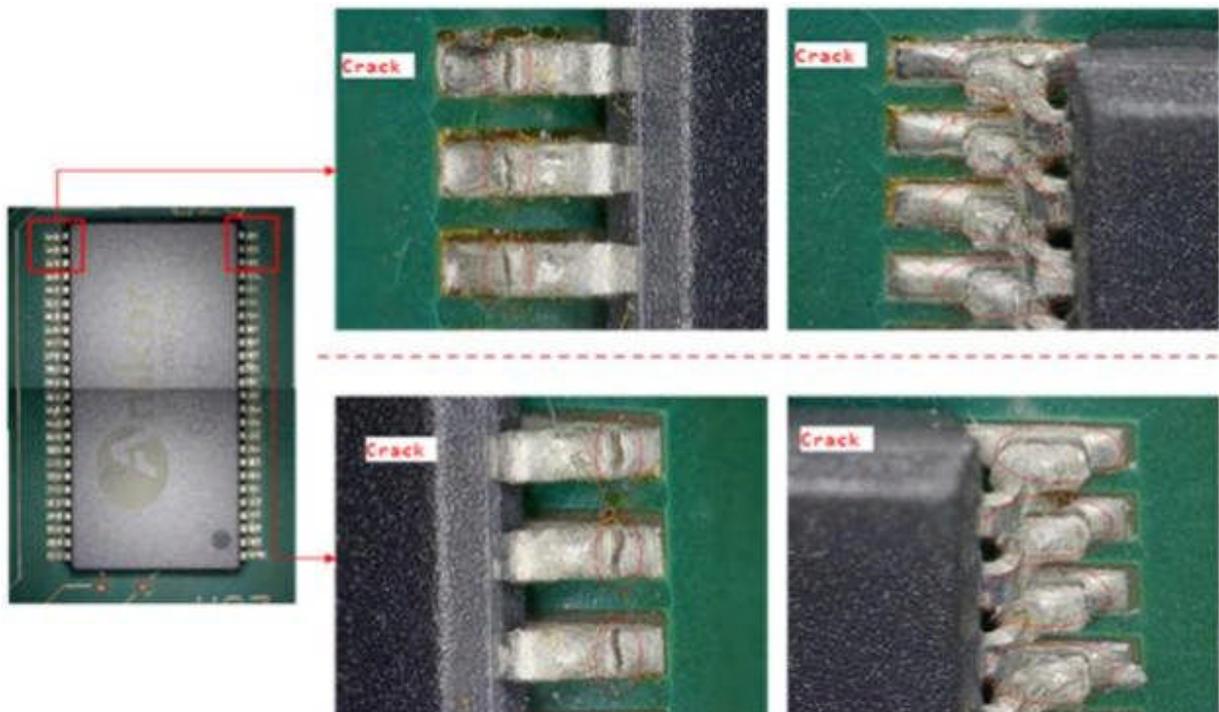
Component location U29 is a TSOP-50 soldered with SAC305 on SnPb component finish. This component failed at 161 cycles of combined environments testing.

Figure 65 - TV72 U29; Visual Inspection Showing Cracked Solder Joints

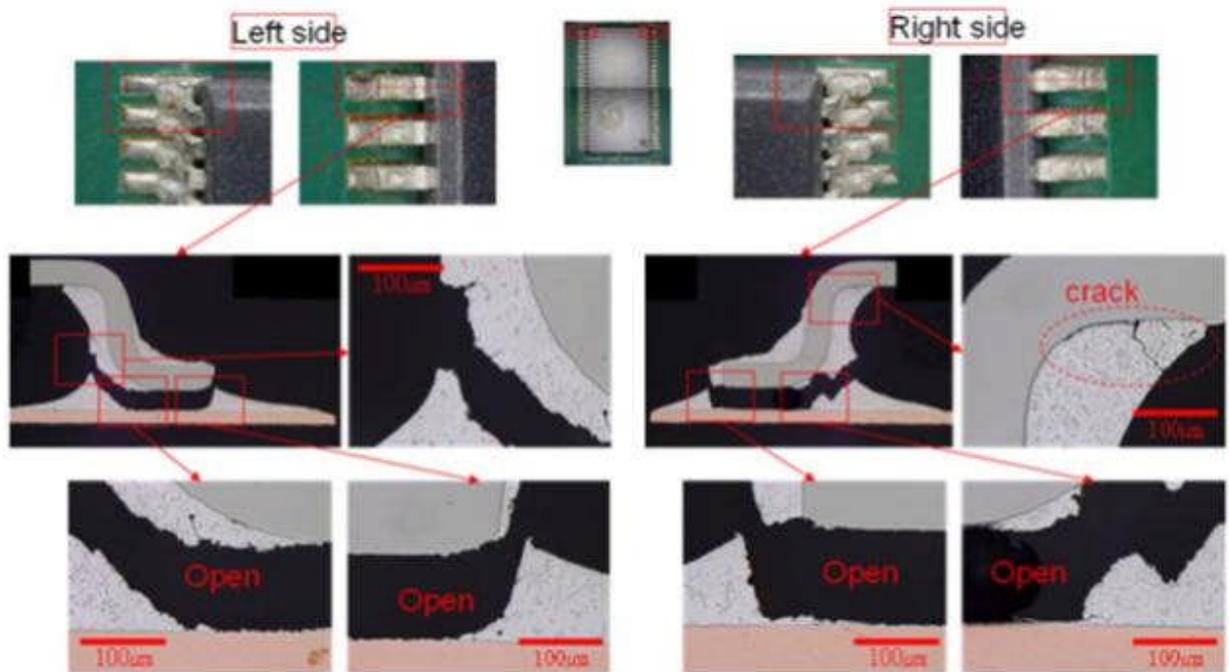
Figure 66 - TV72 U29; Cross-Section Micrographs Showing Open Solder Joints

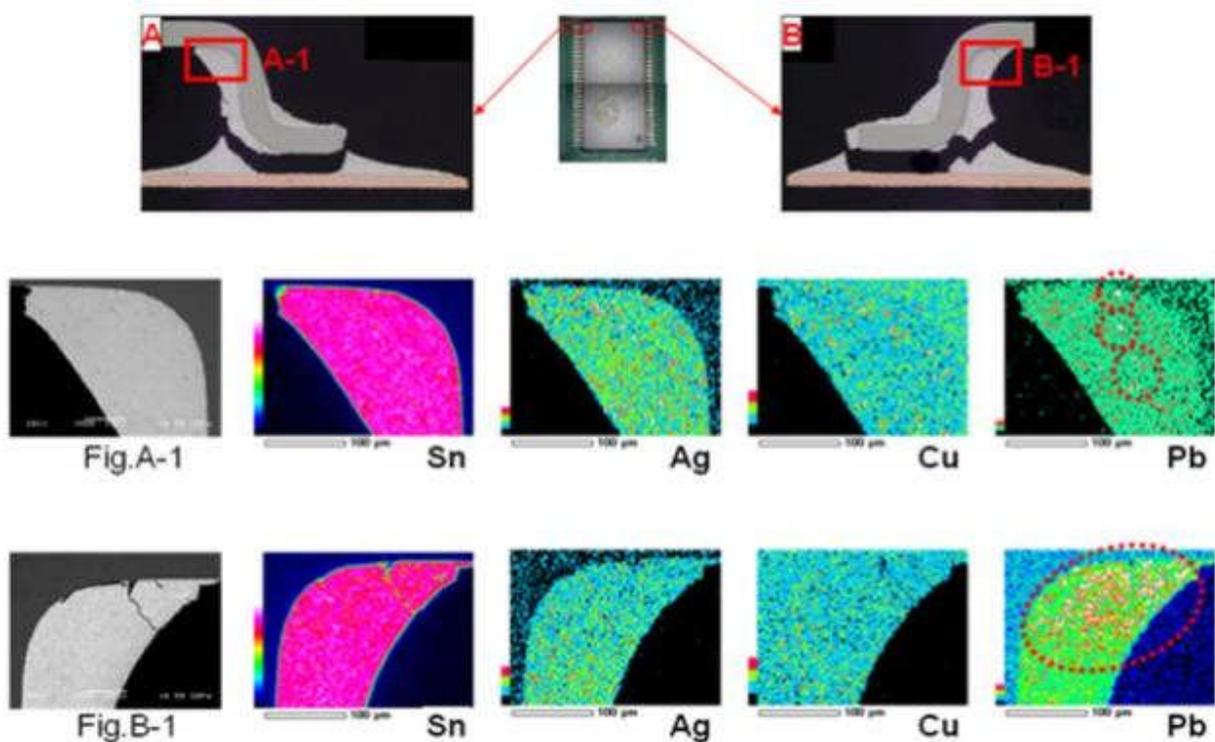
As observed in Figure 67, more Pb was found from the right lead. Source of Pb is from the lead plating.

Figure 67 - TV72 U29; SEM Mapping, Pb was Found Around Upper Part of the Both Leads

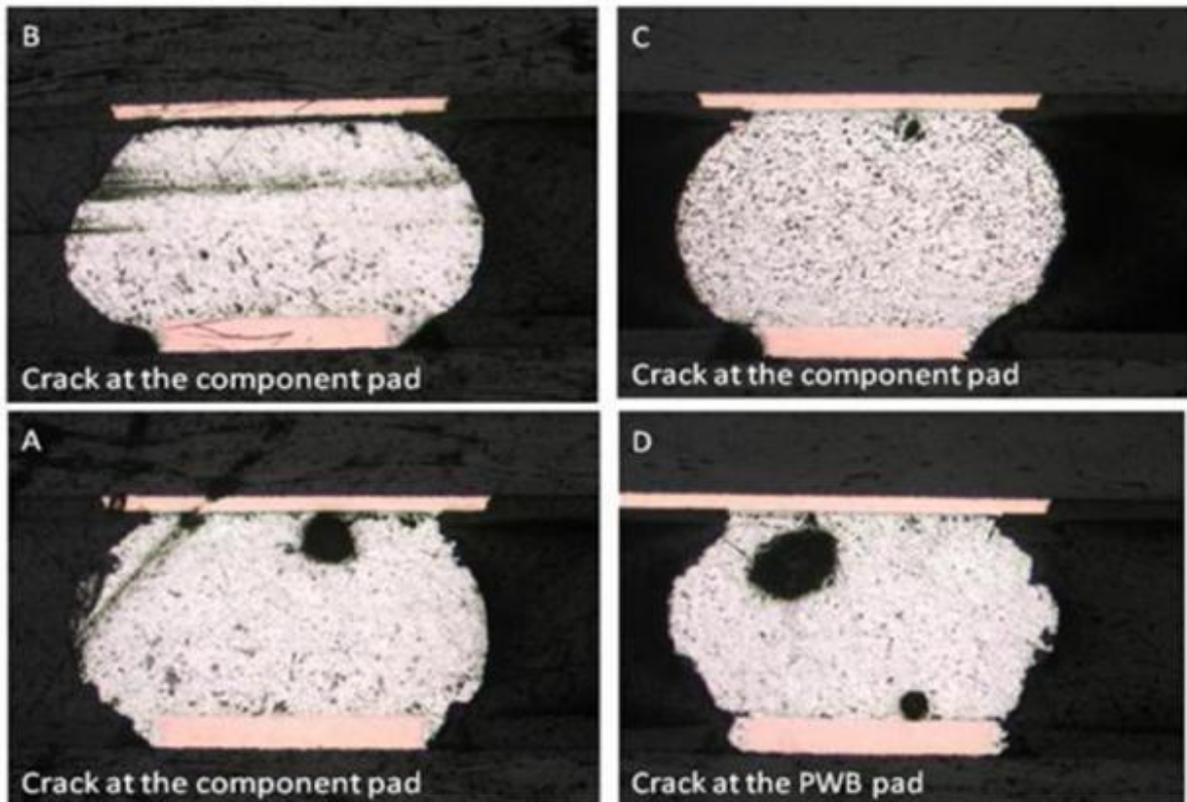
Figure 69 shows cross-sectional micrographs of corner solder balls depicting cracks at component pads on views A, B and C. Crack at the PWB pad detected on view D.

Figure 69 - TV117 U4; Cross-Sectional Micrographs of Corner Solder Balls

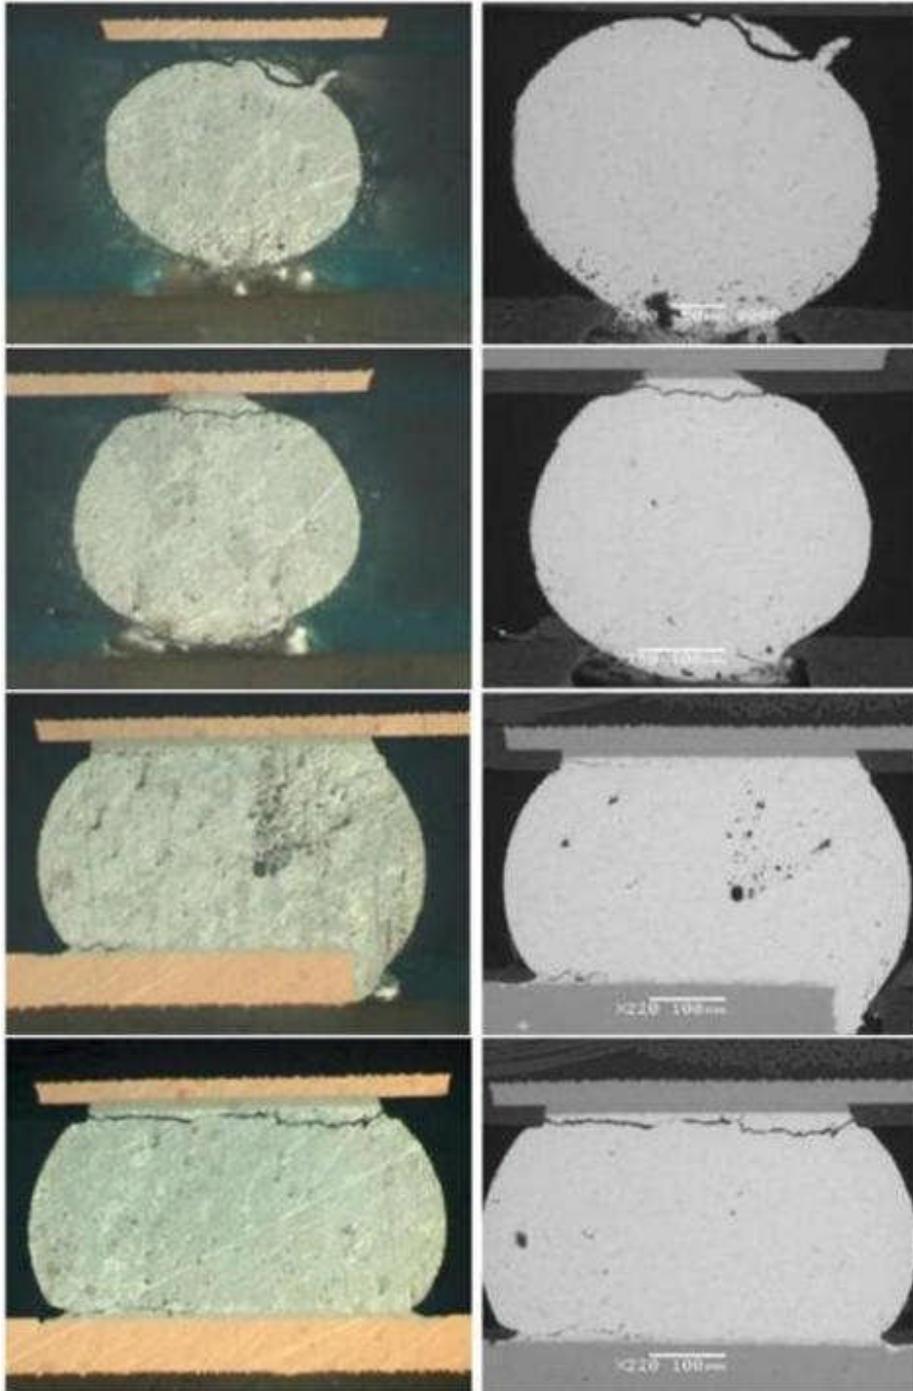
In Figure 73 on the left, cross-sectional micrographs of solder ball A1, A2, A9 and A10, at 274X magnification. On the right, the corresponding SEM images for solder ball A1 (300X), A2 (250X), A9 (220X) and A10 (220X).

Figure 73 - TV119 U36; Cross-Sectional Micrographs of Solder Balls A1, A2, A9 and A10

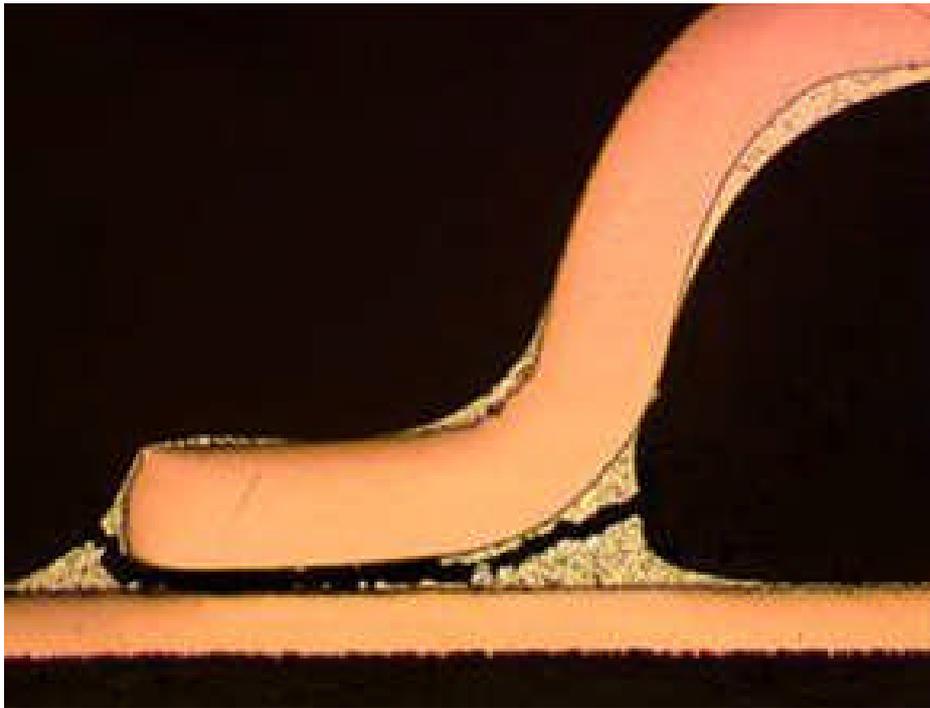
Figure 219 – Fatigue Failure of TQFP-144 with 1x Rework as seen through cross sectioning

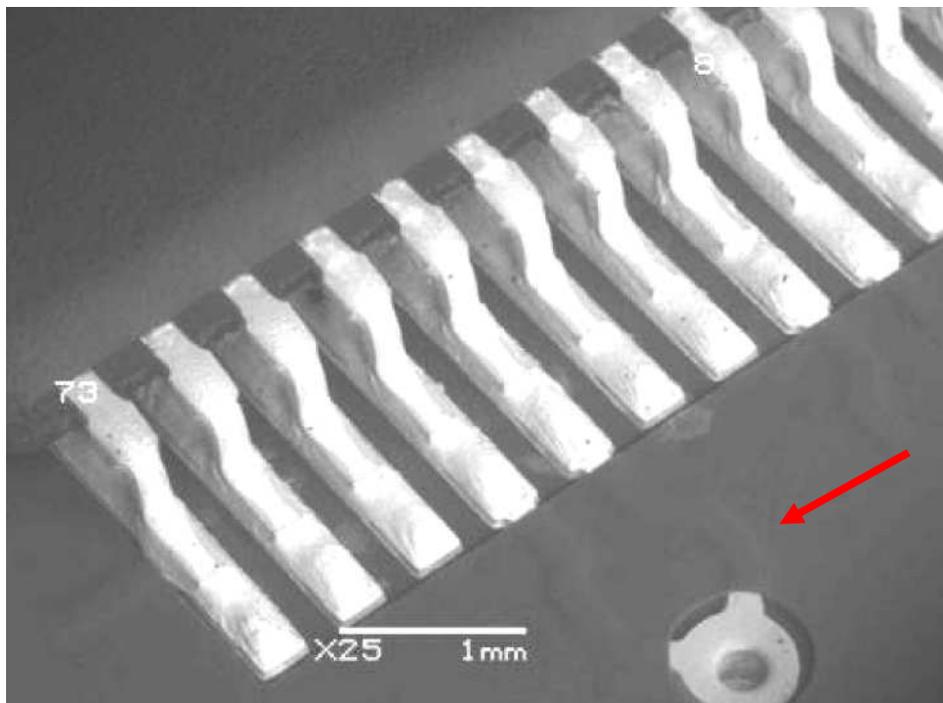
Figure 221 - U57 TQFP, SEM Image, Solder Mask Crack near Leads 73-81 (X25)
