**Technology Evaluation for Environmental Risk
Mitigation Principal Center**

NASA-DoD Lead-Free Electronics Project

Joint Test Report - Final

December 2011

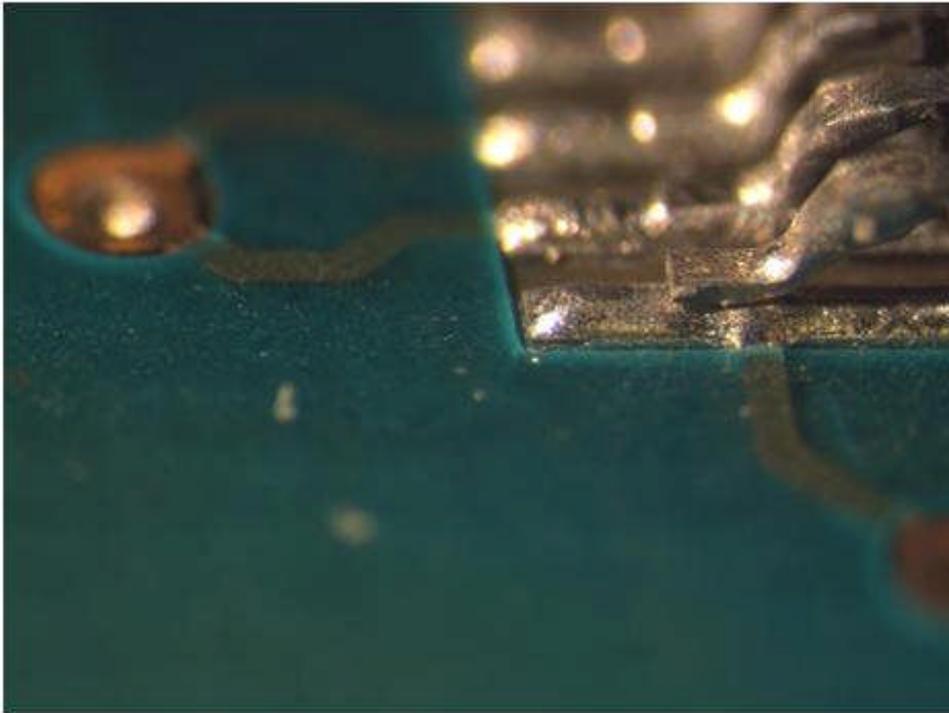
Figure 222 - U34 TQFP, Lead 72 marked (X49); Open due to Non Coplanarity

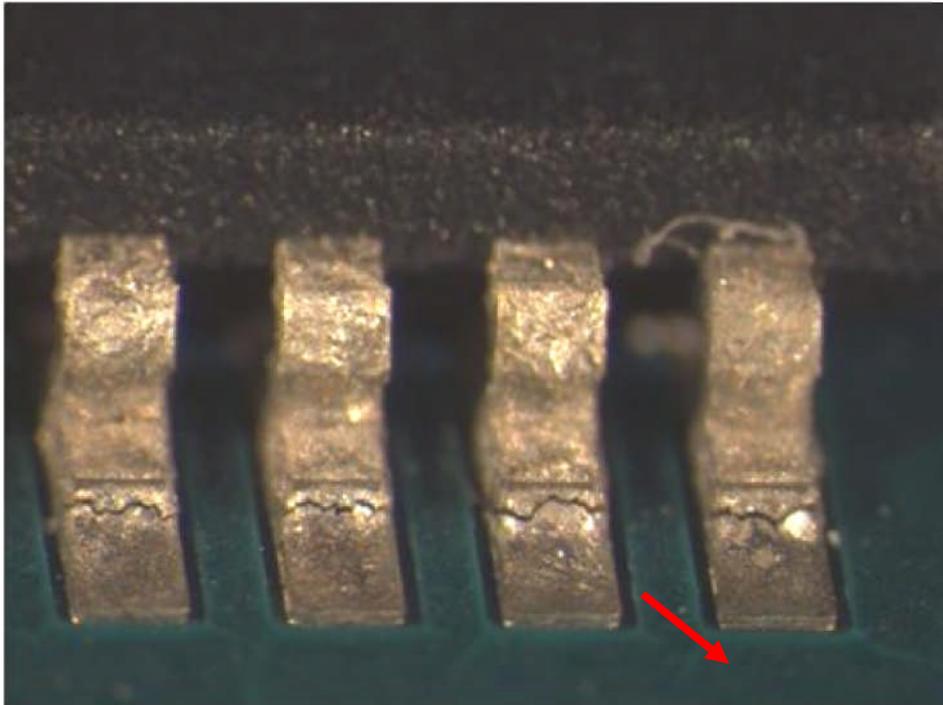
Figure 224 – U39 TSOP, Cracks in Solder Joints and Solder Mask (X49)

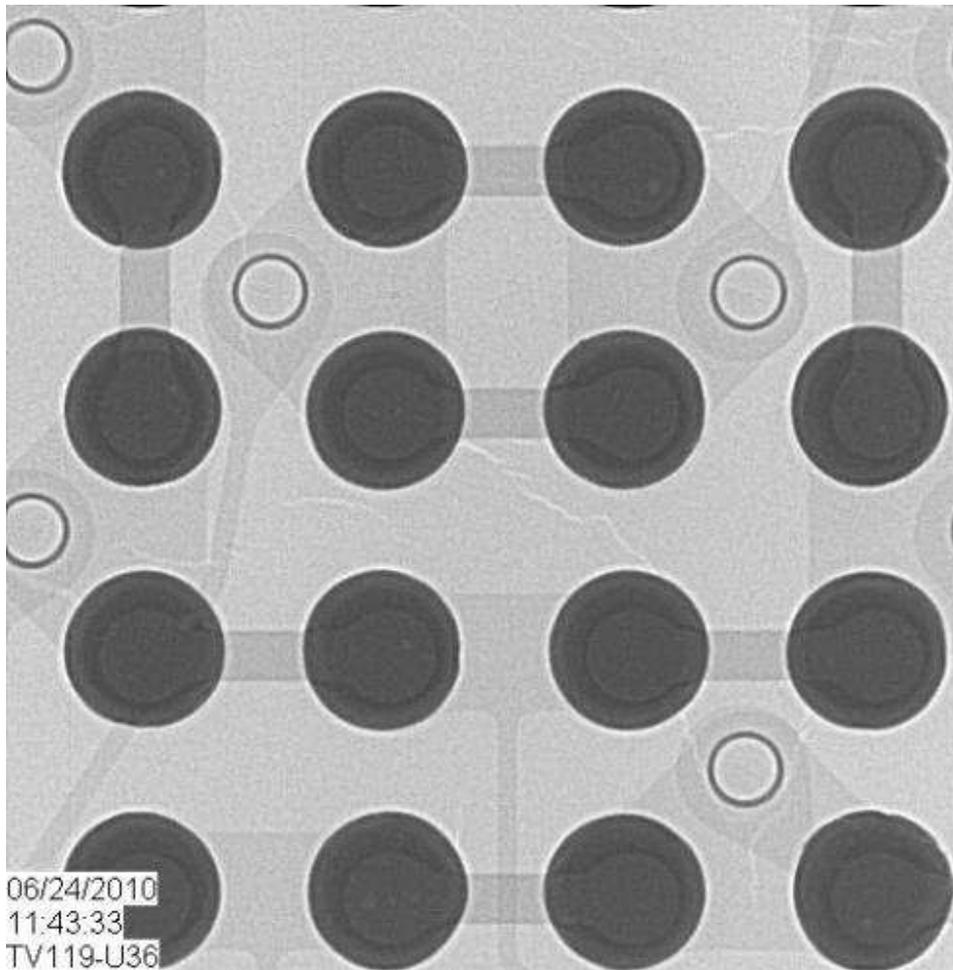
Figure 229 - U36 CSP, X-ray Image, Center Region, Solder Mask Cracks

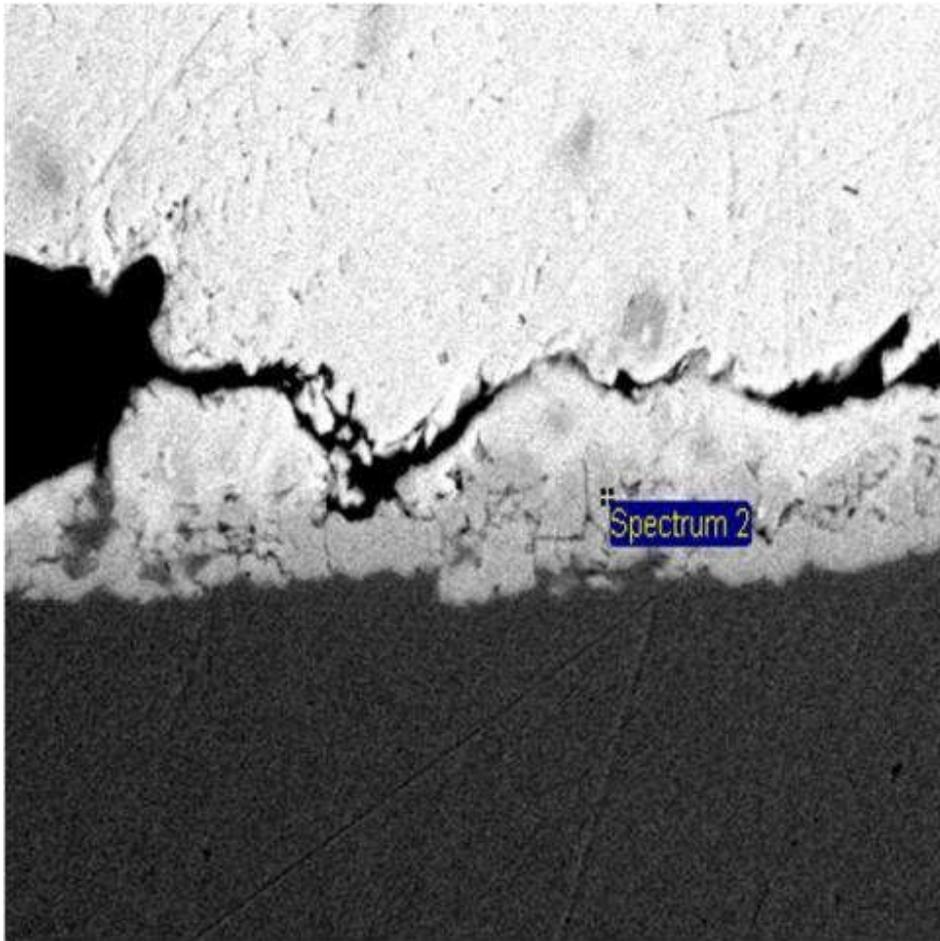
Figure 230 – U36 CSP, Solder Ball A10, PCB Side, Cracks Developed at SnCu Phase

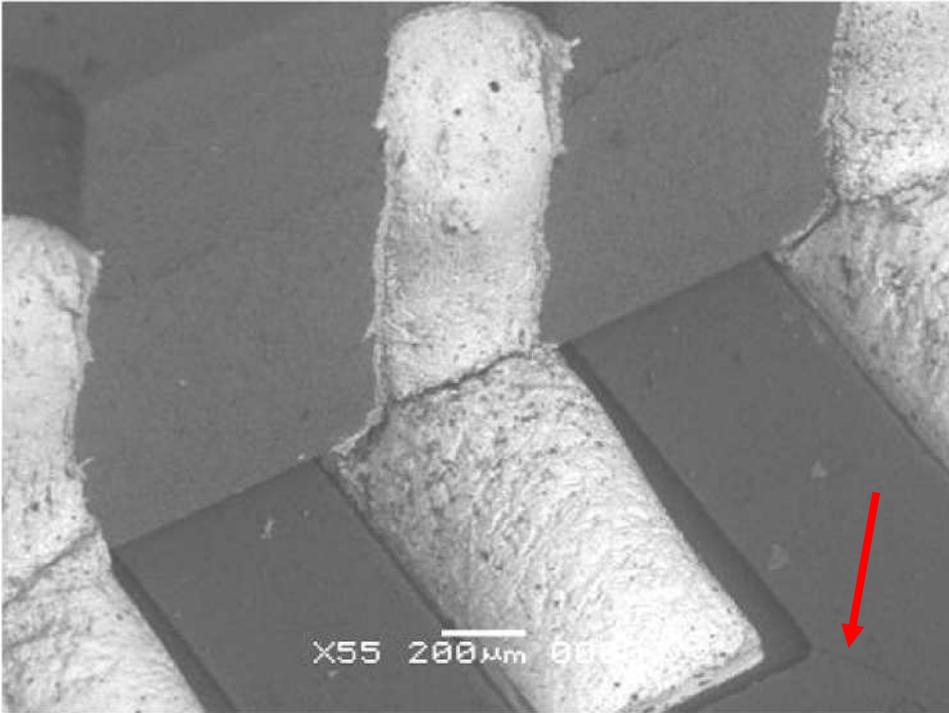
Figure 232 – U13 CLCC, SEM Image, Lead 8, Solder Crack and Solder Mask Crack (X55)

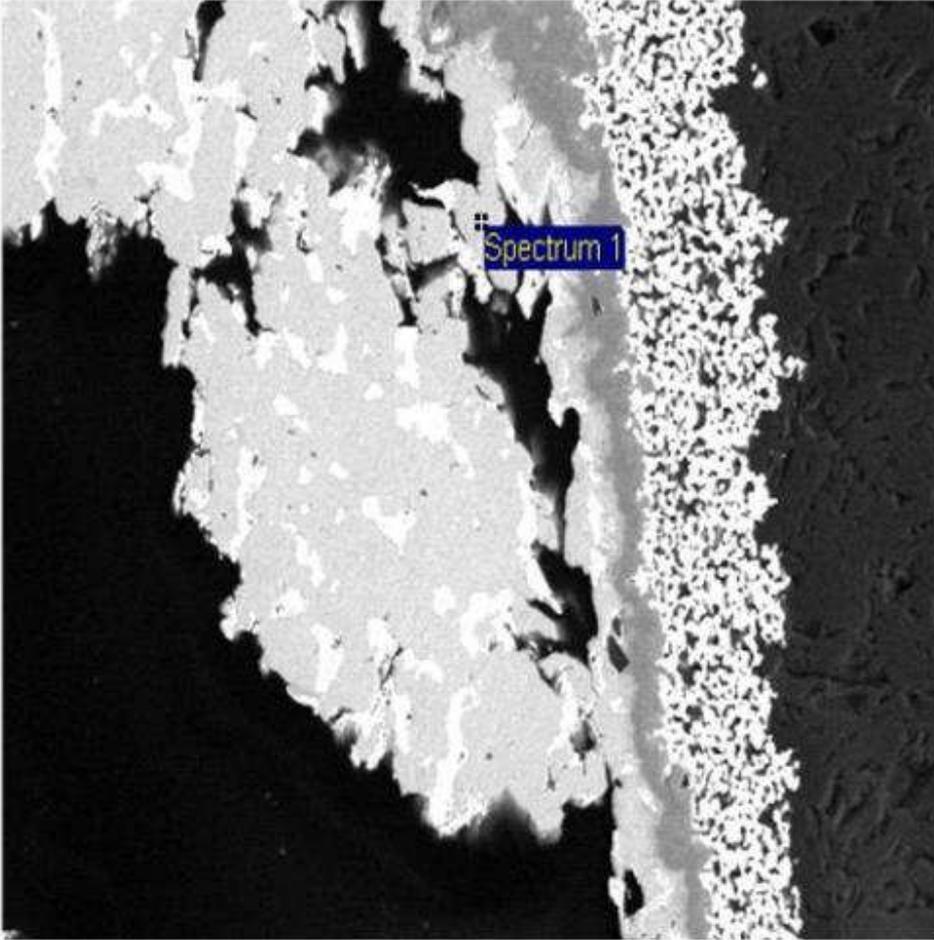
Figure 233 – U13 CLCC, Cracks Developed Through Sn Phase, Lead 20

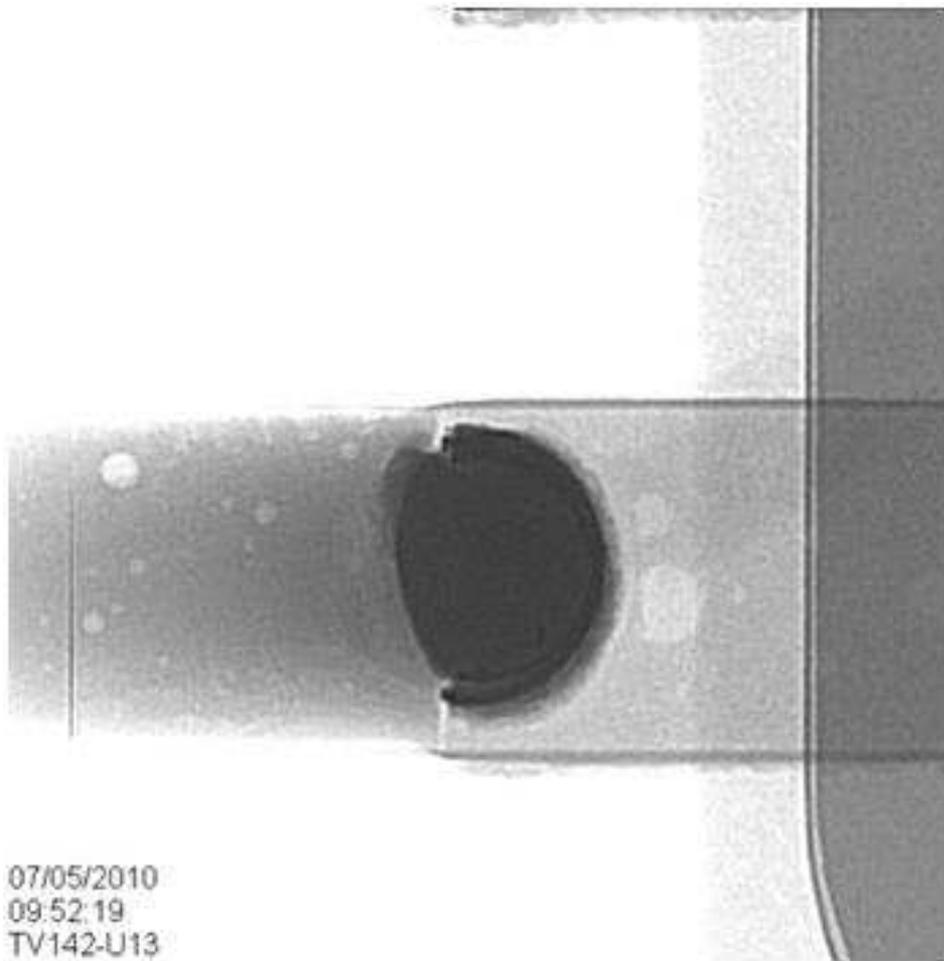
Figure 234 - U13 CCLC, X-ray Image, Voiding, Lead 20

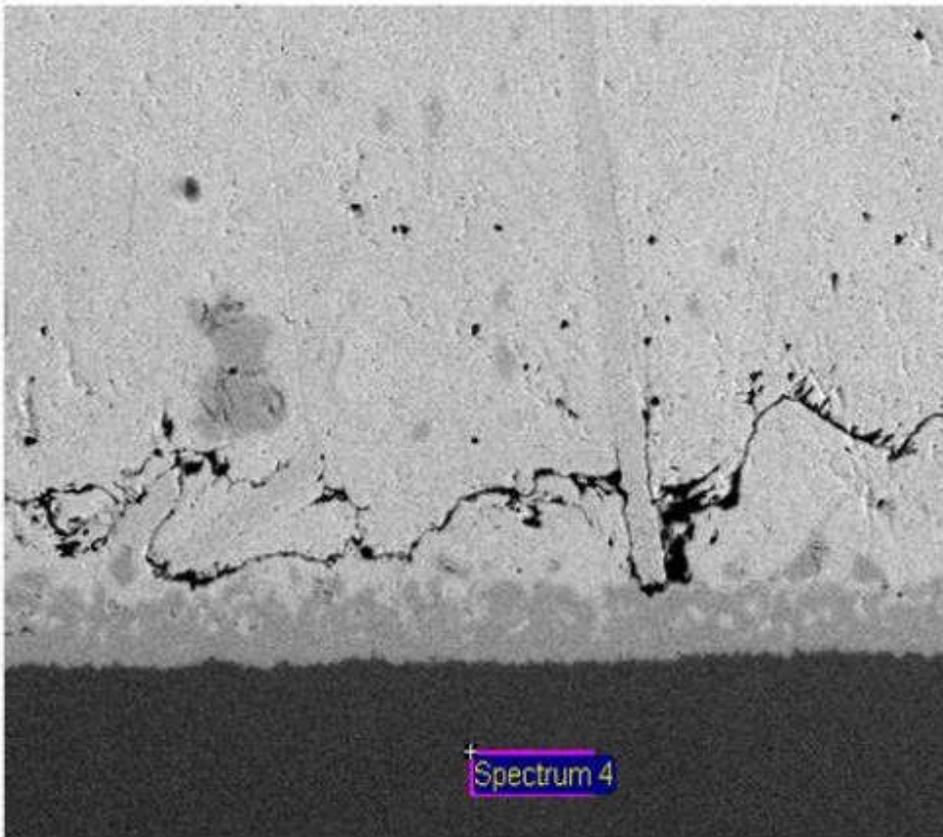
Figure 235 – U56 BGA, Solder Ball A15, Cracks Developed at SnCu Phase

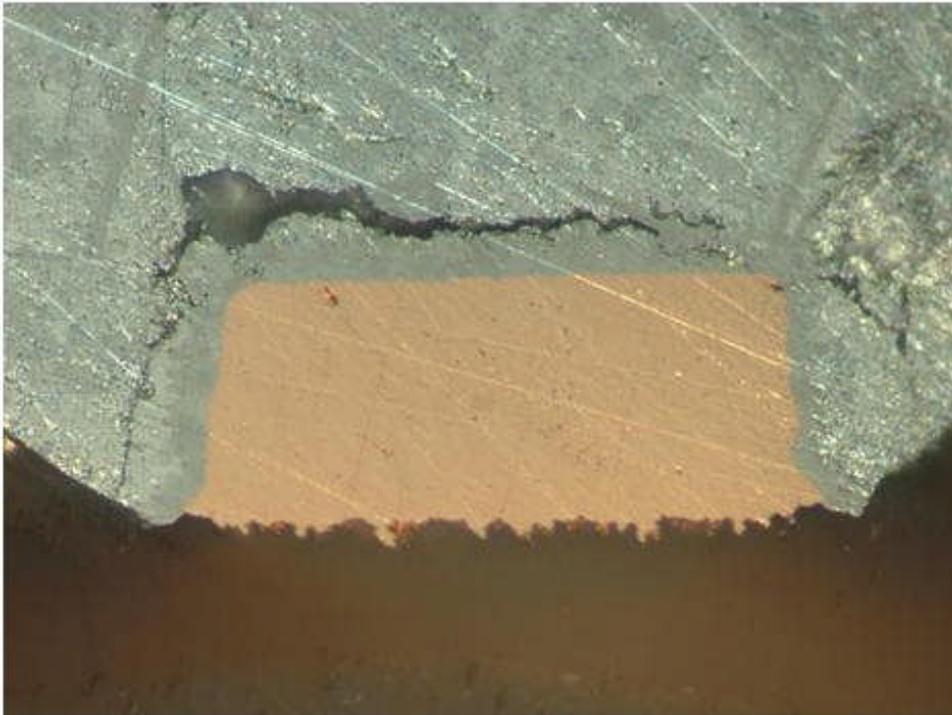
Figure 236 – U56 BGA, Cross Sectional View of Solder Ball A9, Void in Solder Joint (X682)

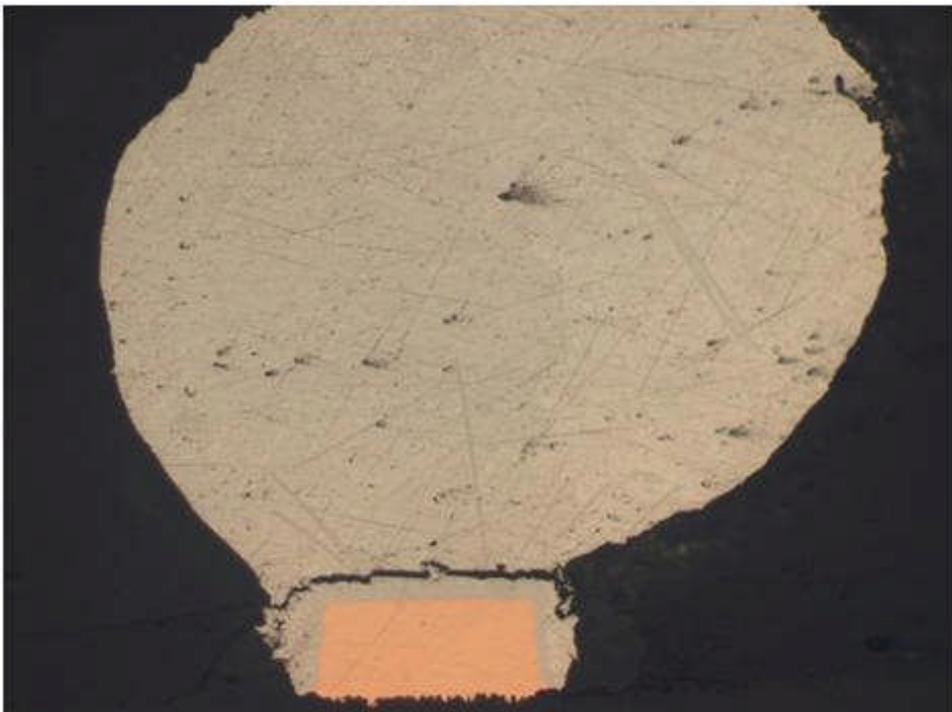
Figure 237 – U56 BGA, Cross Sectional View of Solder Ball A7, Crack on the Solder Joint at PCB Trace Interface

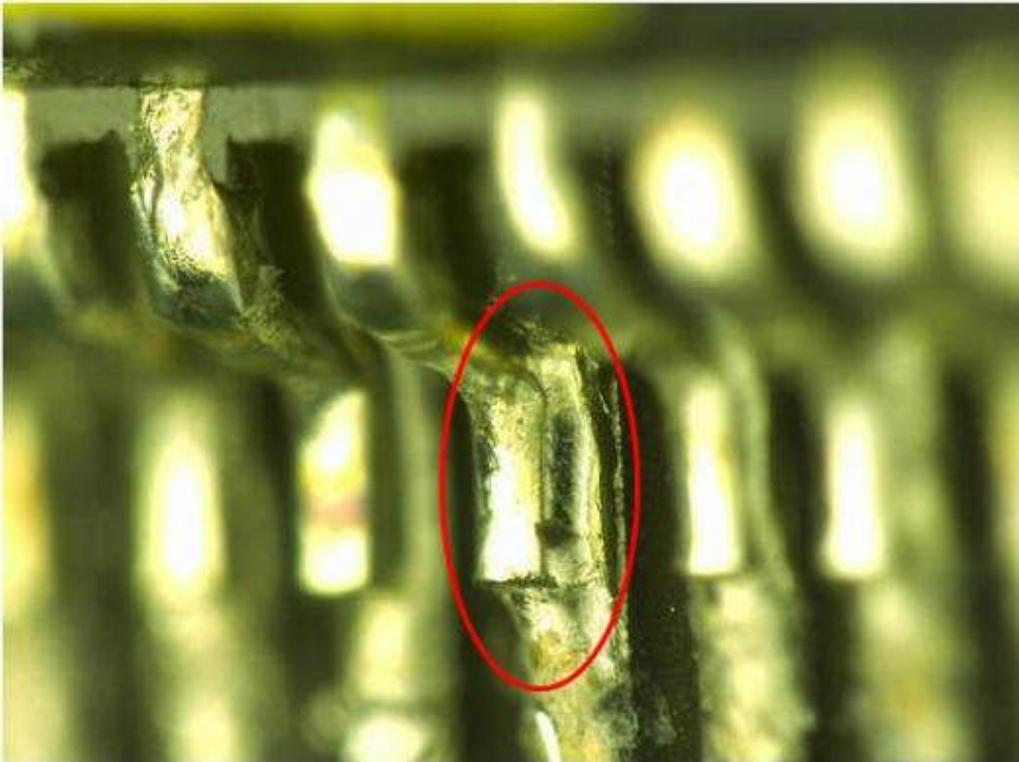
Figure 238 - Test Vehicle 183, Component U41 (TQFP-144); Unsoldered Lead from the Original Manufacturing Process

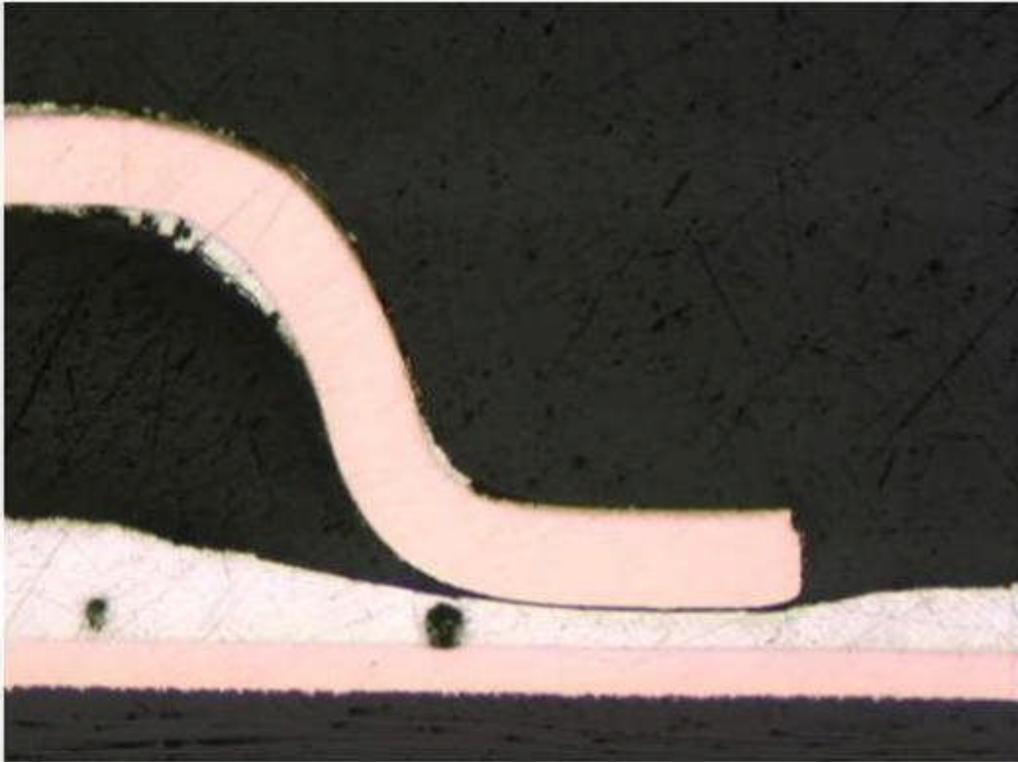
Figure 239 - Test Vehicle 183, Component U41 (TQFP-144); Unsoldered Lead from the Original Manufacturing Process

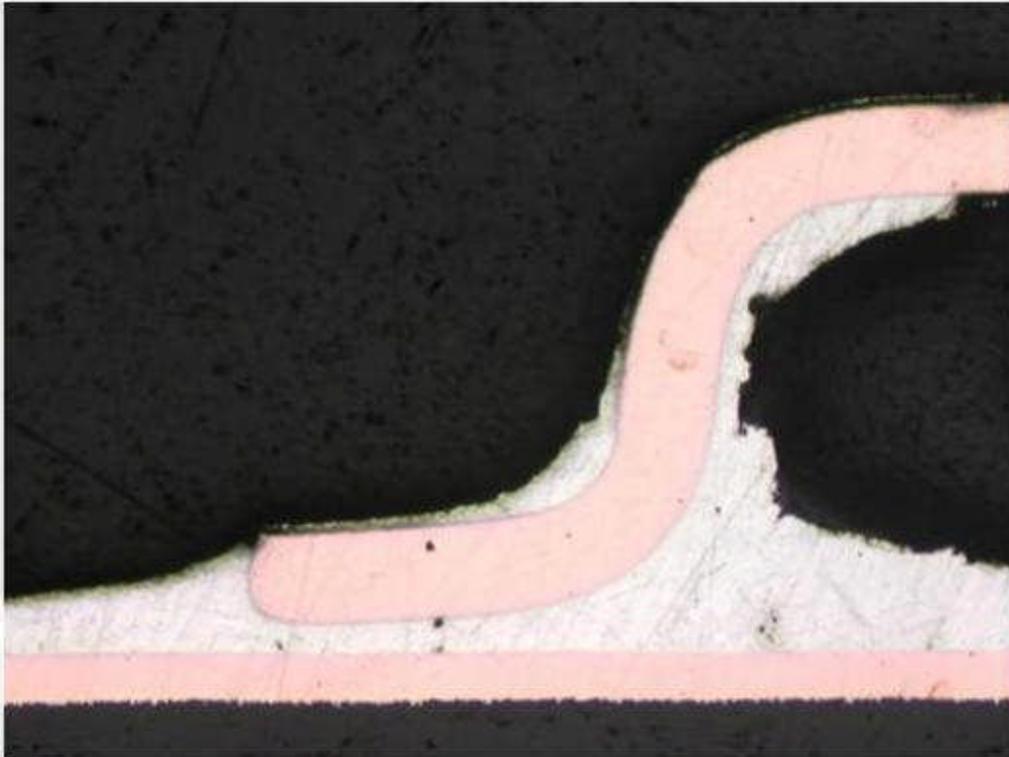
Figure 240 - Test Vehicle 183, Component U41 (TQFP-144); Solder Behind the Lead at the Heel is Irregular

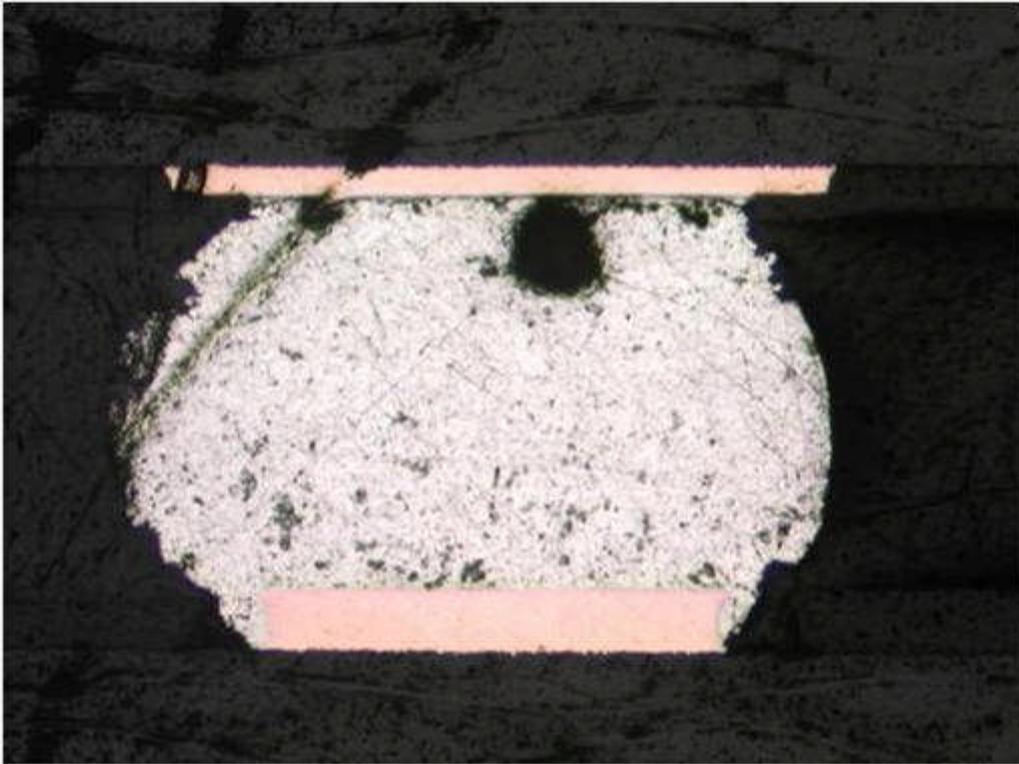
Figure 241 - Test vehicle 117, Component U4 (BGA-225); Crack at the Component Pad

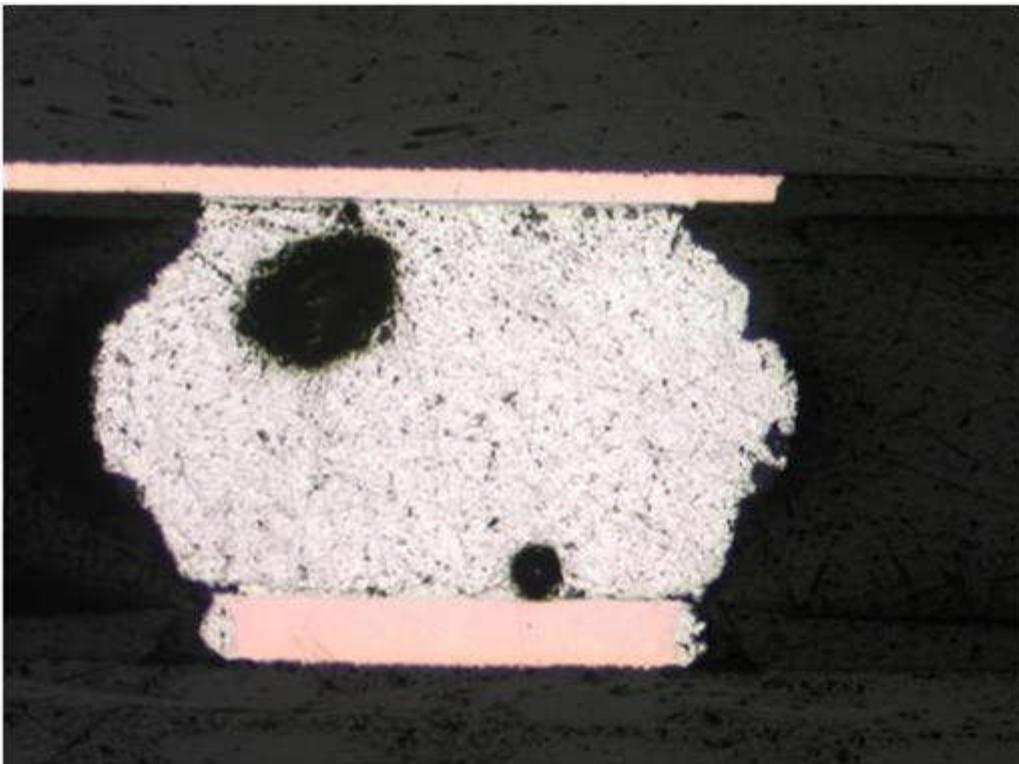
Figure 242 - Test vehicle 117, Component U4 (BGA-225); Crack at the PWB Pad

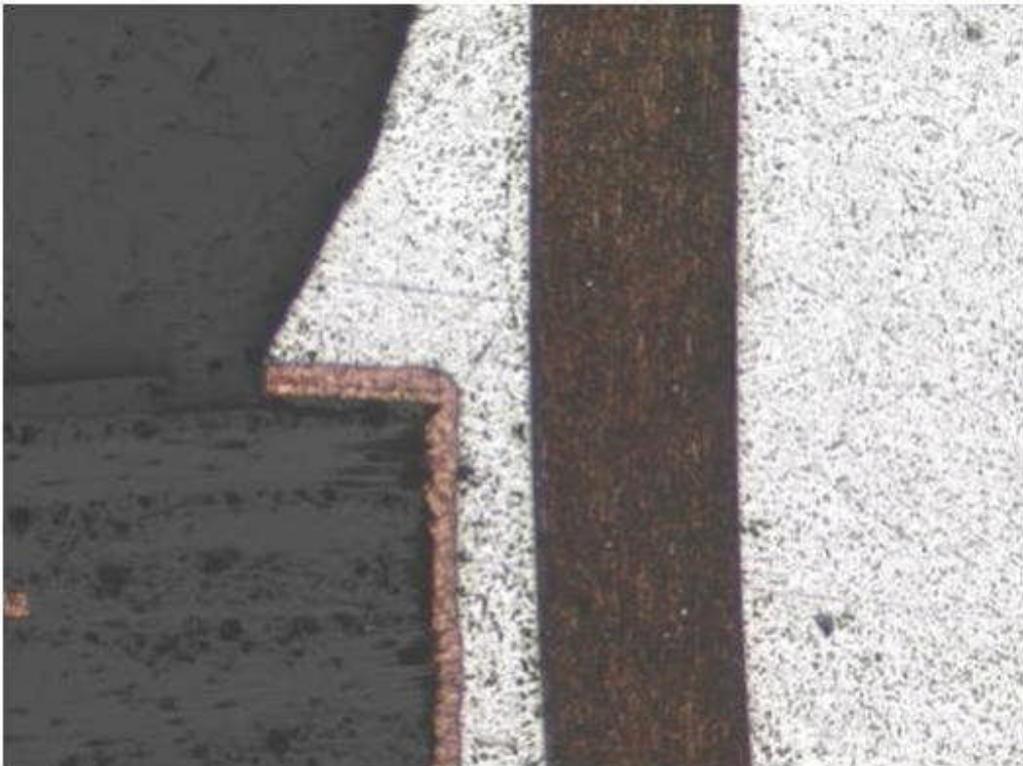
Figure 243 - Test Vehicle 140, Component U11 (PDIP-20); Lifted Pad

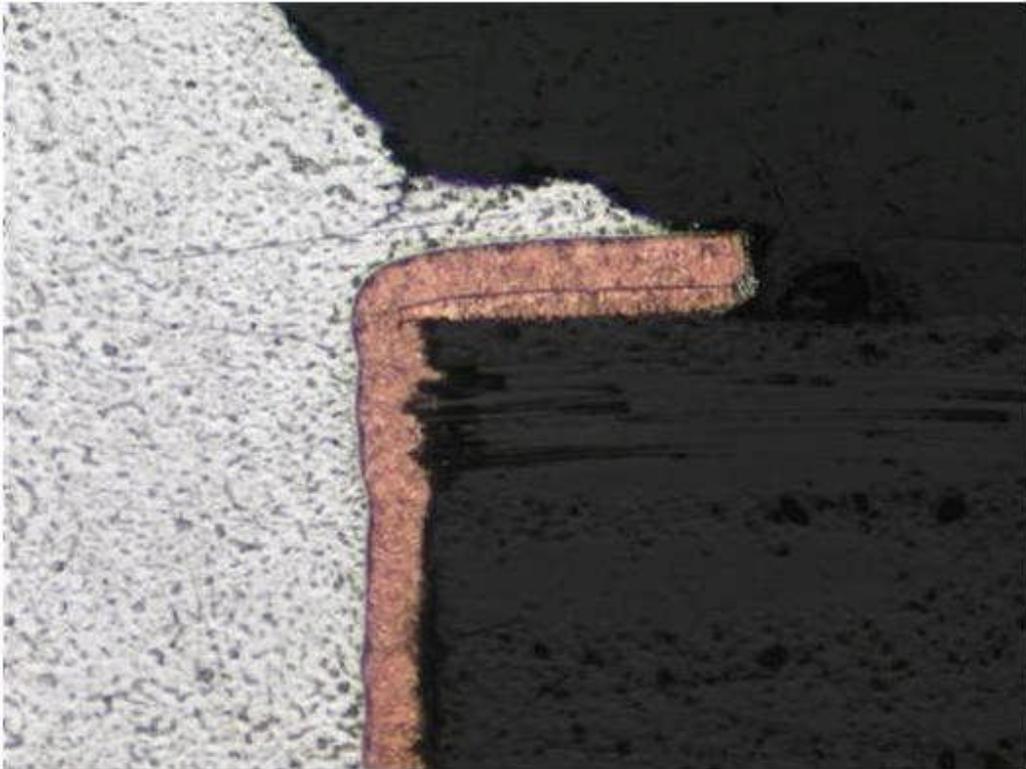
Figure 244 - Test Vehicle 140, Component U11 (PDIP-20); Partial Crack
