CAPE CANAVERAL AIR FORCE STATION,
LAUNCH COMPLEX 39,

HAER FL-8-11-R

SOLID ROCKET BOOSTER ASSEMBLY AND REFURBISHMENT FACILITY
MANUFACTURING BUILDING

PHOTOGRAPHS

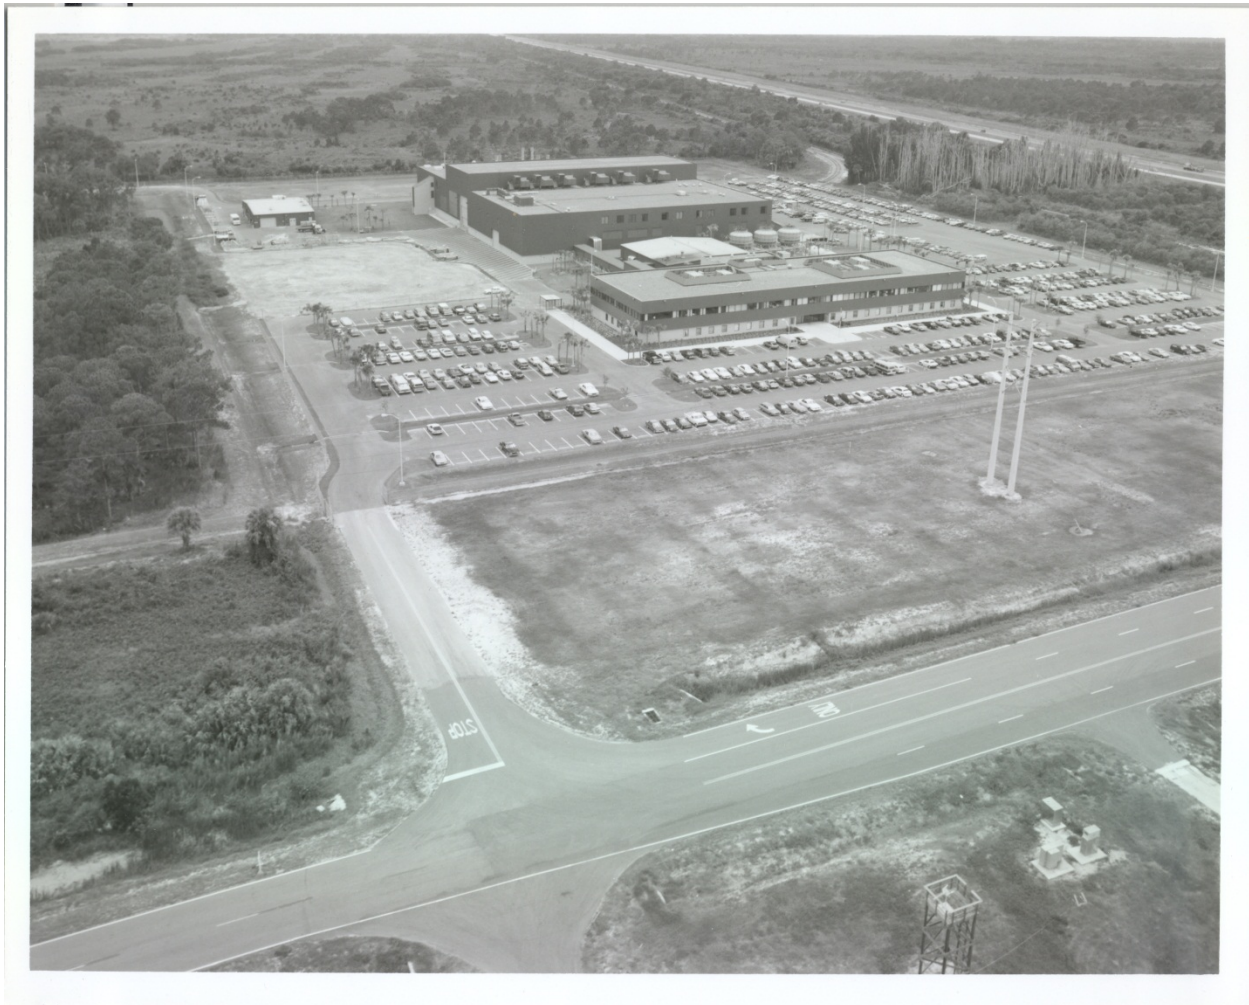
Aerial photograph of the SRB ARF Manufacturing Building, View Southwest, 1987. (Courtesy KSC, Image KSC-87PC-769).

Although KSC added new buildings to the ARF Complex after its original 1986 construction, the ARF Manufacturing Building retains its original appearance. Examinations of the building's original construction drawings and a 1987 aerial photograph show that the building has had no major exterior alterations or additions. The interior floor plan and finish materials also remain intact. A full architectural description is found in Part II of this document.
