CAPE CANAVERAL AIR FORCE STATION,  
LAUNCH COMPLEX 39,  
SOLID ROCKET BOOSTER DISASSEMBLY & REFURBISHMENT COMPLEX  
(Hangar AF Complex)  
(John F. Kennedy Space Center)  
Cape Canaveral  
Brevard County  
Florida

HAER NO. FL-8-11-S

WRITTEN HISTORICAL AND DESCRIPTIVE DATA

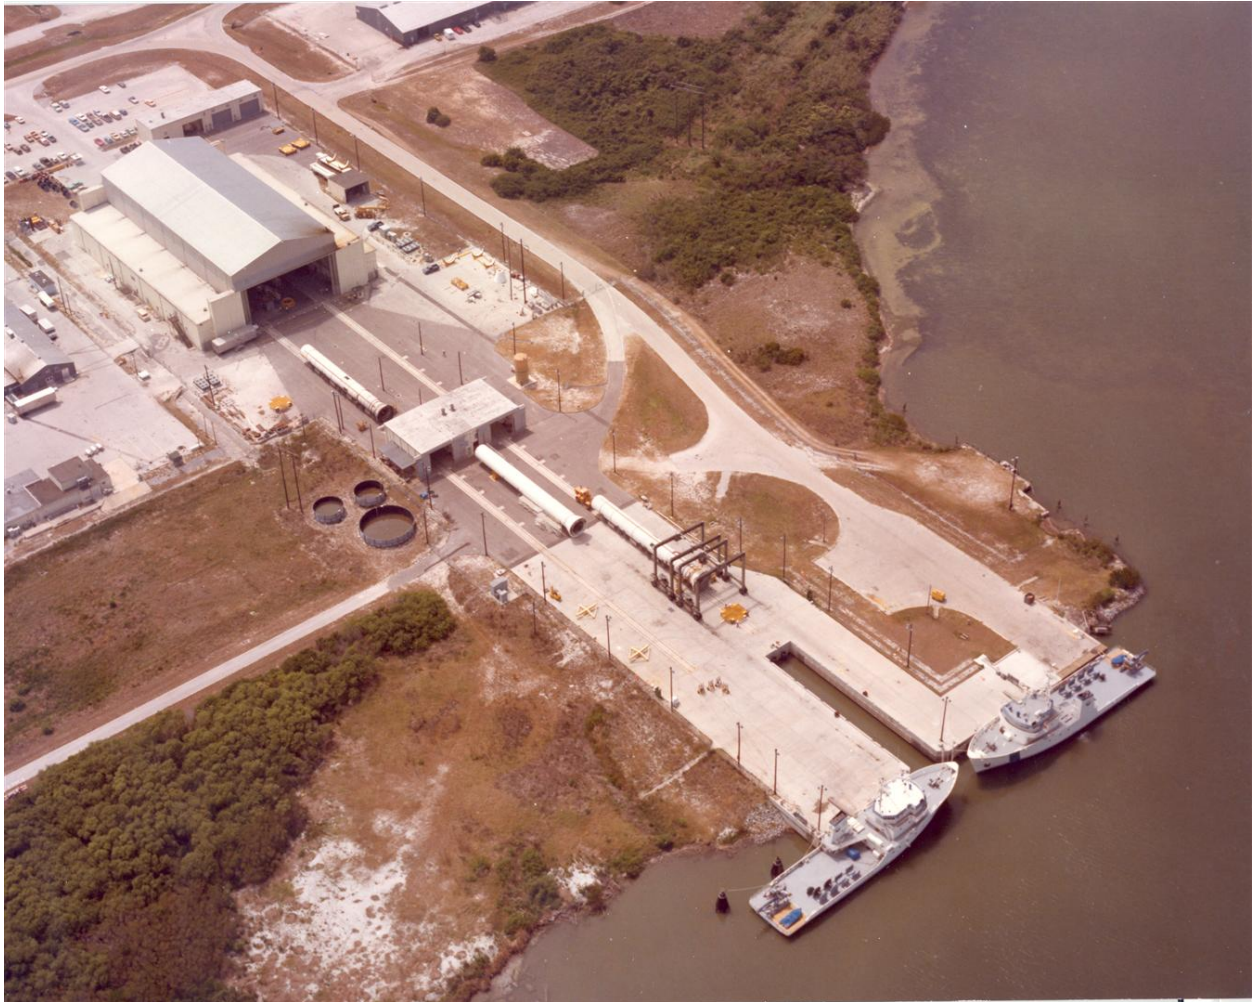
Figure 6. This 1983 aerial photograph shows the condition of the site after the slip and First Wash Building were completed and before the later construction of the SRB Paint Building, the TVC Deservicing Building, the Robot Wash Building (1985), and the Multi-Media Blast Facility (MMBF). (Courtesy of KSC, Image 108-KSC-81PC-459).

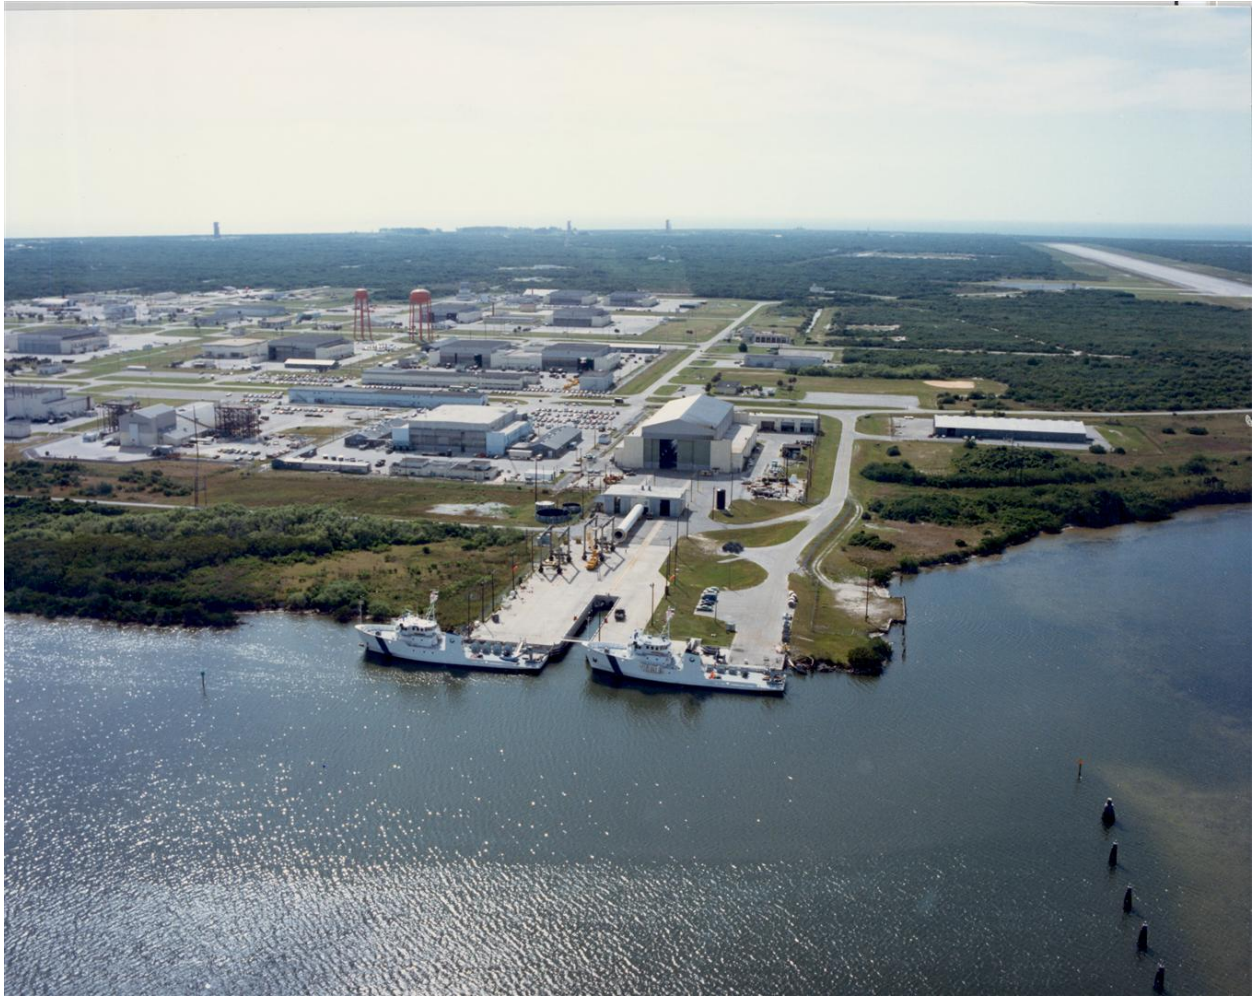
Figure 7. This 1983 aerial photograph shows the condition of the complex and its relationship to the CCAFS Industrial Area. (Courtesy of KSC, Image 116-KSC-383C-1256).

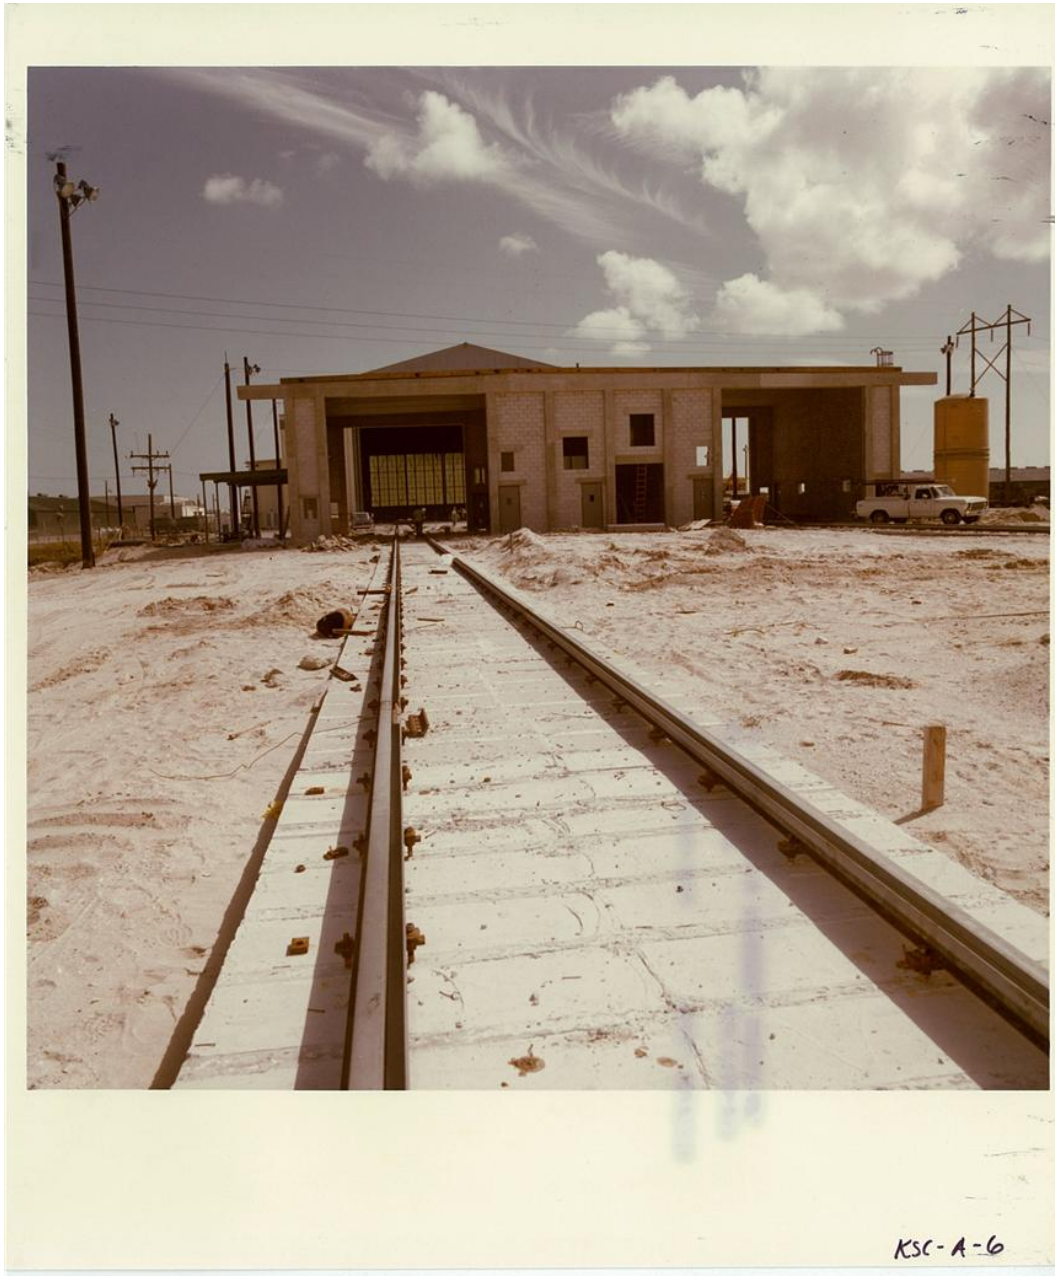
Figure 8. Hangar AF during construction of the High Pressure Wash Building, 1978. (Courtesy KSC, Image 108-KSC-378C-364/3).

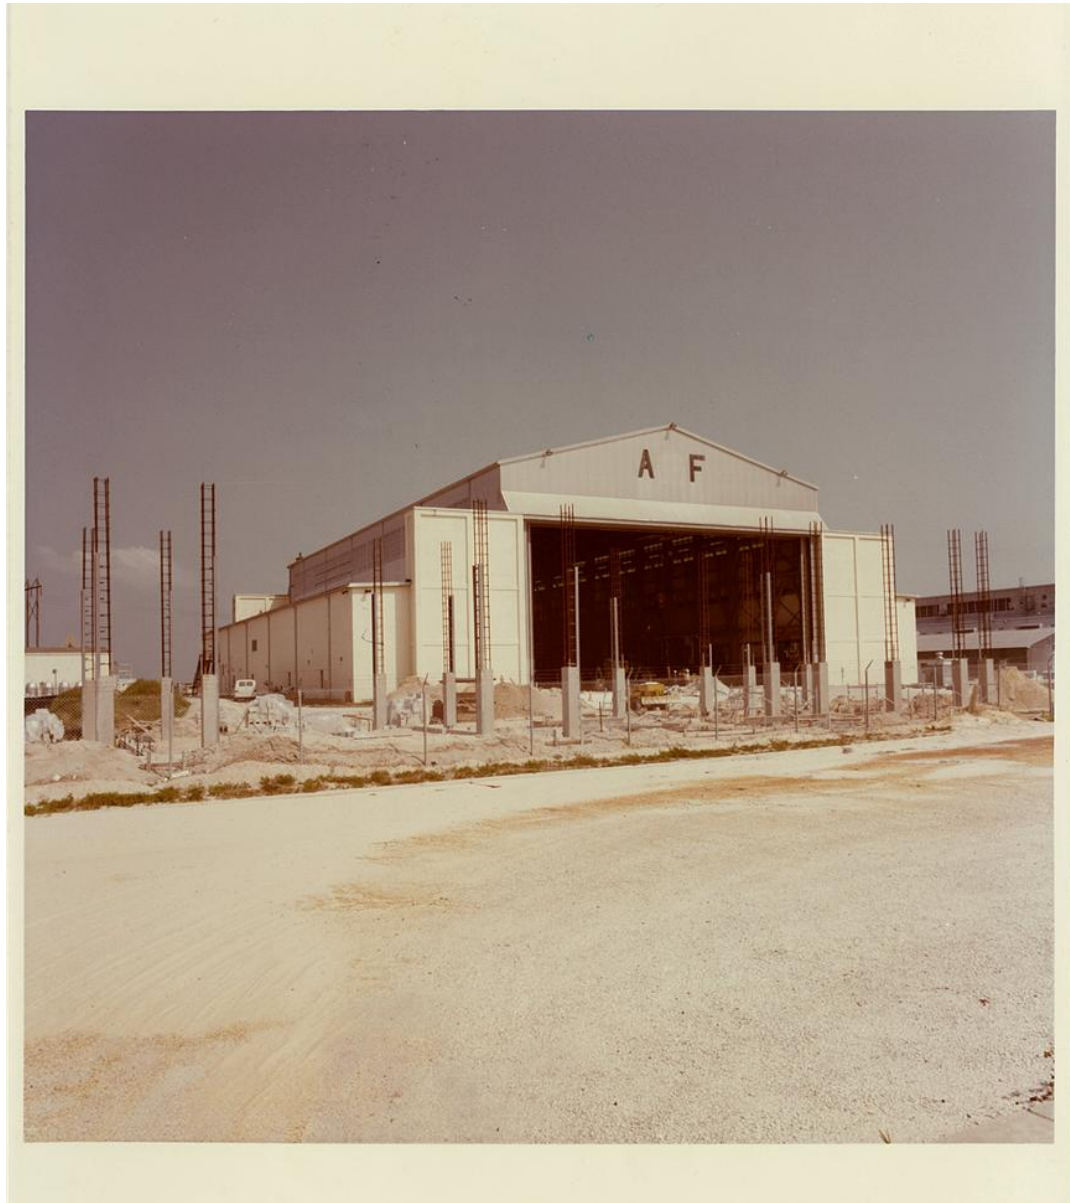
Figure 9. Construction of the First Wash Building and SRB dolly rails with Hangar AF in the Background, 1978. (Courtesy KSC, Image 108-KSC-378C-759).

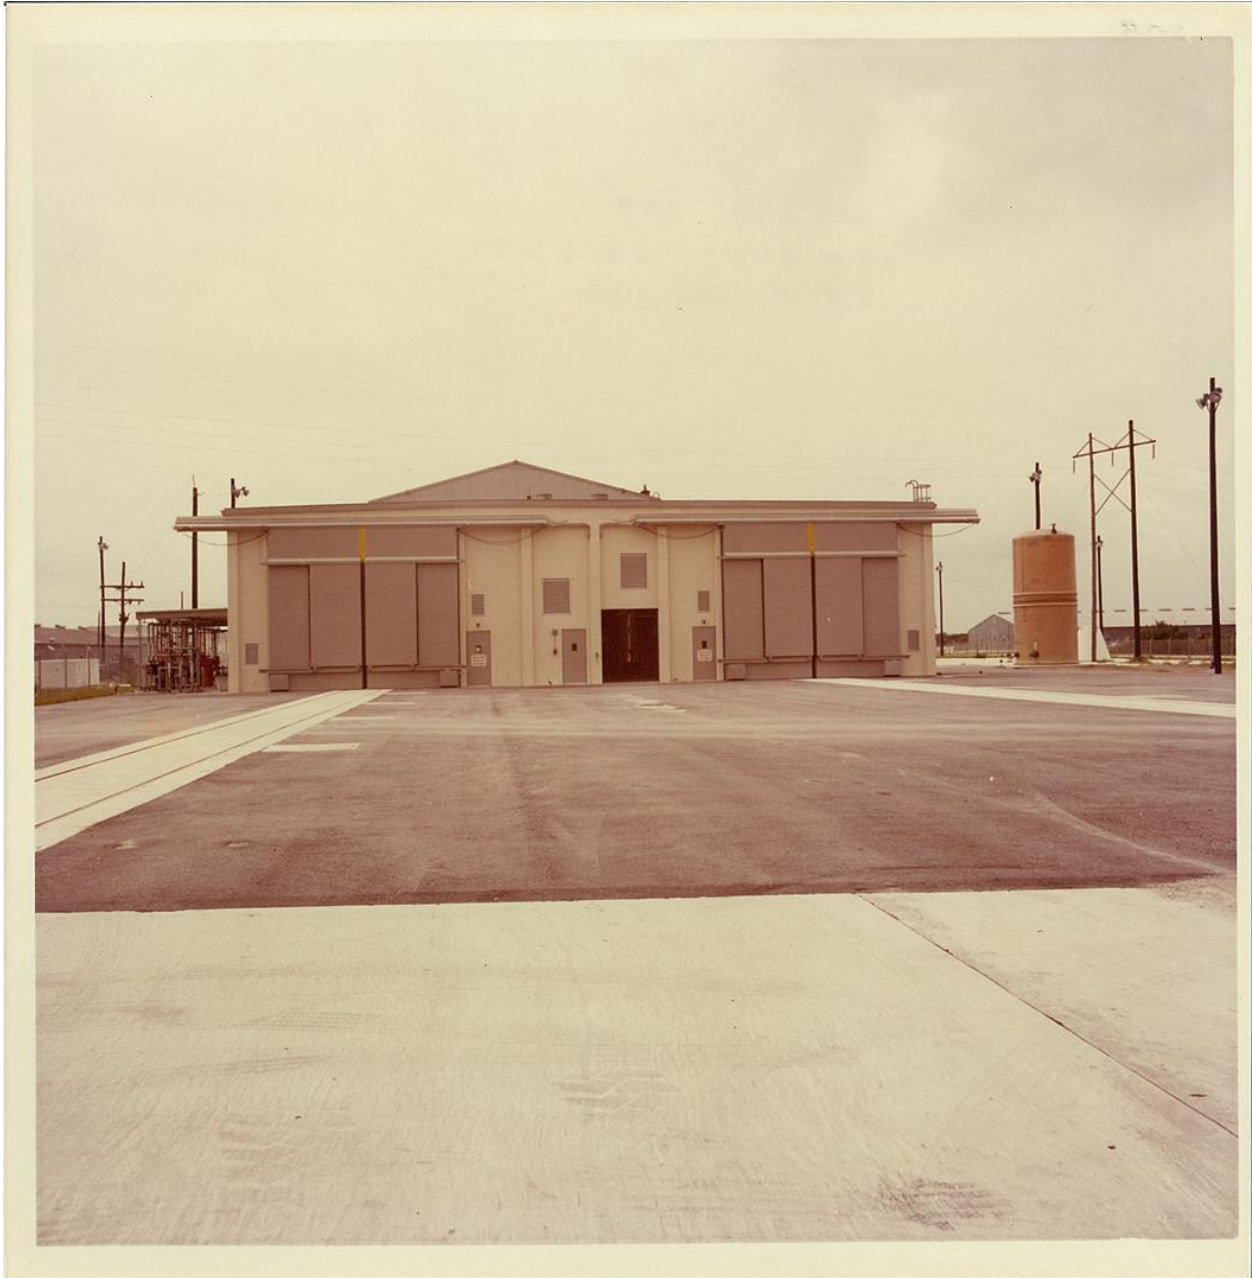
Figure 10. First Wash Building with original multi-part doors, 1978. (Courtesy KSC, Image 108-KSC-379C-1060/1).

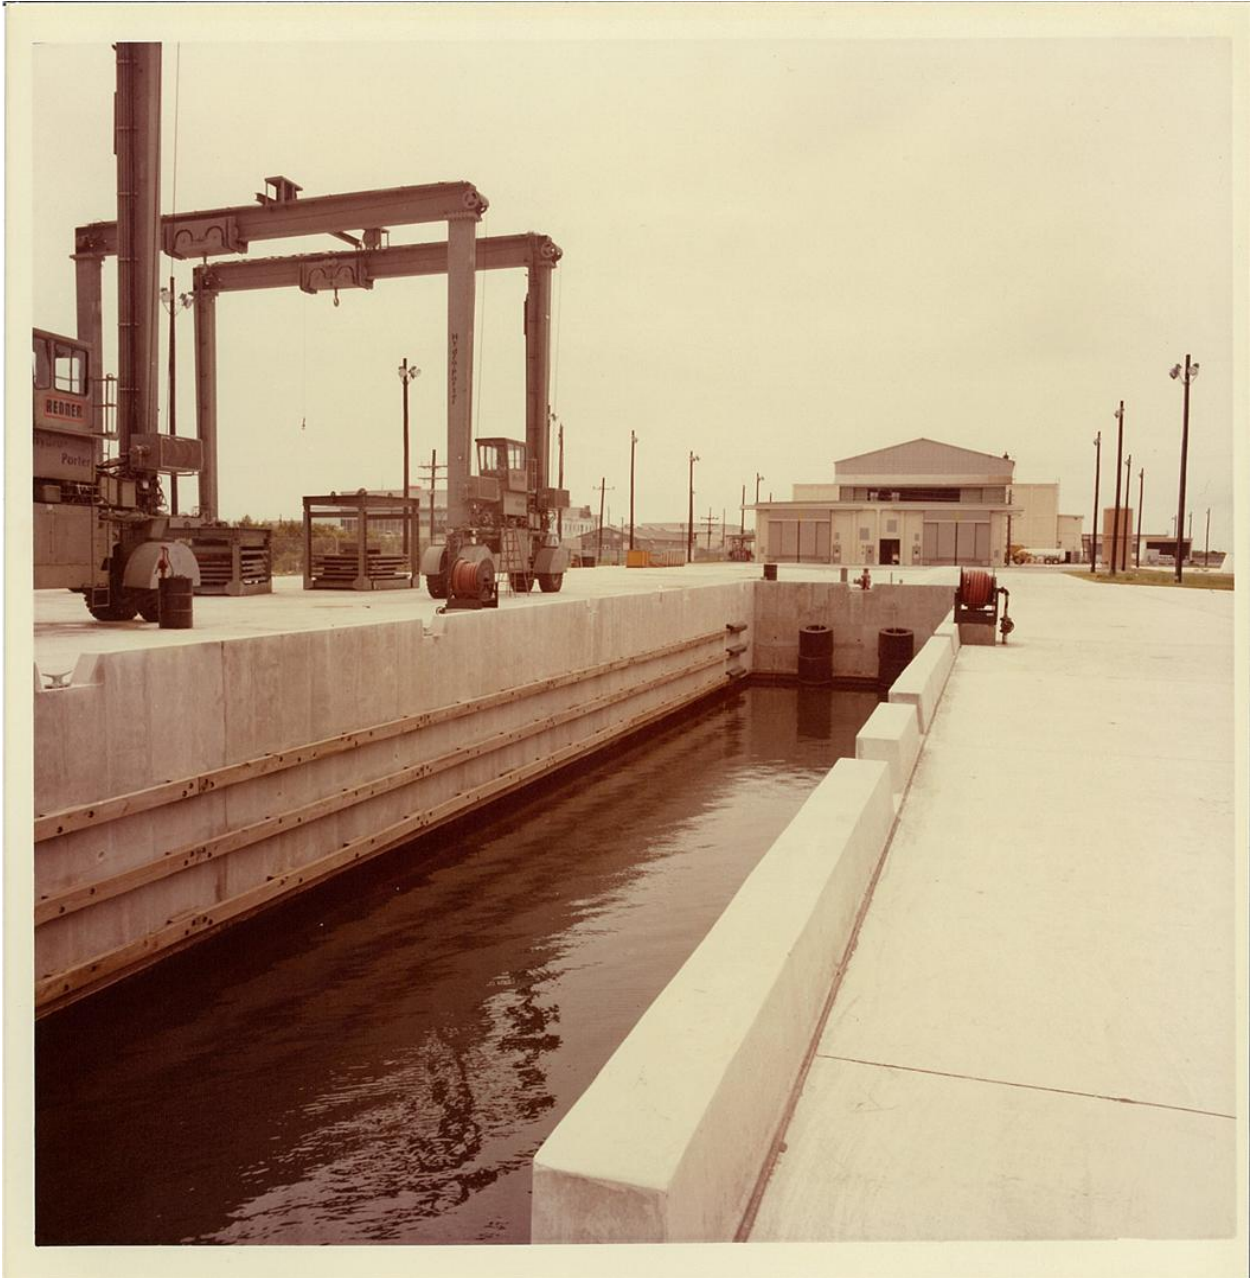
Figure 12. SRB Recovery Slip with gantry cranes, First Wash Building, and Hangar AF, 1978. (Courtesy KSC, No Image Number).

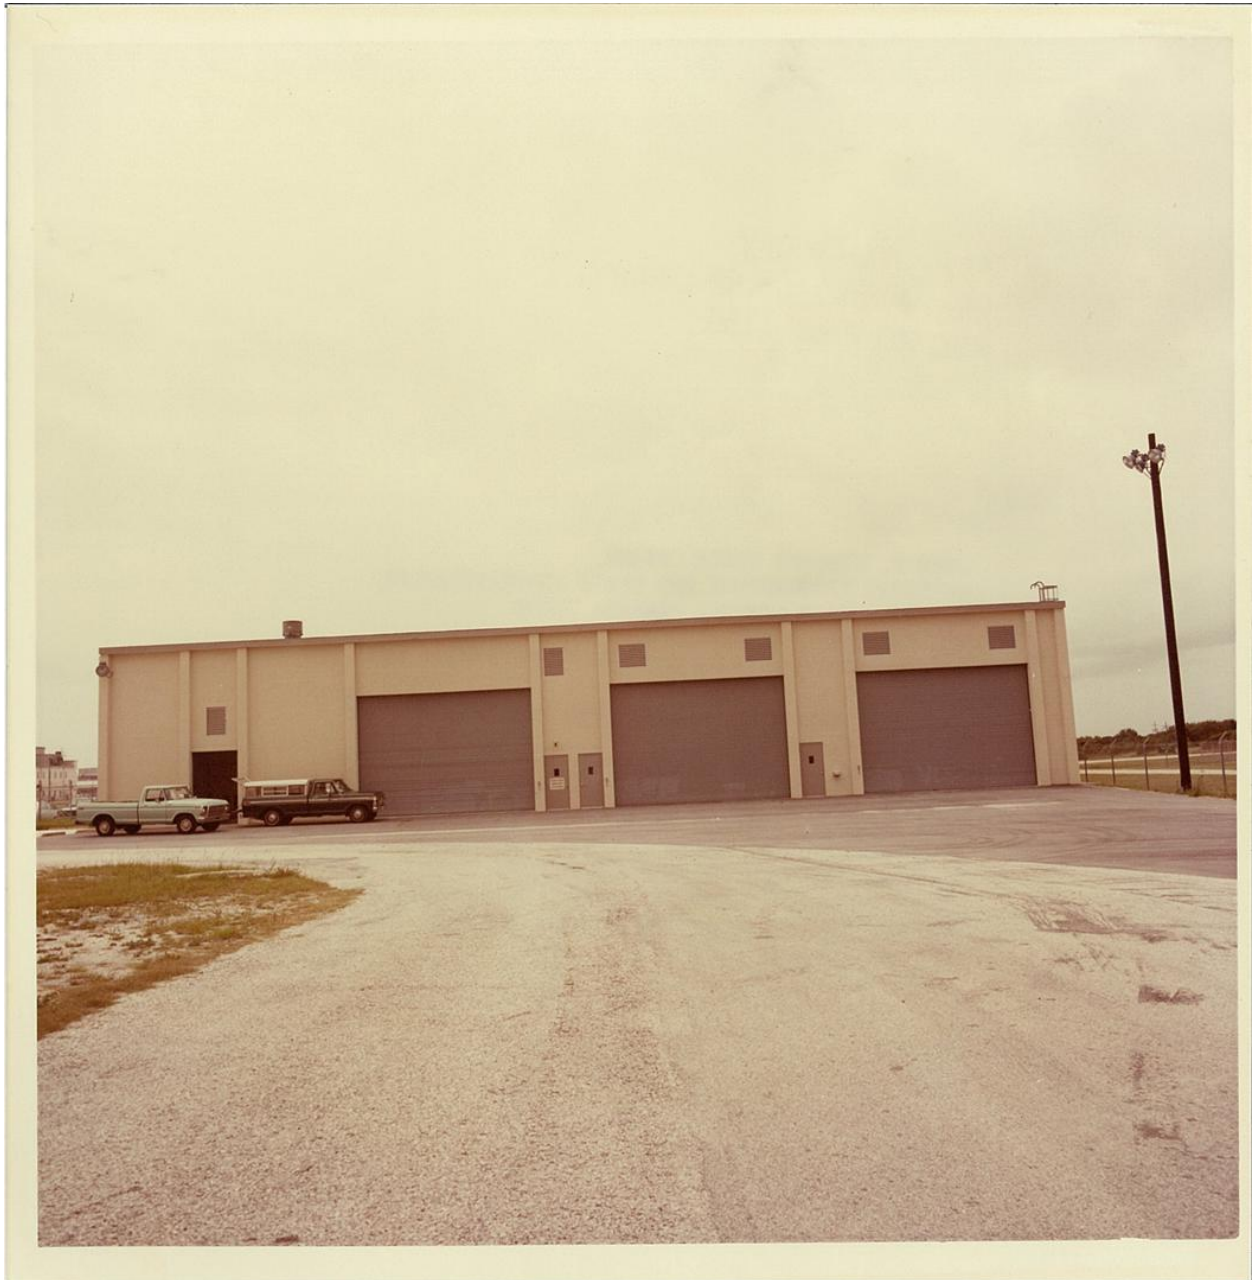
Figure 13. High Pressure Wash Building, 1978. (Courtesy KSC, Image 108-KSC-3796-1060/3).

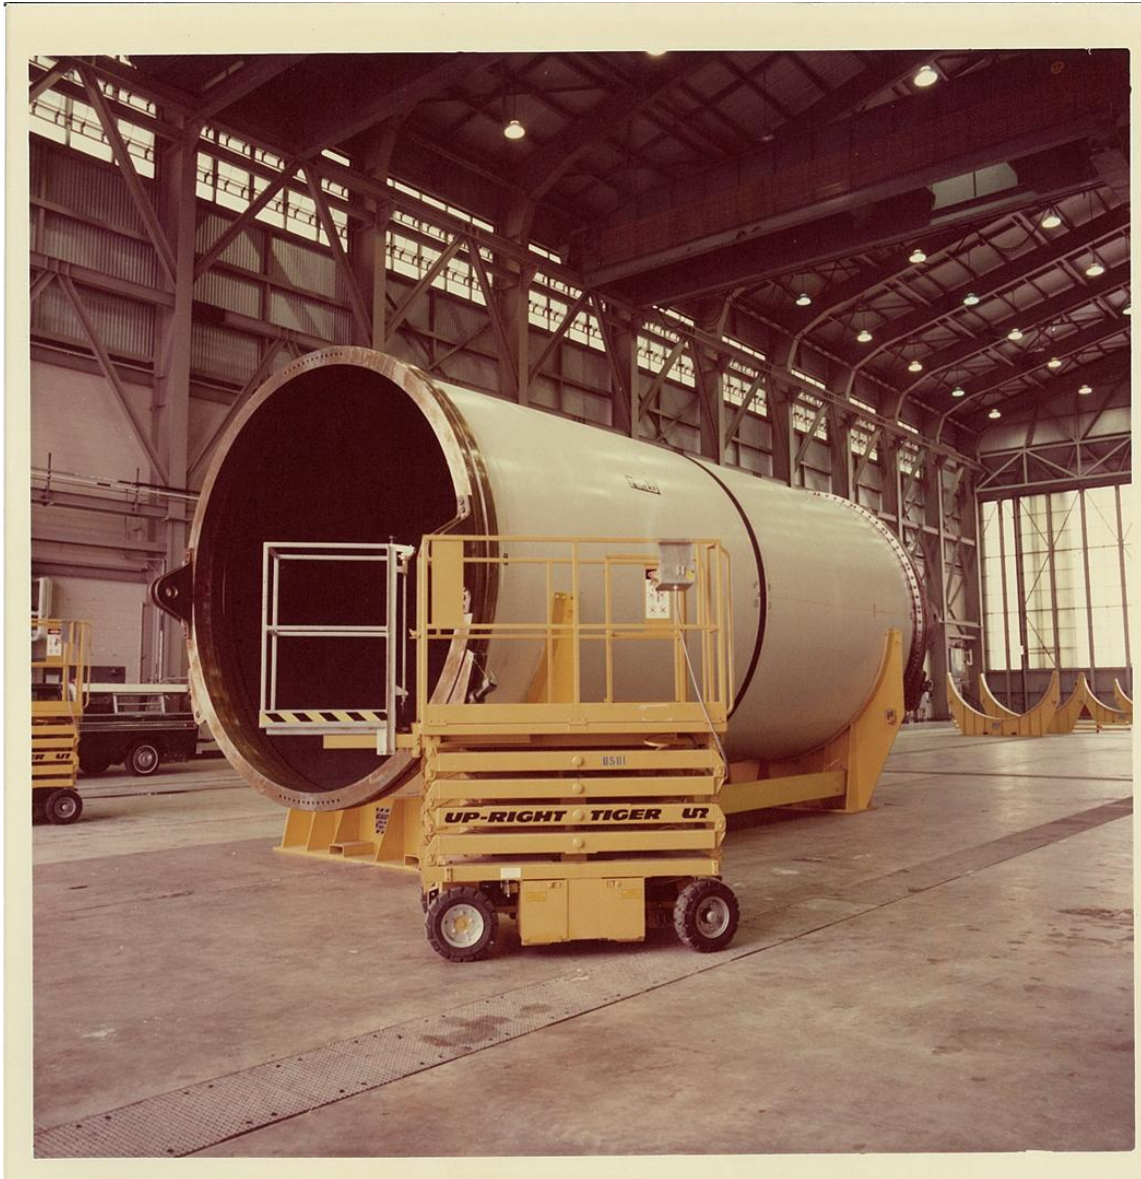
Figure 15. SRB Solid Rocket Motor (SRM) segment inside Hangar AF, 1979. (Courtesy: KSC, Image 108-KSC-379C-1061/9).
