ADDENDUM TO:
CAPE CANAVERAL AIR FORCE STATION, LAUNCH COMPLEX 39,
OPERATIONS AND CHECKOUT BUILDING
(John F. Kennedy Space Center)
First Street, between Avenue D and Avenue E
Cape Canaveral
Brevard County
Florida

HAER No. FL-8-11-E

CAPE CANAVERAL AIR FORCE STATION, LAUNCH COMPLEX 39,
OPERATIONS & CHECKOUT BUILDING
(John F. Kennedy Space Center)
HAER No. FL-8-11-E, ADDENDUM

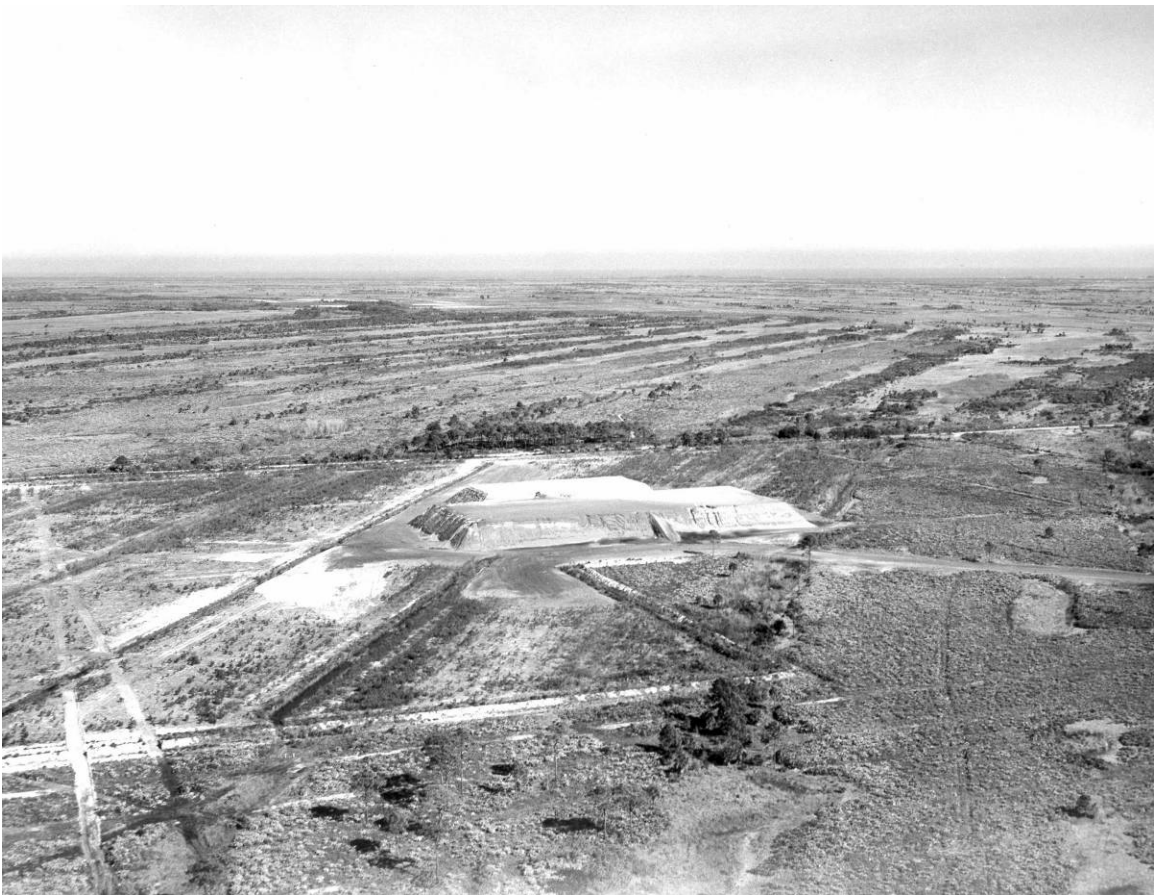
Figure B-1. View of surcharge used to compact soil underneath the O&C Building foundation, facing northeast, December 11, 1962.

The ACOE, NASA's supervisory design and construction agent, hired Burns and Roe, Inc. to complete the design for the O&C Building, which at one time was referred to as the Manned Spacecraft Operations Building.⁶ Preliminary groundwork for the facility was completed by the Azzarelli Construction Company, of Tampa, Florida, in November 1962. Part of this work included piling 200,000 cubic feet of soil on the site to compact the shale, fine sand, and clay silt earth in order to form a stable foundation for the building (Figure B-1).⁷

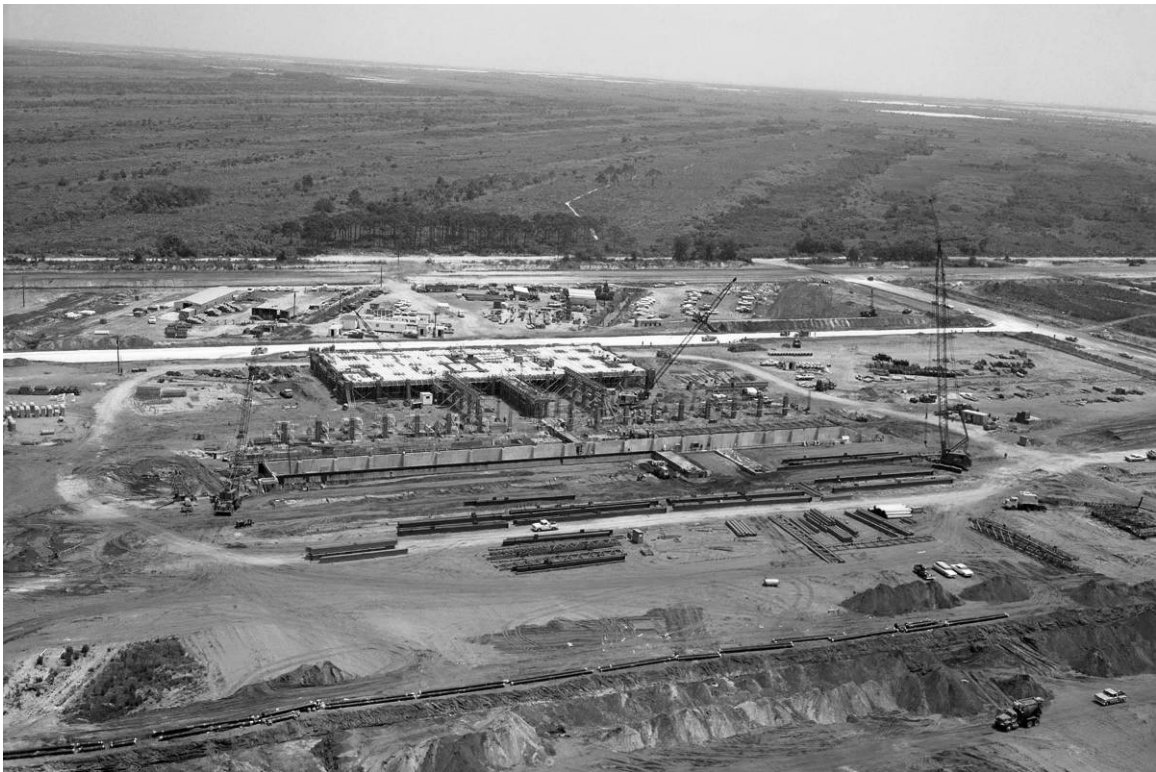
Figure B-2. Early construction of the O&C Building, facing northeast, May 17, 1963.
Source: Kennedy Institutional Imaging Facility, KSC-63C-1682.

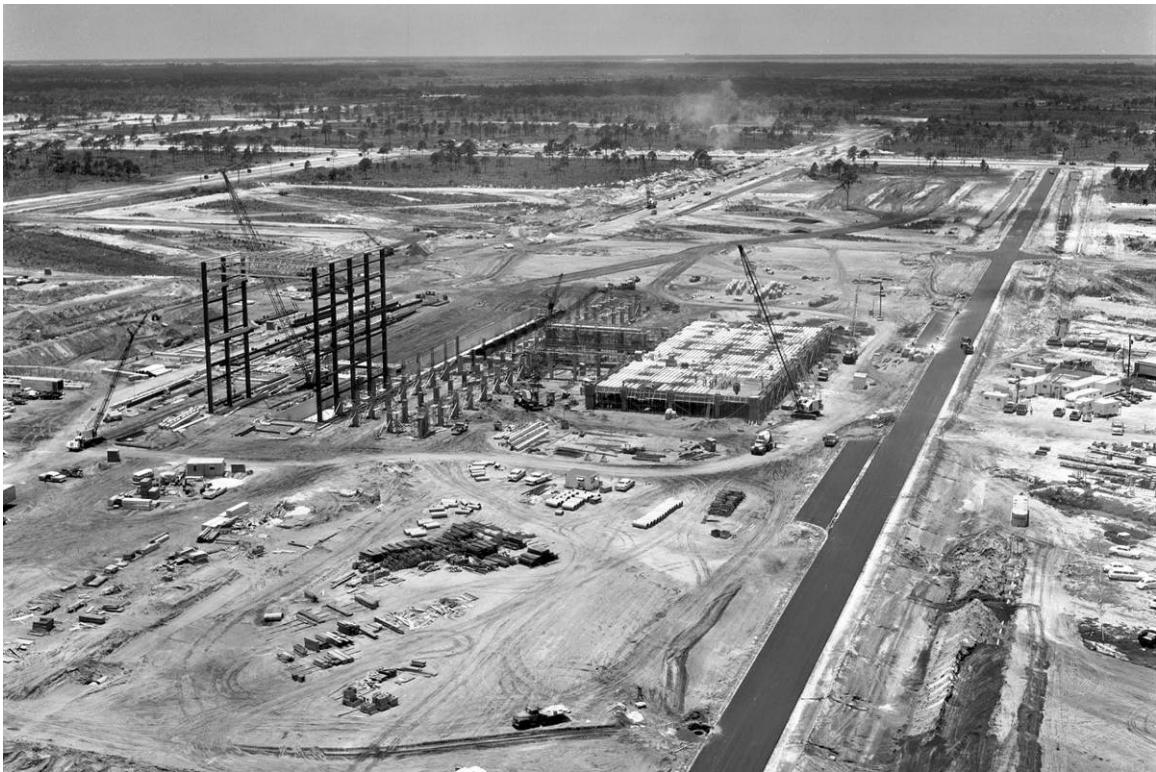
Figure B-3. Aerial showing early construction of O&C Building, facing southwest, June 4, 1963.
Source: John F. Kennedy Space Center Archives, LOC-63-5667.

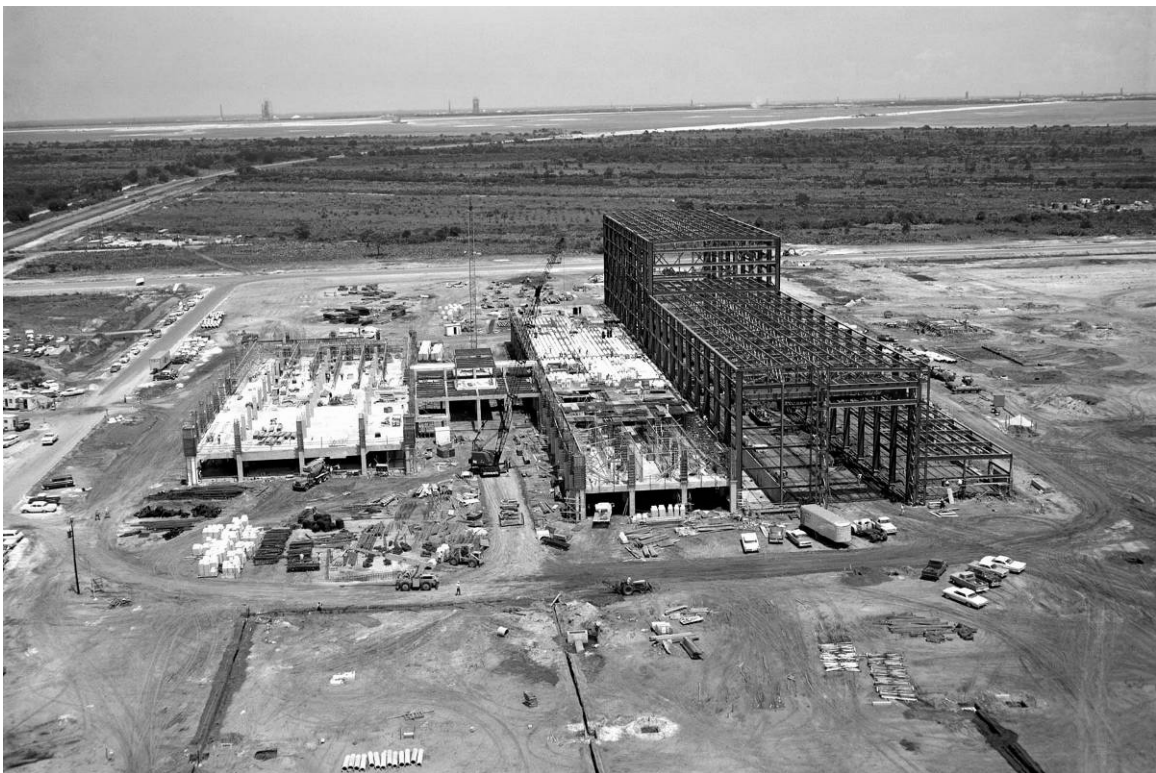
Figure B-4. Construction of the O&C Building, facing east, July 29, 1963.
Source: Kennedy Institutional Imaging Facility, KSC-63C-2376.

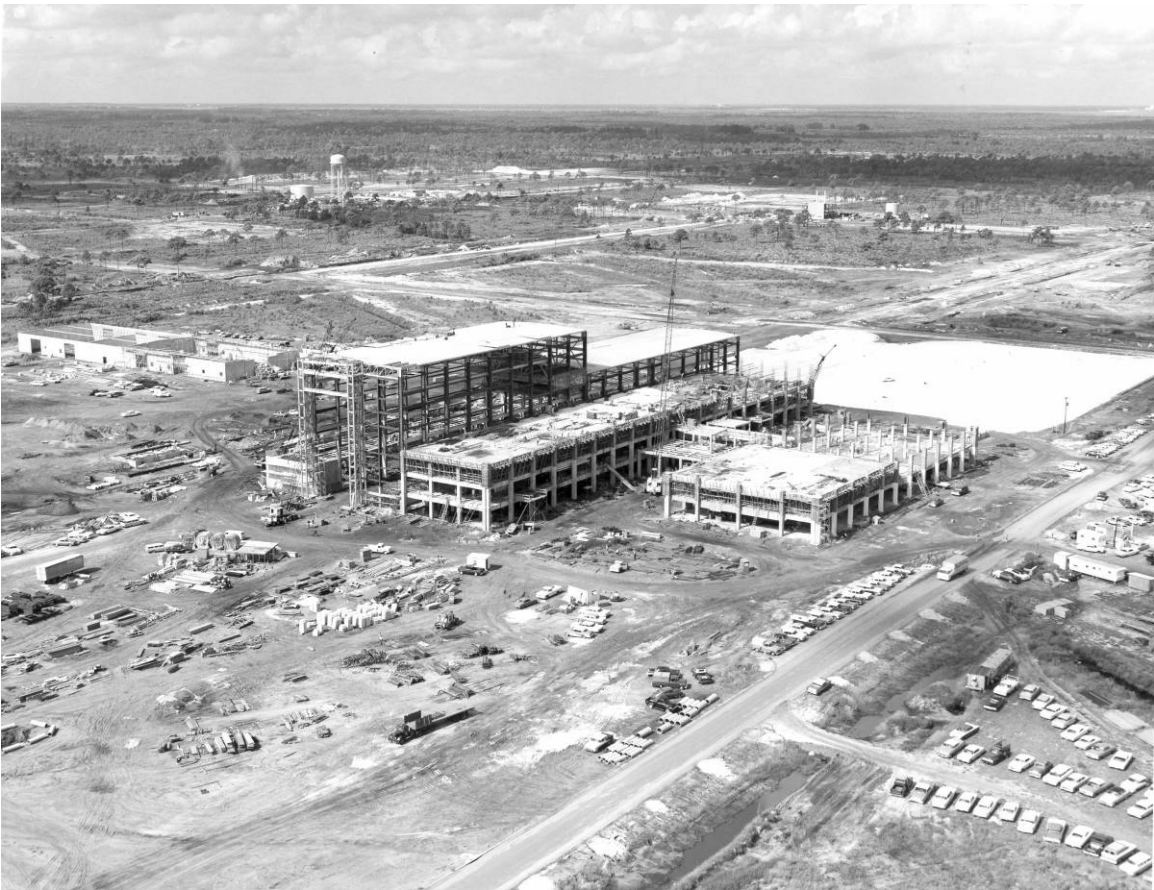
Figure B-5. Construction of the O&C Building, facing southwest, August 27, 1963.
Source: John F. Kennedy Space Center Archives, LOC-63-8557.

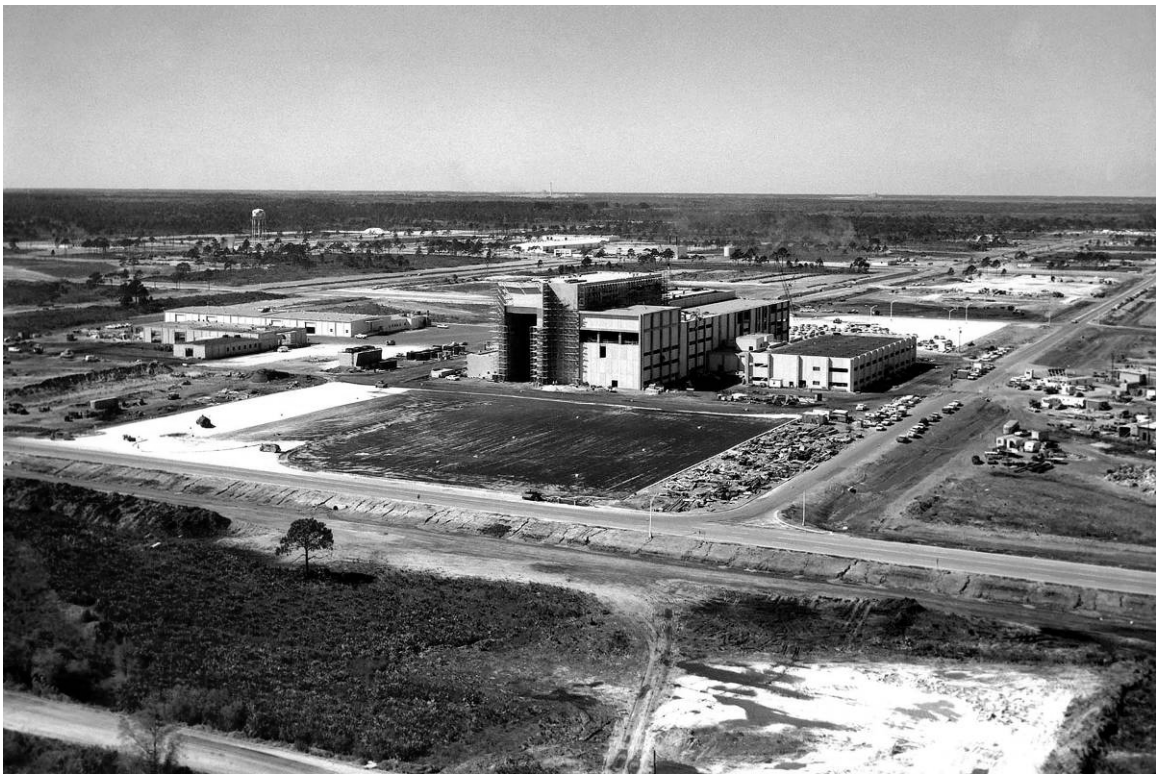
Figure B-6. Construction of the O&C Building, facing southwest, 1964.
Source: Kennedy Institutional Imaging Facility, KSC-64C-1712.

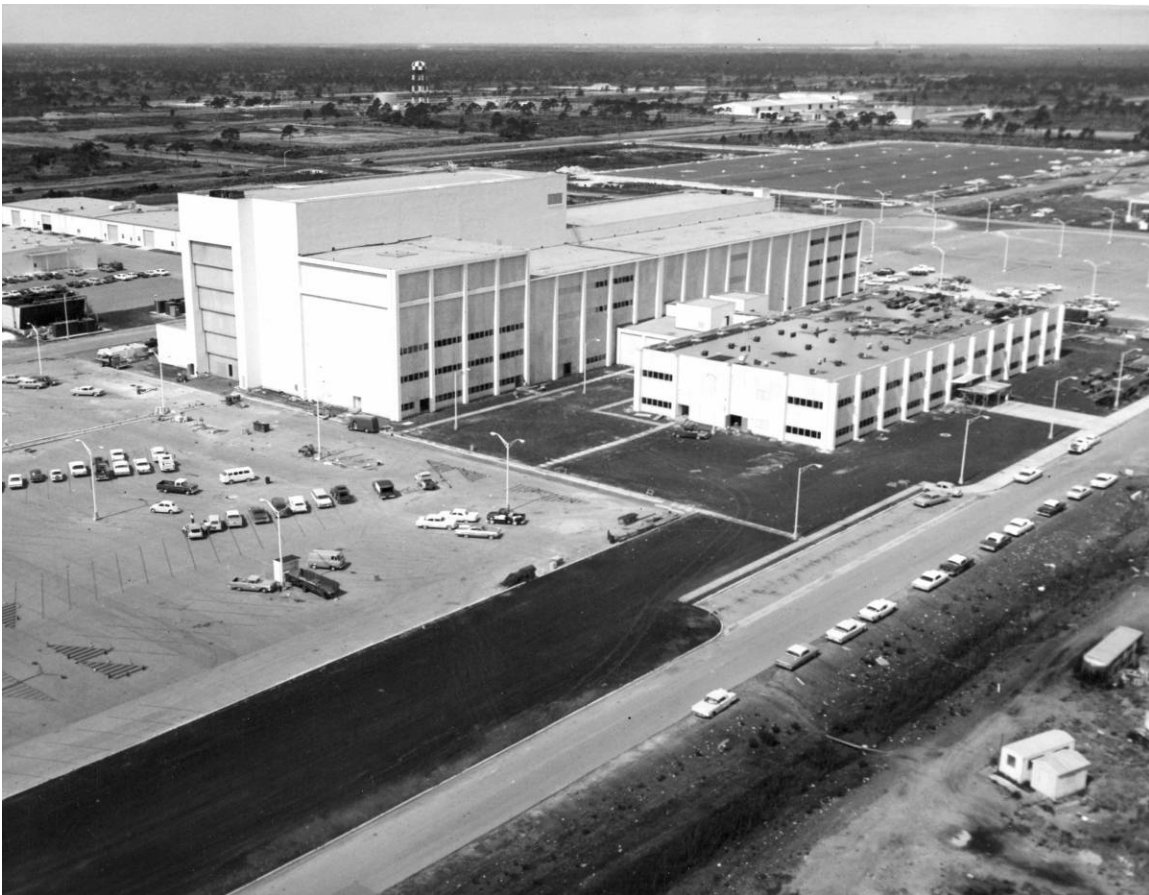
Figure B-7. Construction of the original O&C Building nearing completion, facing southwest,
June 25, 1964.

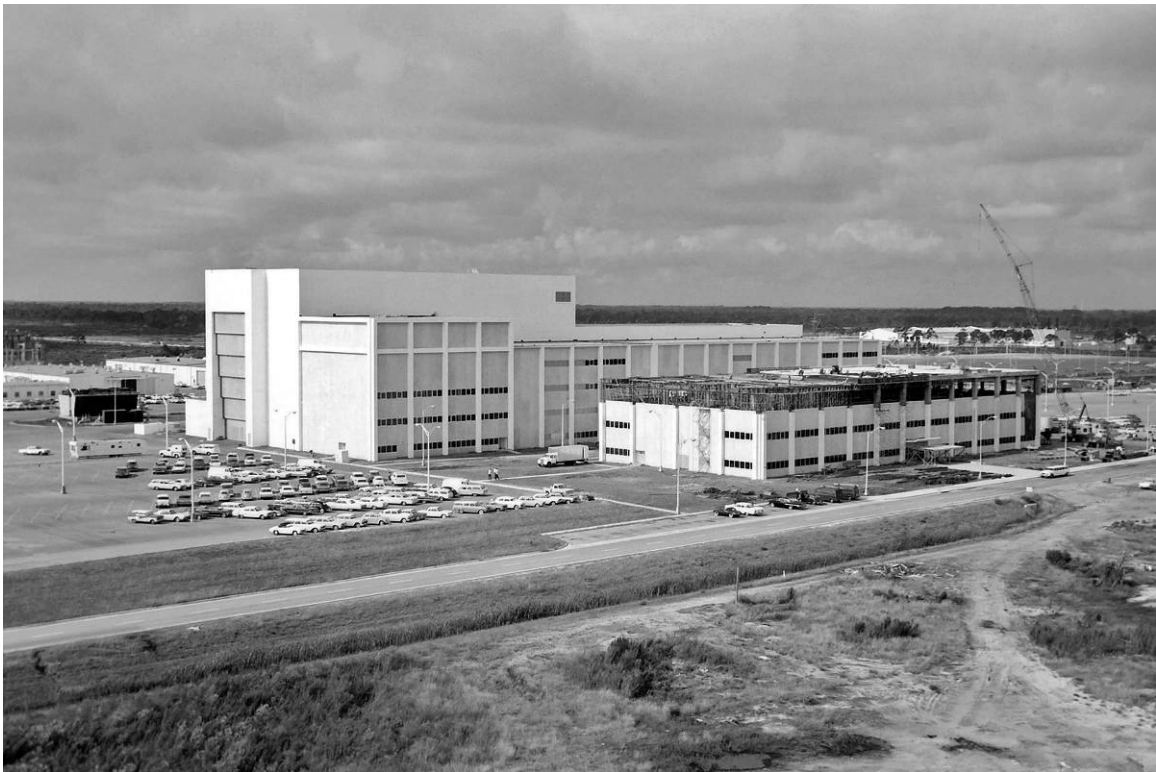
Figure B-8. Construction of the third floor of the O&C Building north wing, facing southwest, September 3, 1964.

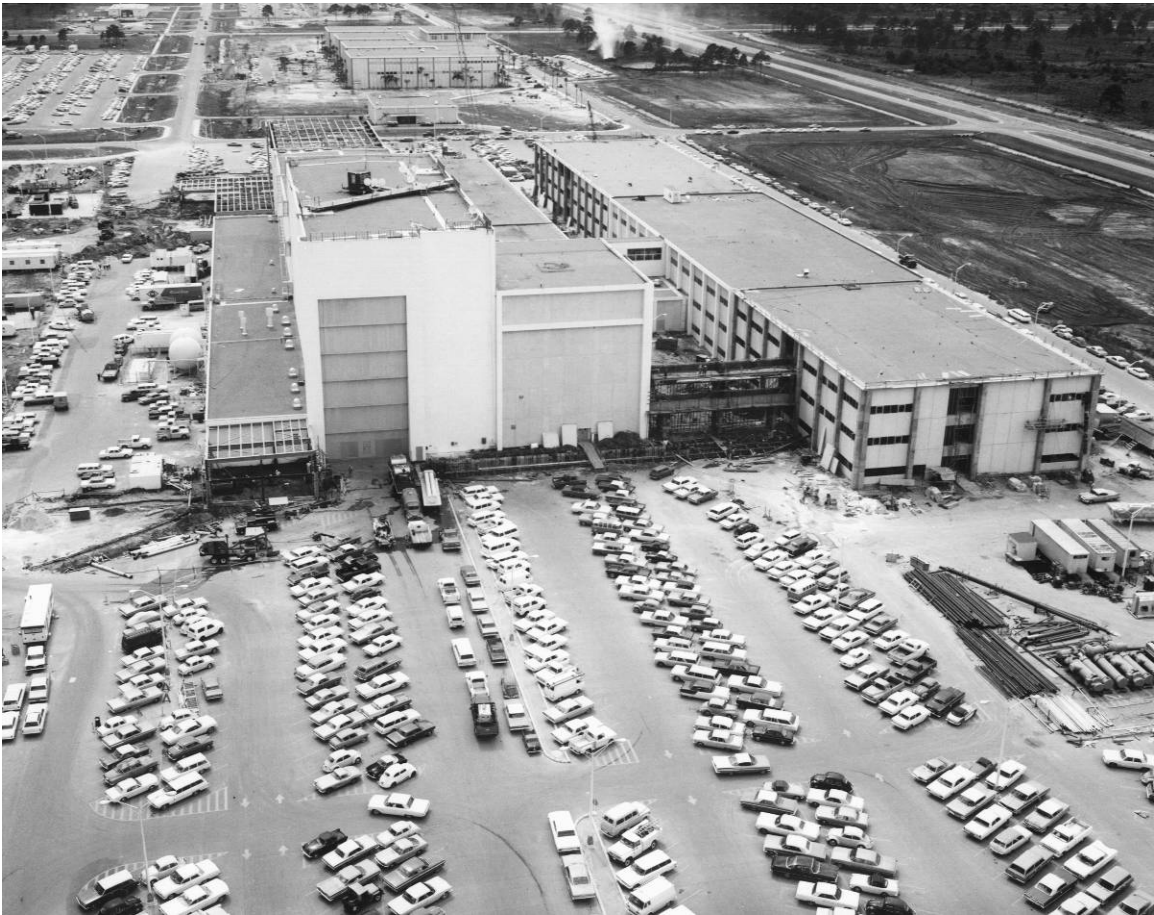
Figure B-9. Construction of the east and west additions to the O&C Building, facing west-northwest, August 5, 1965.

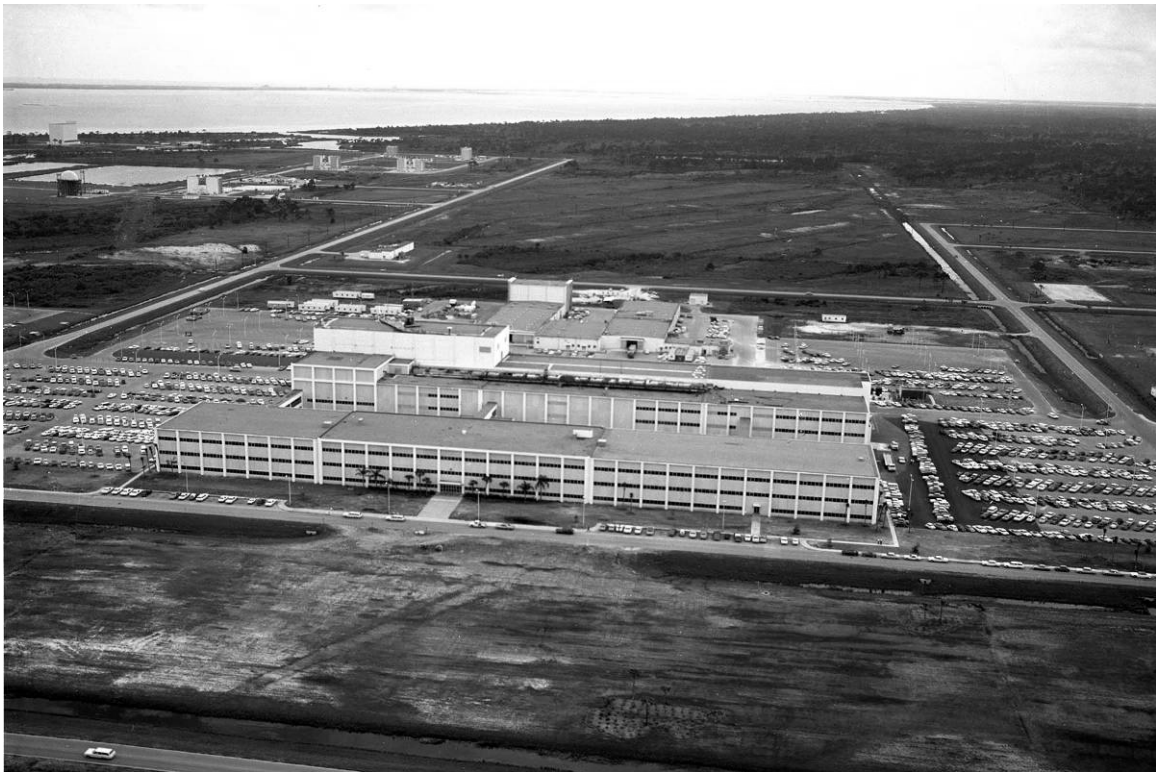
Figure B-10. Aerial of the O&C Building with the completed exterior shells of the additions, facing south, June 21, 1966.

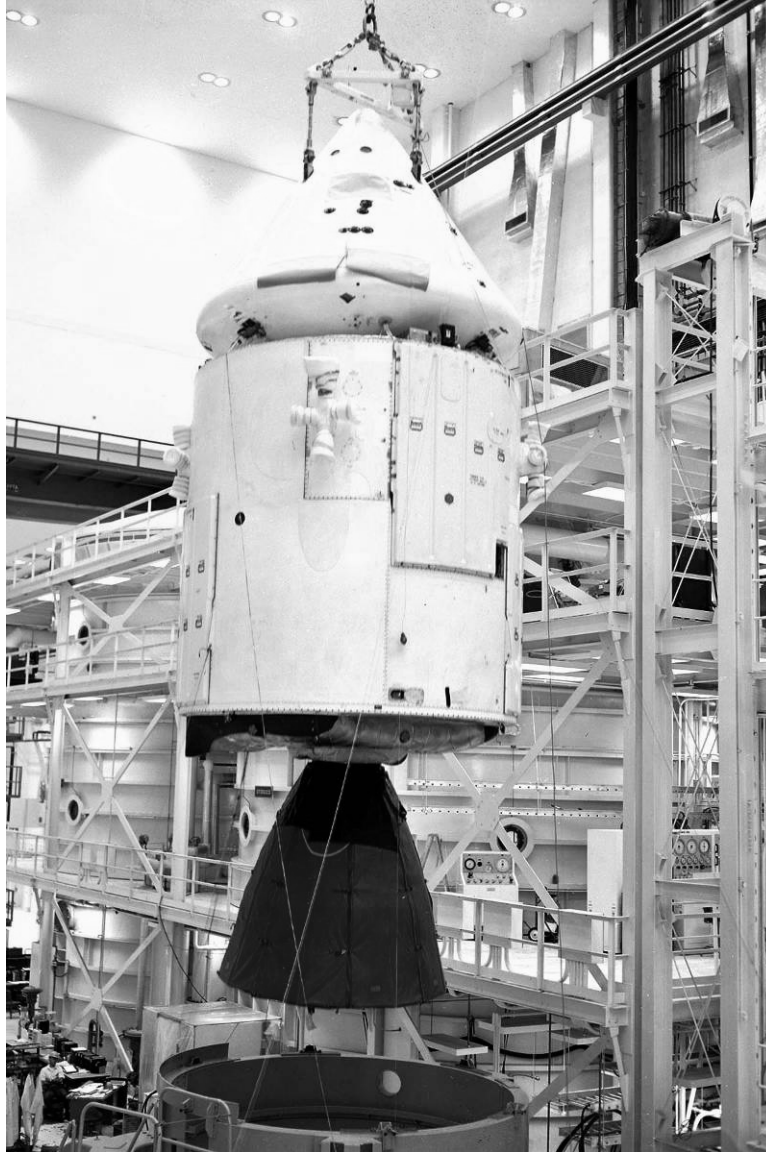
Figure B-11. Apollo command and service modules being hoisted for mating, facing northwest,
June 25, 1966.

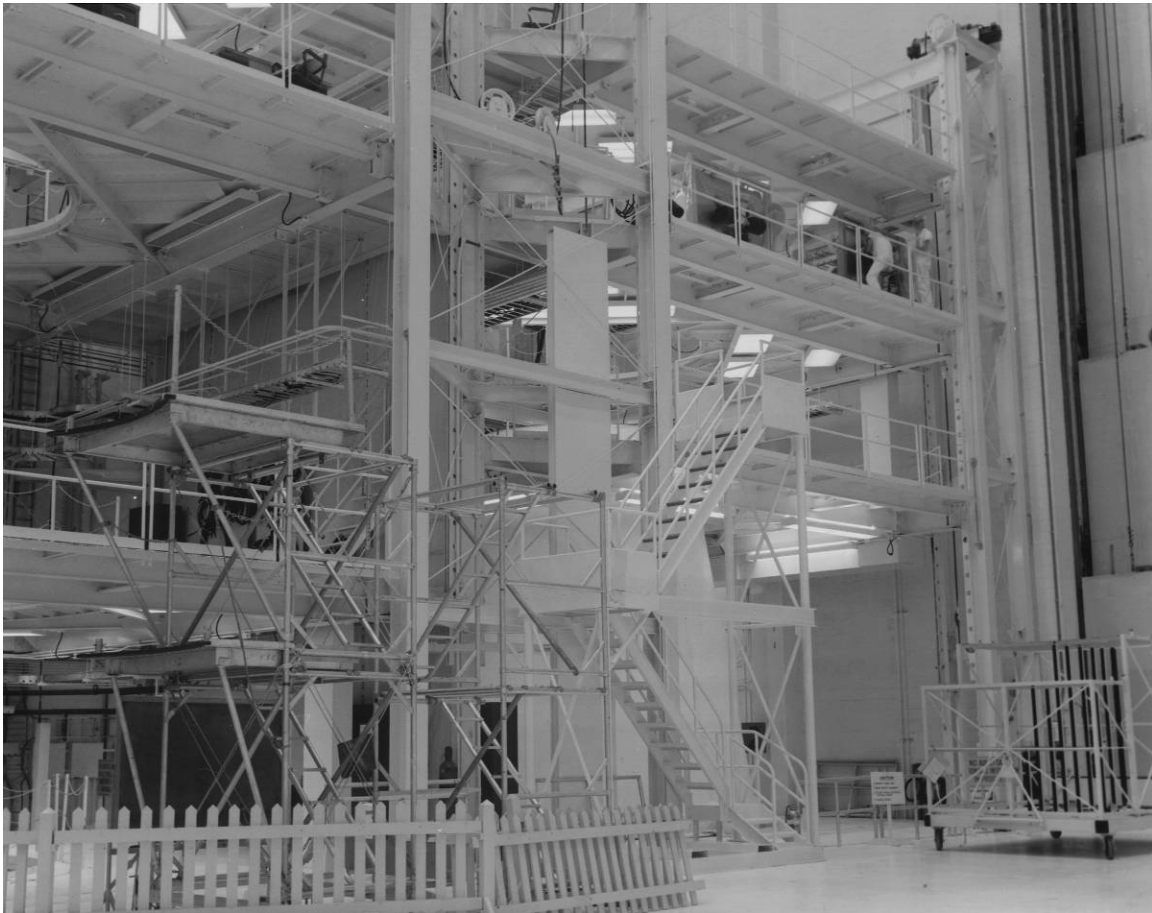
Figure B-12. Construction of the Lunar Module assembly and test area, facing northeast,
August 15, 1966.

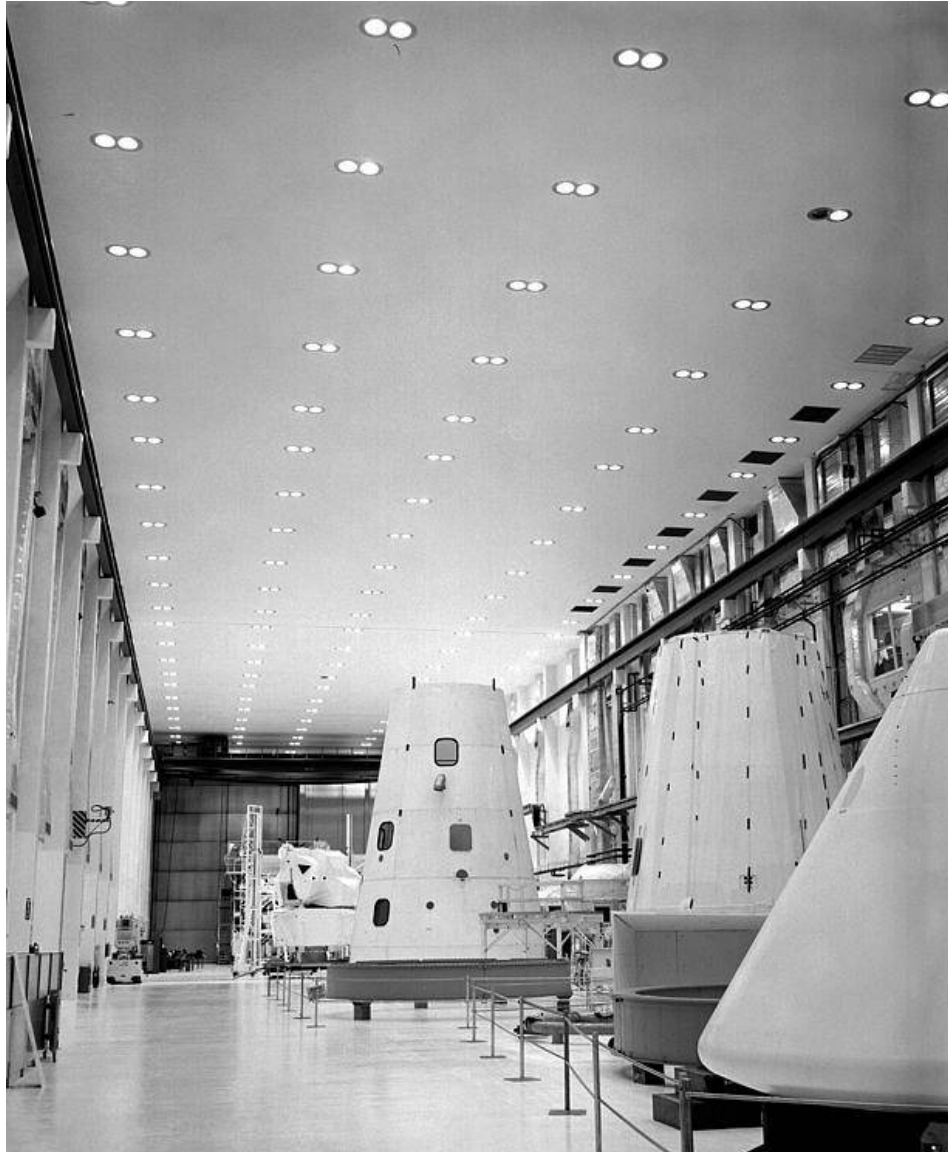
Figure B-13. Apollo spacecraft components within the Low Bay, facing west, March 1, 1968.
Source: John F. Kennedy Space Center Archives, 116-KSC-68-2629.

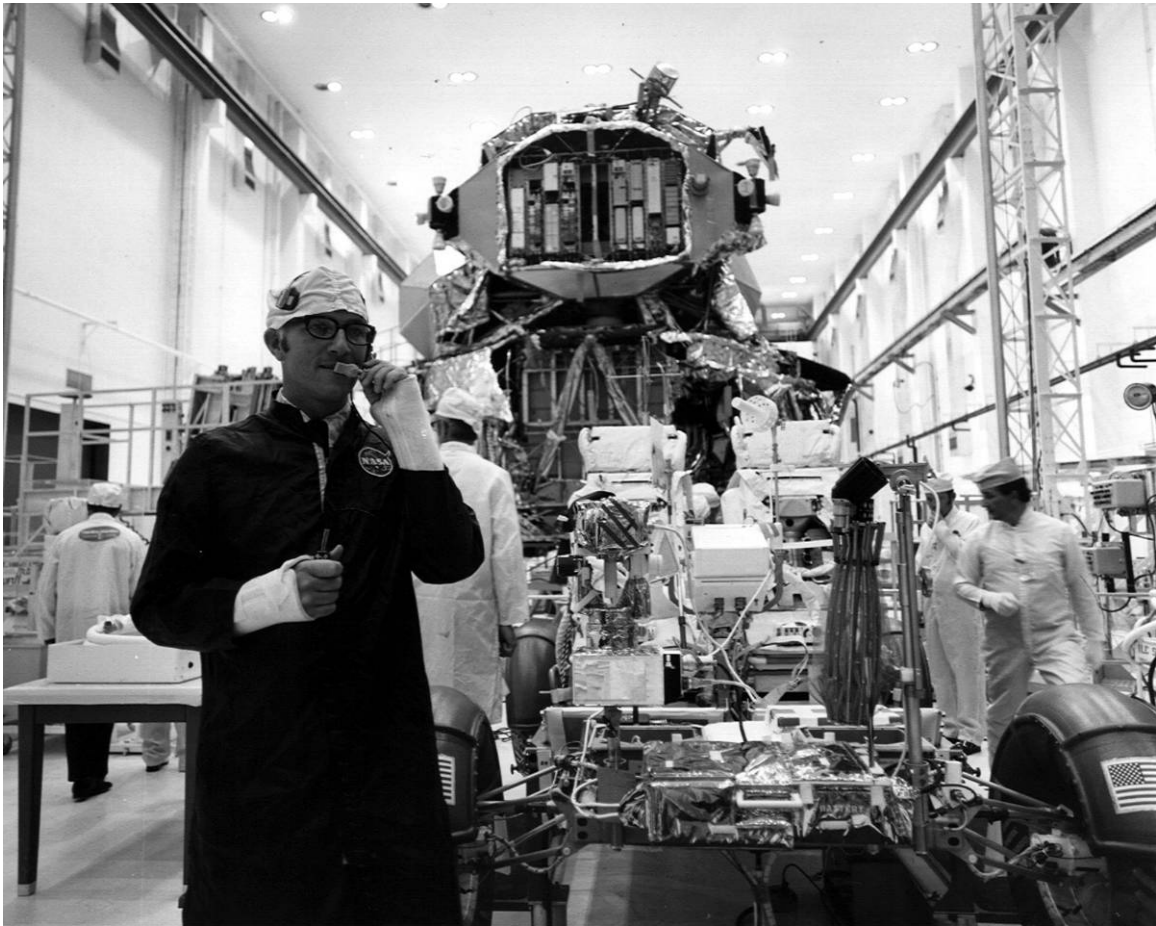
Figure B-14. Apollo 17 Lunar Rover Vehicle being readied for a test simulation in the Low Bay, direction unknown, August 4, 1972.

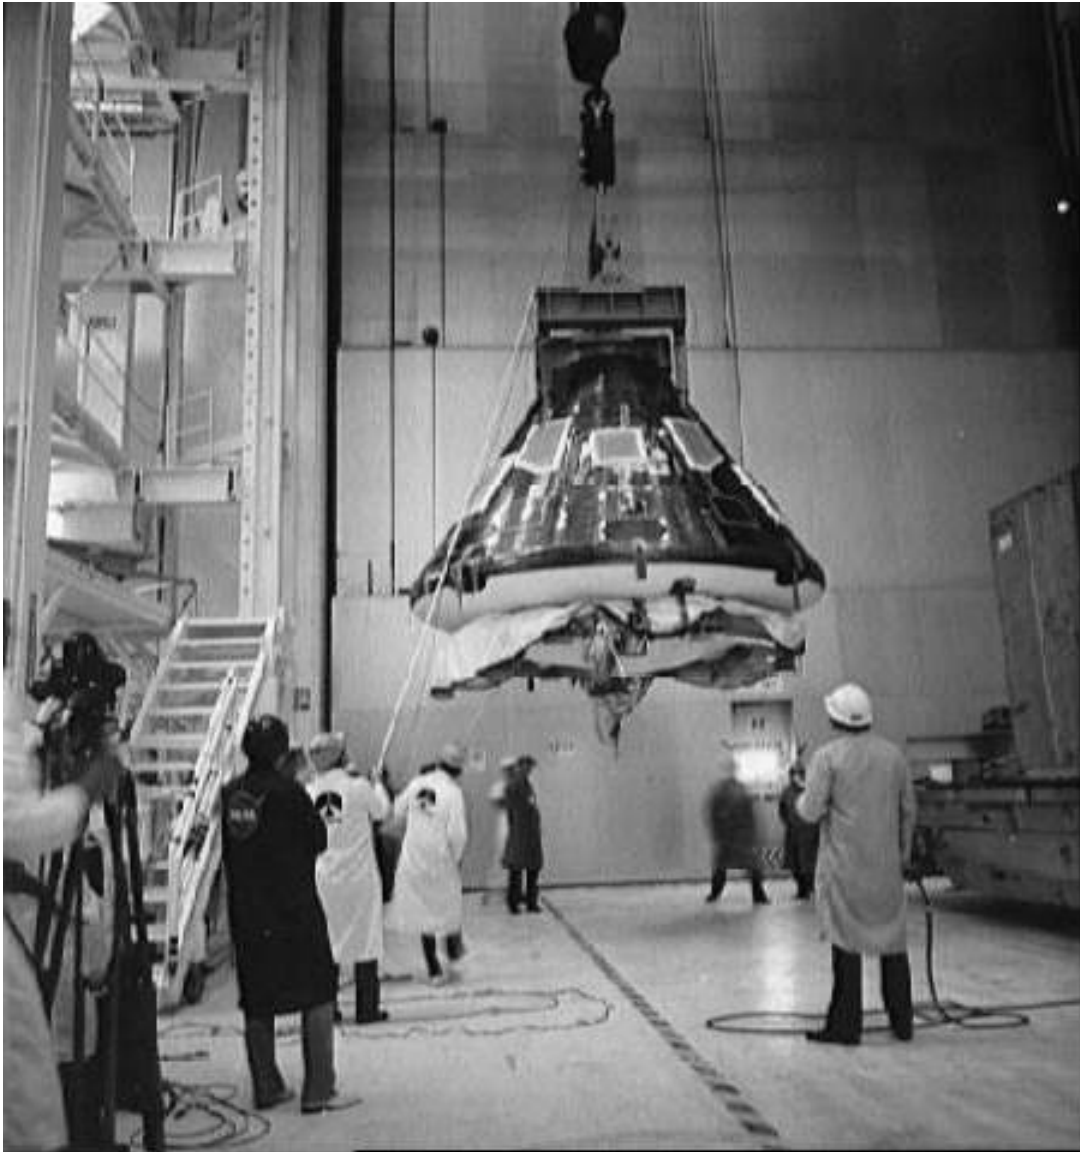
Figure B-15. Command module for the Apollo-Soyuz Test Project being received in the O&C Building, facing east, September 8, 1974.

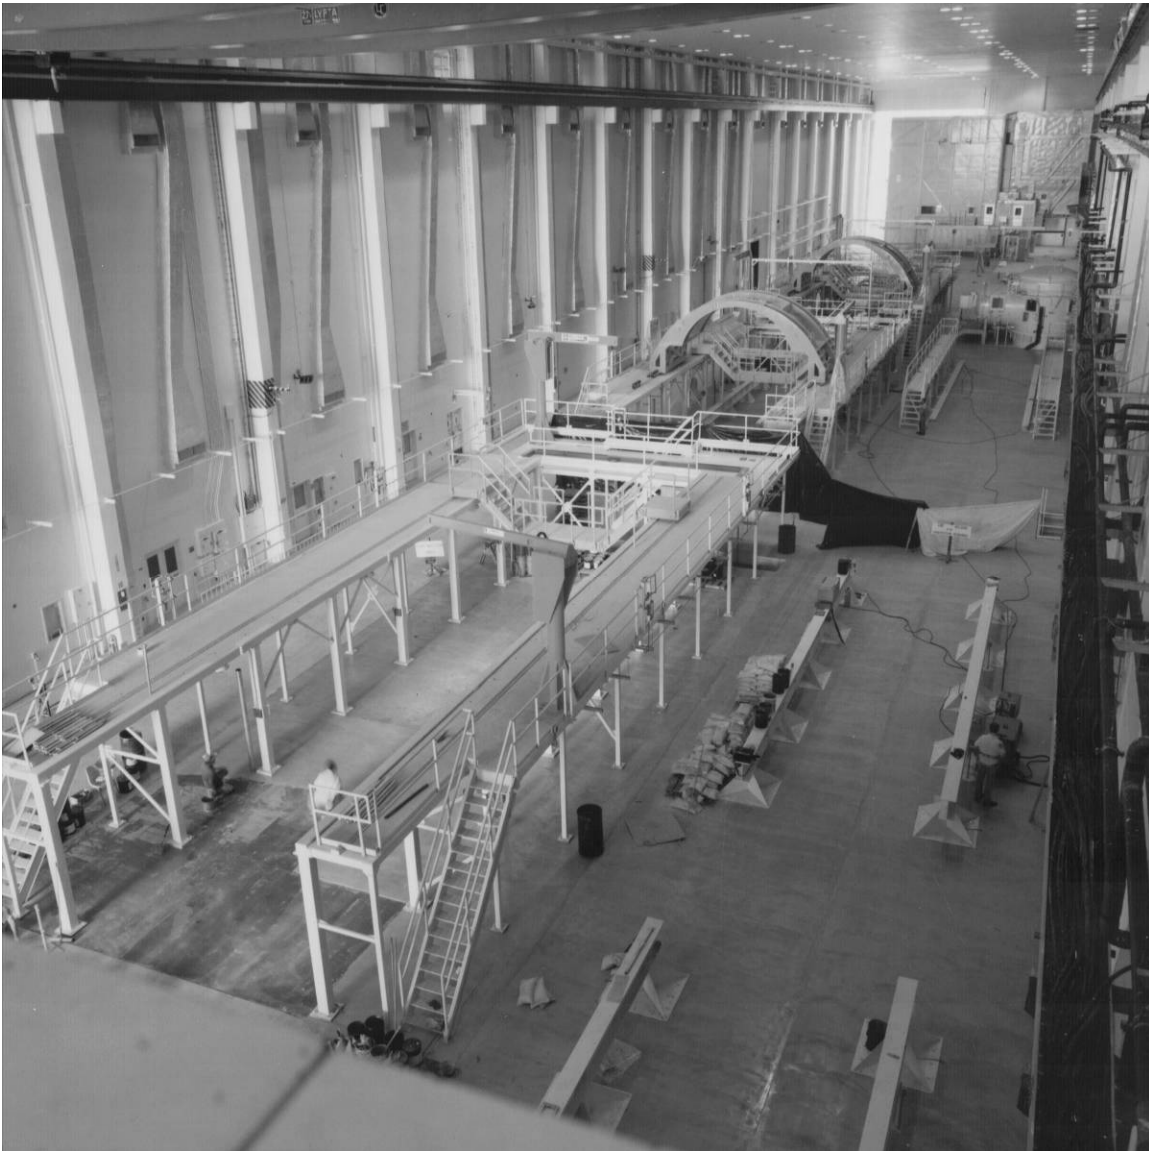
Figure B-16. Construction of the Spacelab workstands in the Low Bay, direction unknown,
May 31, 1978.

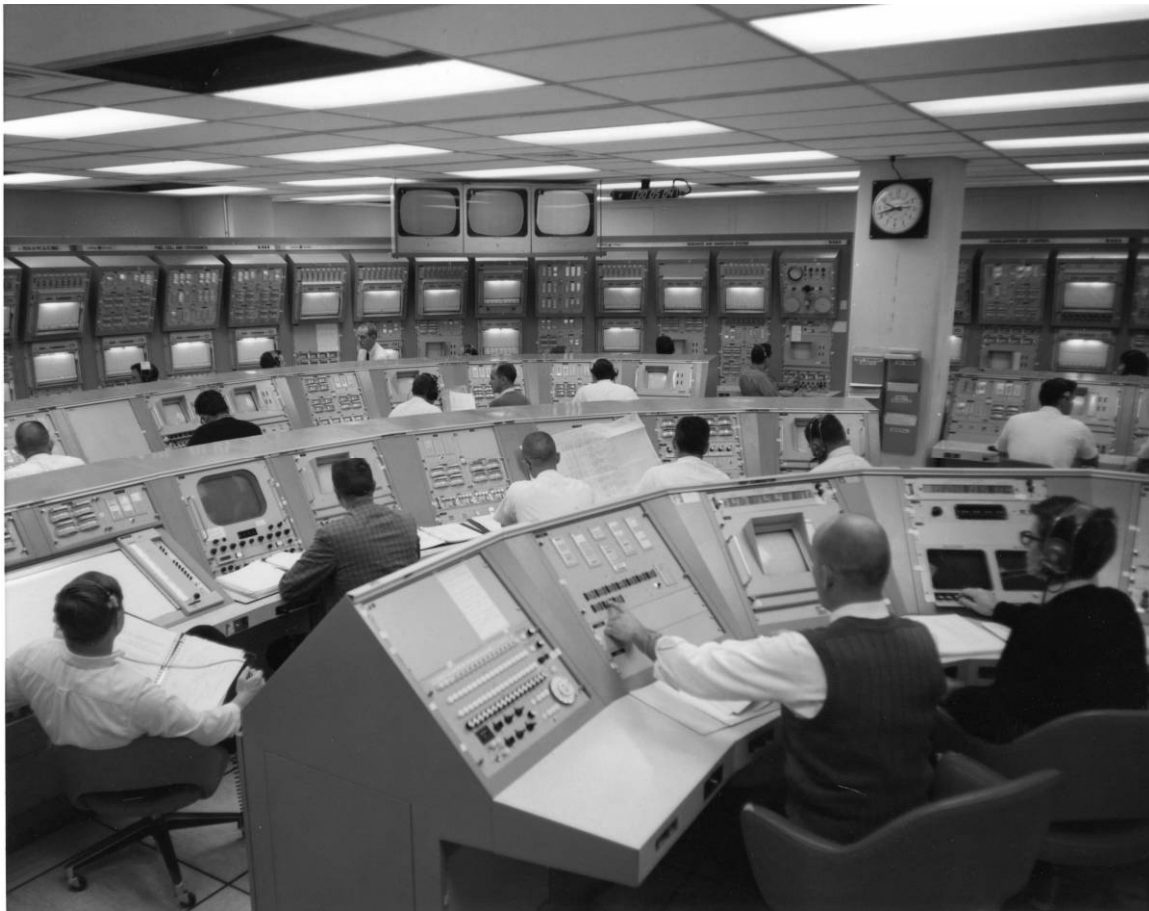
Figure B-17. View of Acceptance Checkout Equipment Station No. 1, direction unknown,
February 16, 1967.

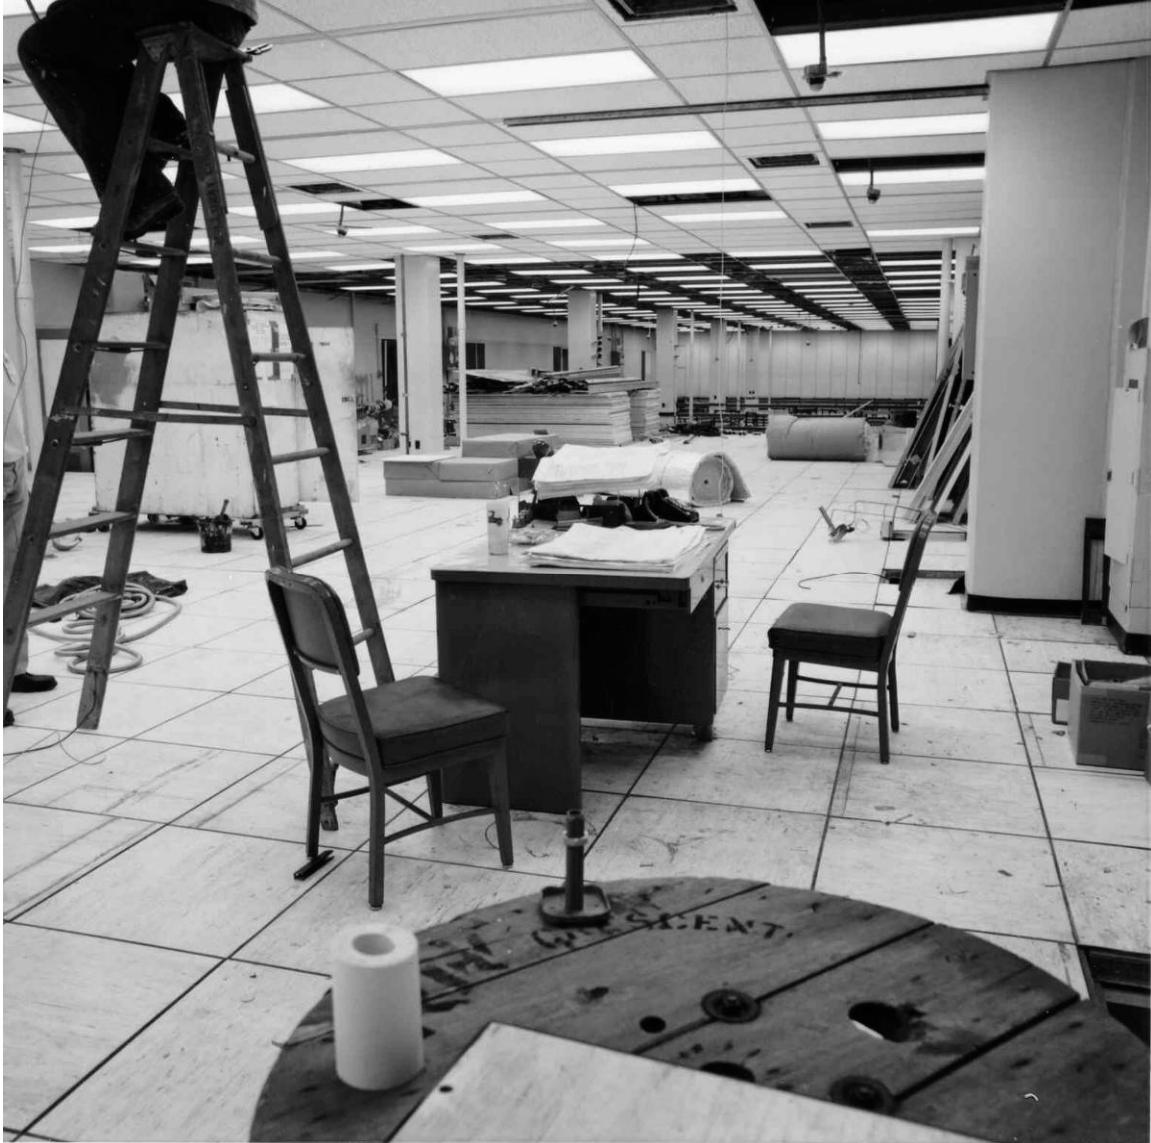
Figure B-18. Renovation of an Acceptance Checkout Equipment Station into Payload User Room Nos. A and B, direction unknown, April 28, 1981.

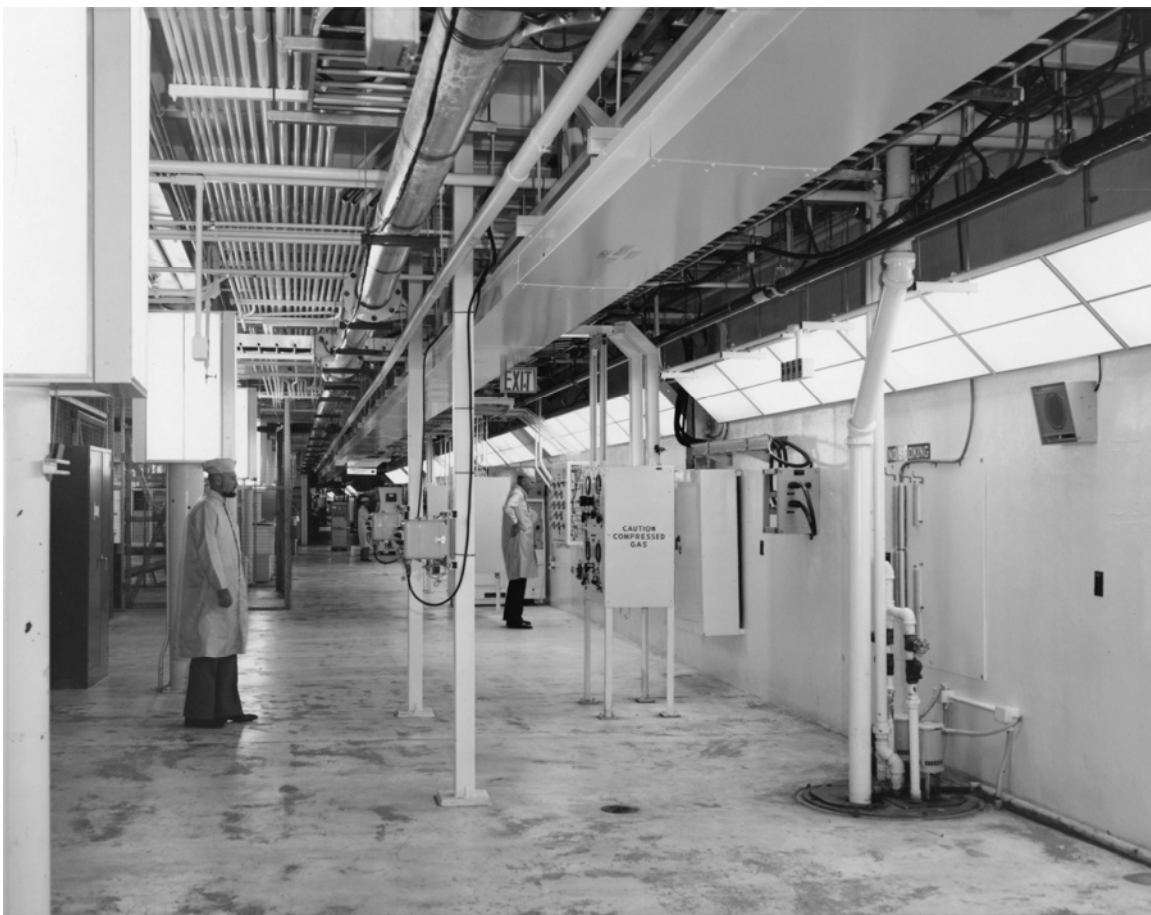
Figure B-27. View of the cable/utility tunnel, February 6, 1974.
Source: John F. Kennedy Space Center Archives, 108-KSC-74C-82.

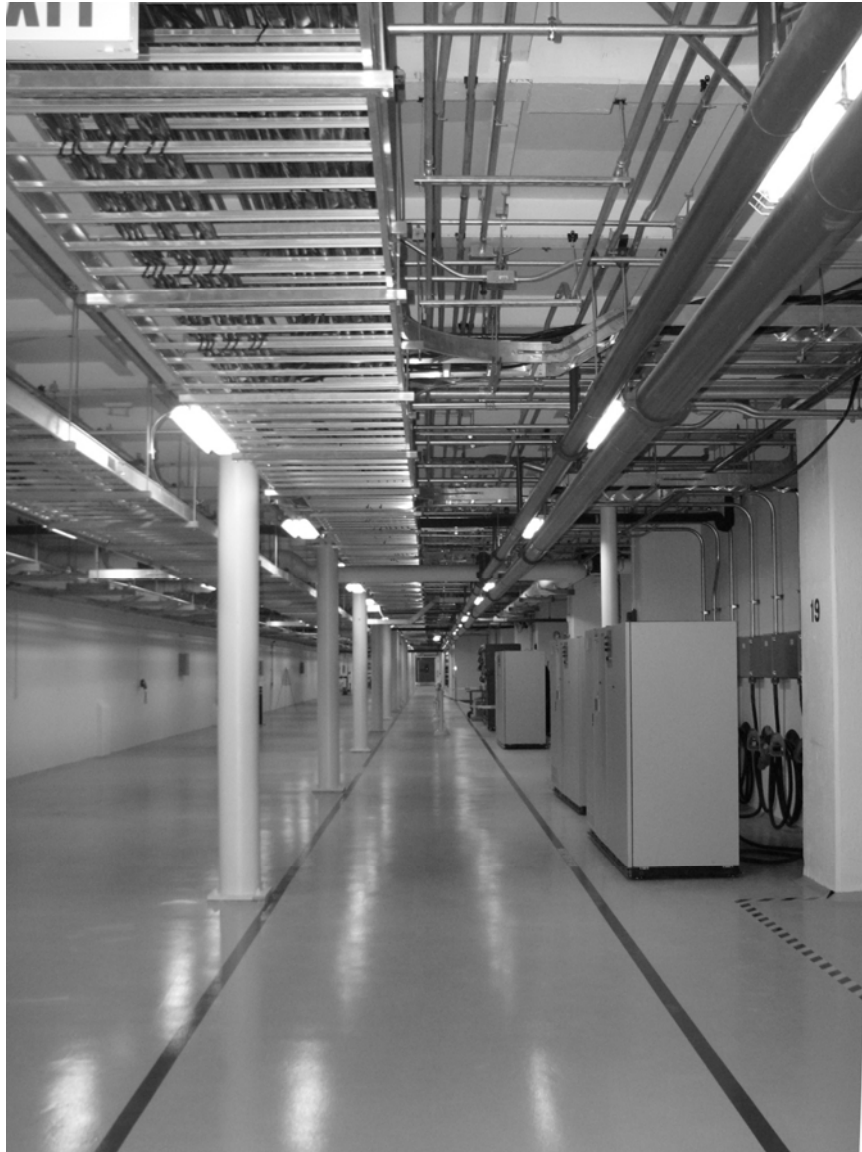
Figure B-28. View of the cable/utility tunnel, circa 2010.
Source: Lockheed Martin.
