**Technology Evaluation for Environmental Risk
Mitigation Principal Center**

NASA-DoD Lead-Free Electronics Project

Joint Test Report - Final

December 2011

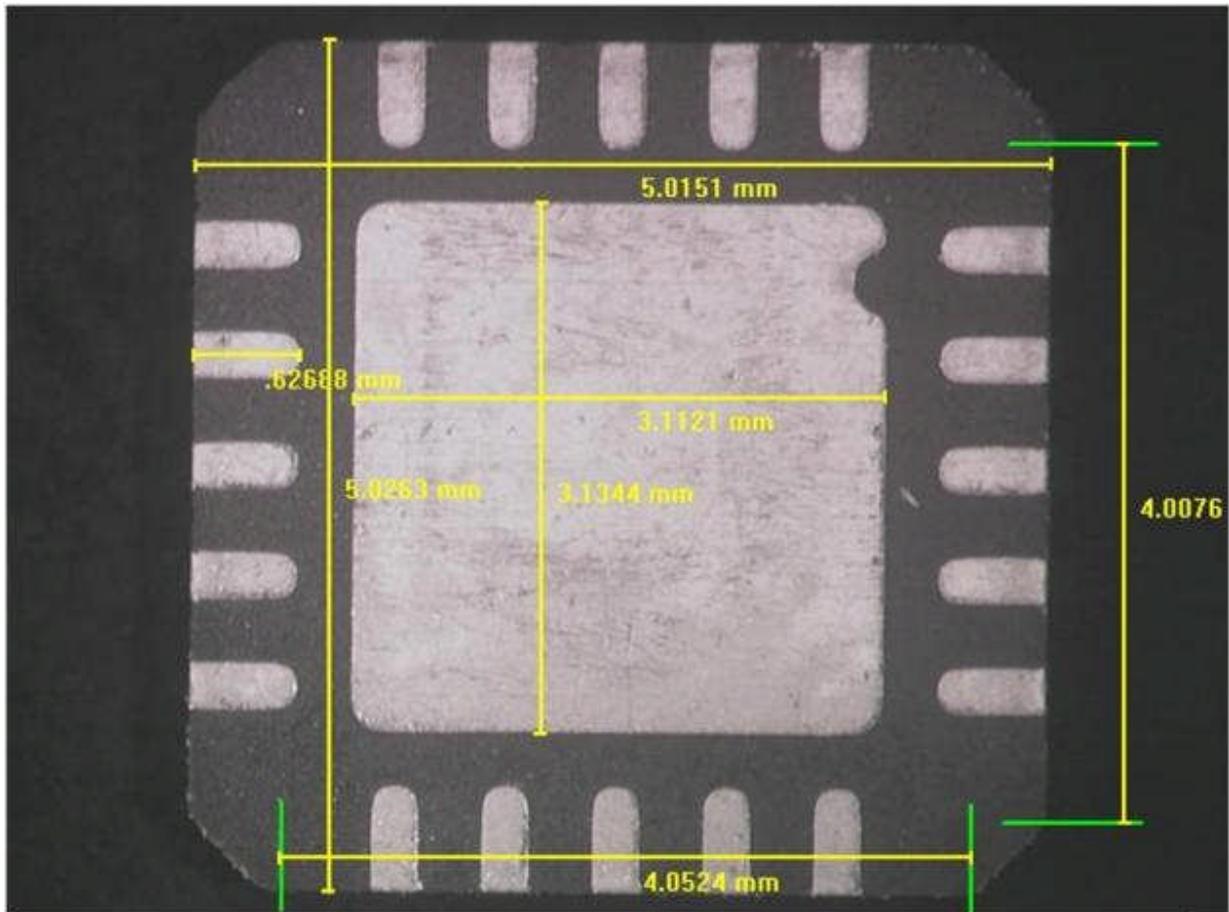
Figure 1 – QFN-20 Component Bottom Side Showing Die Thermal Pad

Note – QFN-20 components with the thermal die pad (see Figure 1) soldered to the board were the most reliable components under this test program

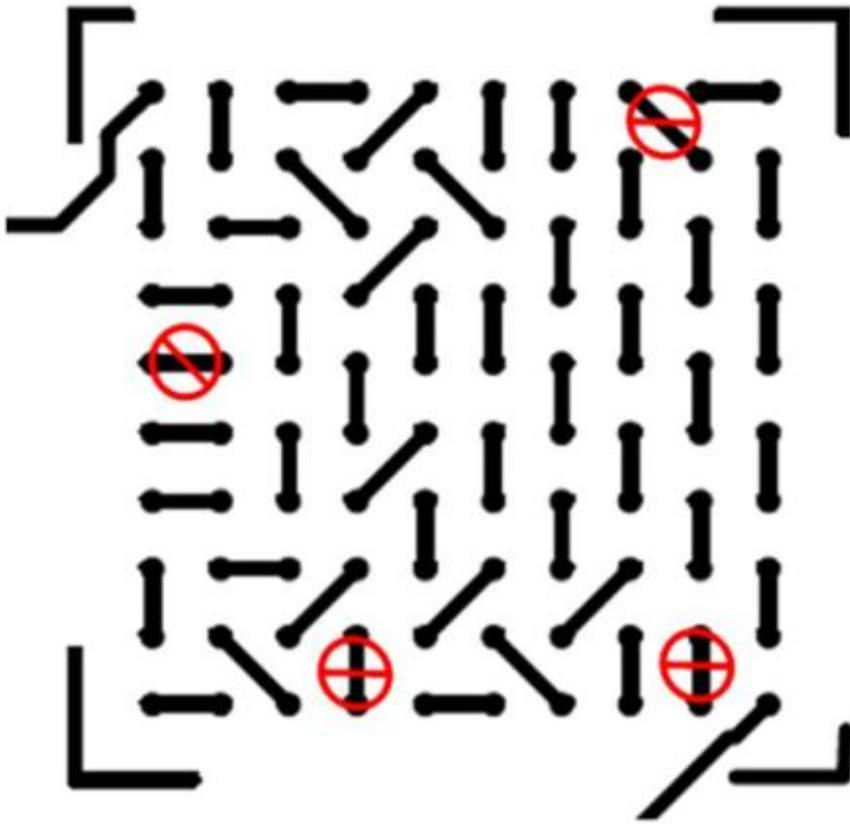
Figure 4 - Test Vehicle Drawing, Chip Scale Package (CSP)

When reviewing the CSP data, please note that the CSP components on all test vehicles only have continuity in the outside solder balls. The wrong component configuration was used during test vehicle drafting. Traces interconnecting internal rows of balls to the outside row of balls do not exist on the test vehicles, Figure 4. In order for a CSP component failure to be recorded, breaks in both sides of the continuity box must occur, Figure 5.

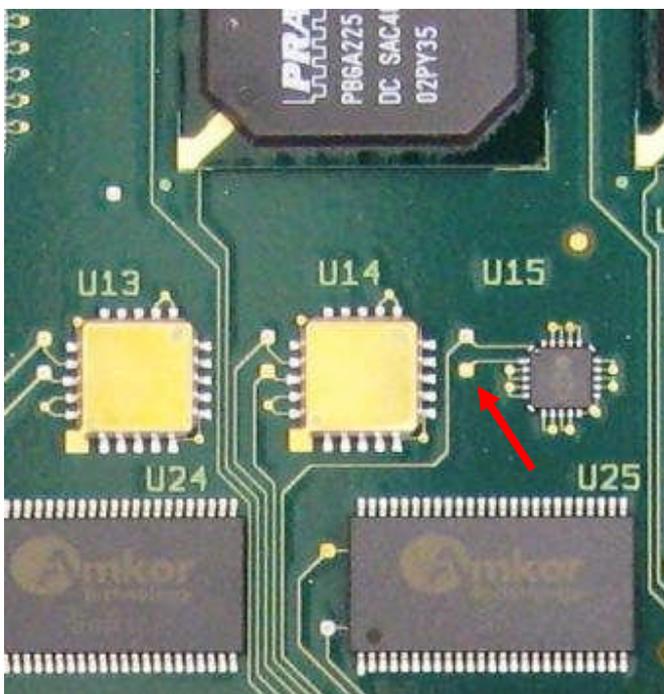
Figure 7 - Missing Trace, QFN – U15

Component location U15, a QFN, is missing a wire trace, Figure 6. During drafting, the trace was not included in the test vehicles drawing, Figure 7. Test data cannot be collected for this component unless a jumper wire is used in-place of the missing trace. Jumper wires were used for the thermal cycle test vehicles. For vibration, drop, mechanical shock and combined environments testing, it was determined that a jumper wire is not feasible. For the NSWCR Crane rework test vehicles, QFN U15 is an active rework component. For drop and vibration testing, a jumper wire was attached to each U15 location to permit collection of test data (see Figure 8).

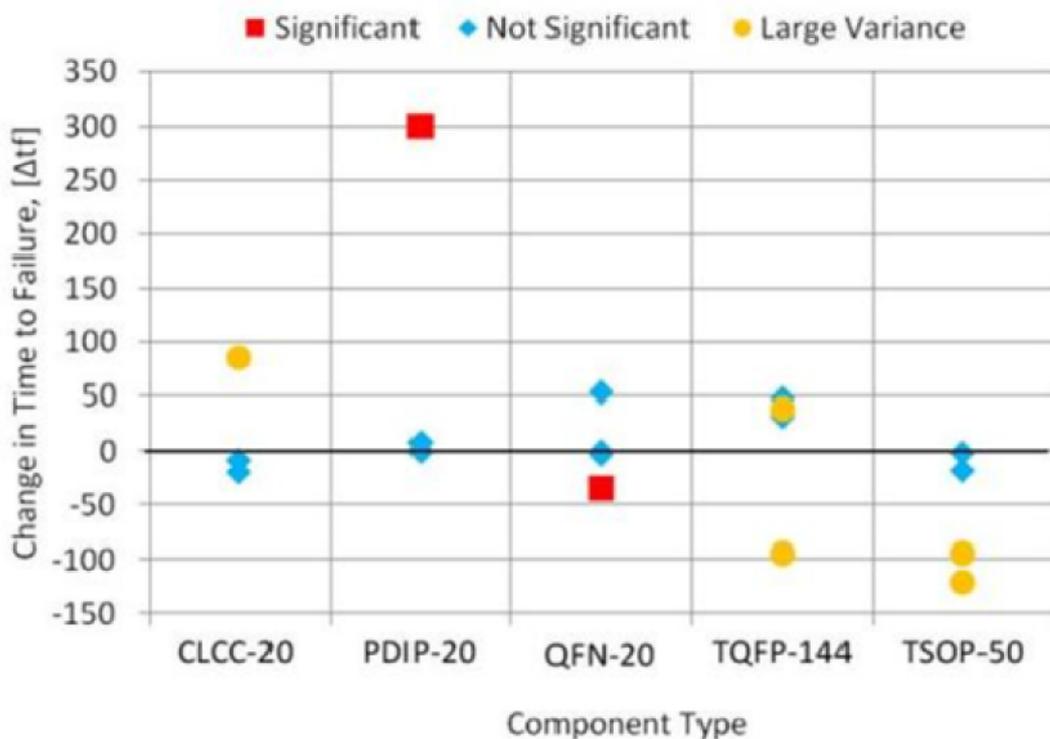
Figure 13 - The difference in average time to failure for each component type when comparing as-manufactured parts to reworked parts. A positive change indicates an increased time to failure after rework.

Looking at Figure 13, overall, it appears that rework had minimal effect in most cases. There are only five sets of tests where the absolute value of the delta Tf was 75 or larger. In two cases, the CLCC-20 and PDIP-20, the delta Tf was positive, and for three others, aTQFP-144 and two TSOP-50s, it was negative.

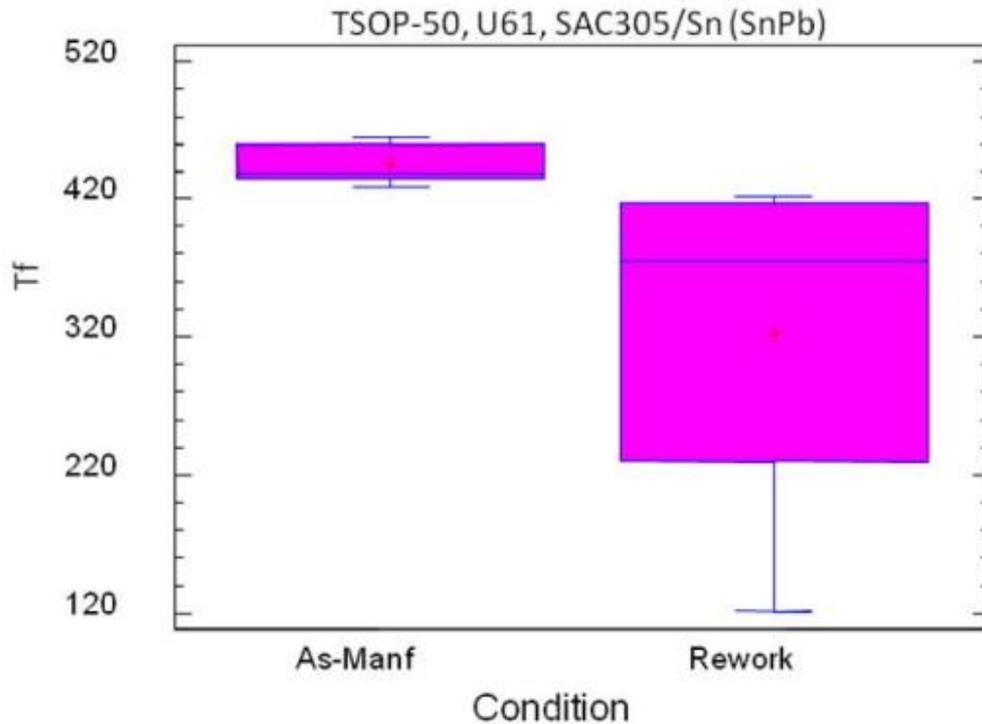
Figure 14 - Test results for U61, in the As-Manufactured Condition and after Rework

Starting with the cases where the reworked samples failed more quickly, there were two test runs where the reworked TSOP-50s did not perform as well as samples in the as-manufactured condition. In one run, the reworked parts failed 121 minutes earlier. This was U62, and the difference can be attributed to one outlier; an early life failure on just one reworked sample. Another TSOP, U61 failed an average of 95 minutes earlier after rework. The test results are shown in Figure 14.

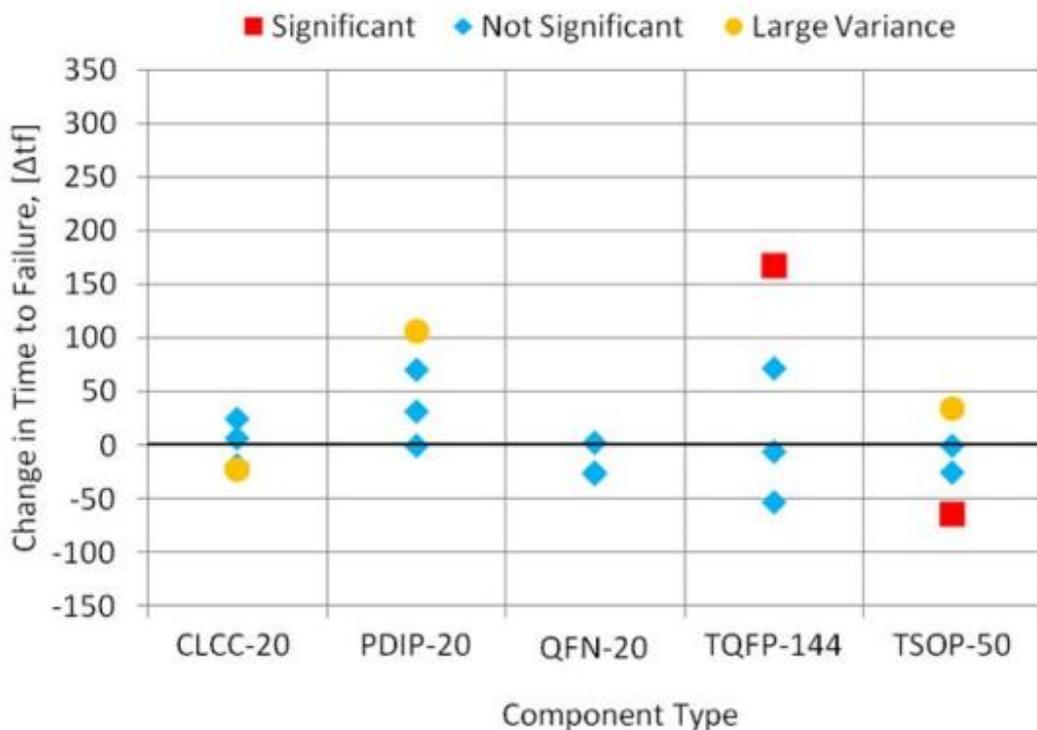
Figure 16 - The difference in average time to failure for each component type when comparing the 1st SnPb rework to the 2nd SnPb rework. A positive change indicates an increased time to failure after the 2nd rework.

Another potential “noise” problem is large differences in variation between sample test groups. When we performed the F-tests, we tested for differences in the variation between the groups using Bartlett’s Test. The p-values for the variance check are shown in Table 15. Cases where the p-value is less than 0.05 (5%) show that there is a significant difference in the variation between the sample test groups. The significant results are shown as circles on Figure 16. Difference in variation between the test groups can distort the F-test results.

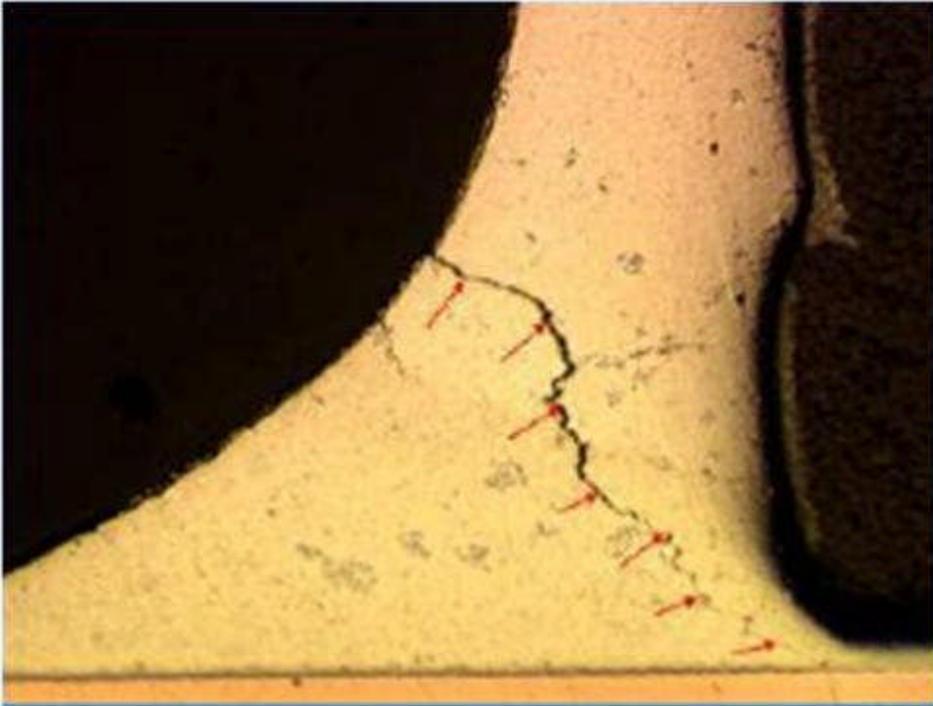
Figure 17 - SN63 U52, Left Side Pad

All of the tested CLCC-20s had SAC305 component finish. None of these solder joints were reworked. Solder cracks we observed around every solder joint. The cross sections of all CCLC-20 packages were performed on corner pads. Each cross section revealed cracking across the length of the solder, see Figure 17. SN67 also showed voiding, in this case the crack traveled along the void, see Figure 18.

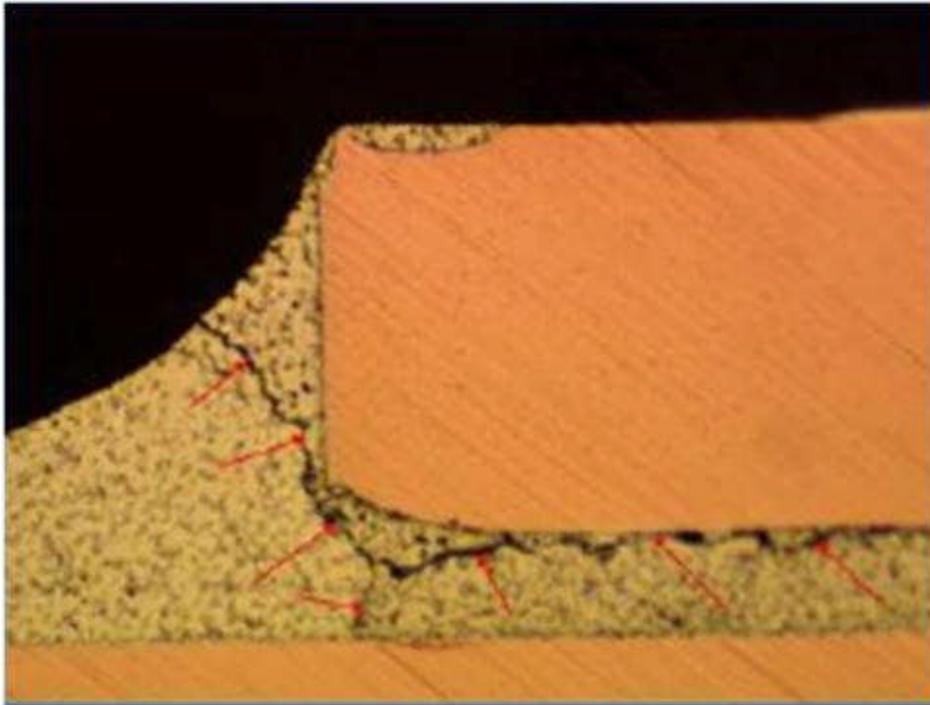
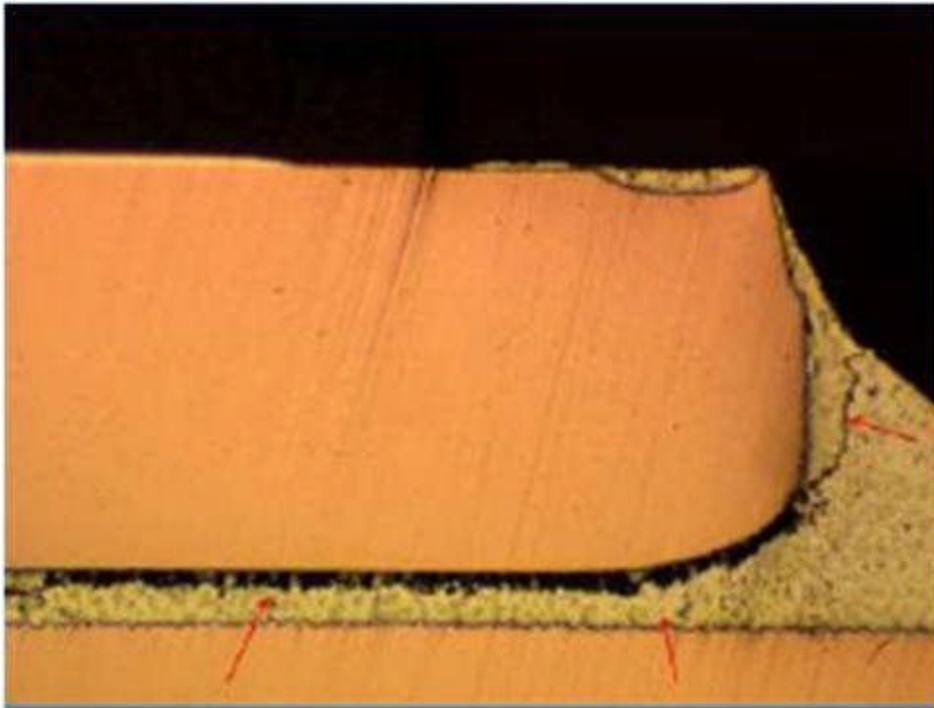
All of the QFN-20 packages were fabricated using Sn finish and were exposed to one or two reworks with SnPb solder. Approximately half of the solder joints exhibited cracks which ran along the component pad. There does not appear to be a correlation between the cracked solder and the number of re-work cycles to which the part was exposed. Cross sections of the QFN-20 packages reveal that the cracks propagated along the component pad, see Figure 19 and Figure 20.

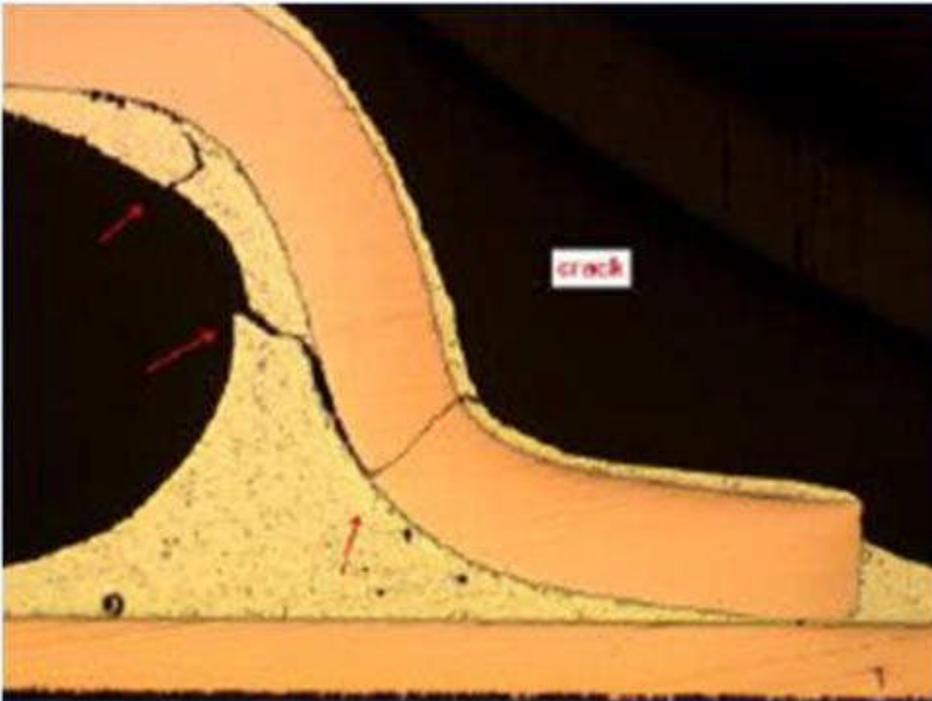
Figure 22 - SN61 U20 Right Lead

Cross-sectioning revealed cracks in the actual copper leads of the TQFP-144 packages. This damage was observed only on parts which were not reworked and therefore the solder joint was Pb-free. This is to be expected as the Pb-free solder is stiffer than the SnPb solder and transfers the stress to the weaker copper leads. Figure 21 and Figure 22 illustrate TQFP-144 packages which were not reworked and therefore contain only Pb-free solders.

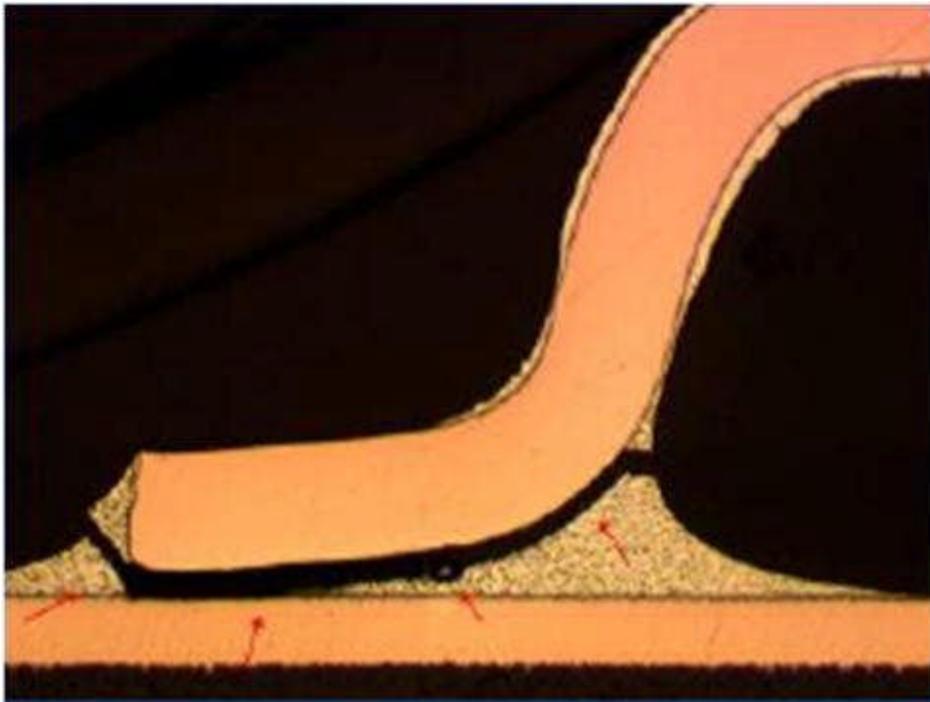
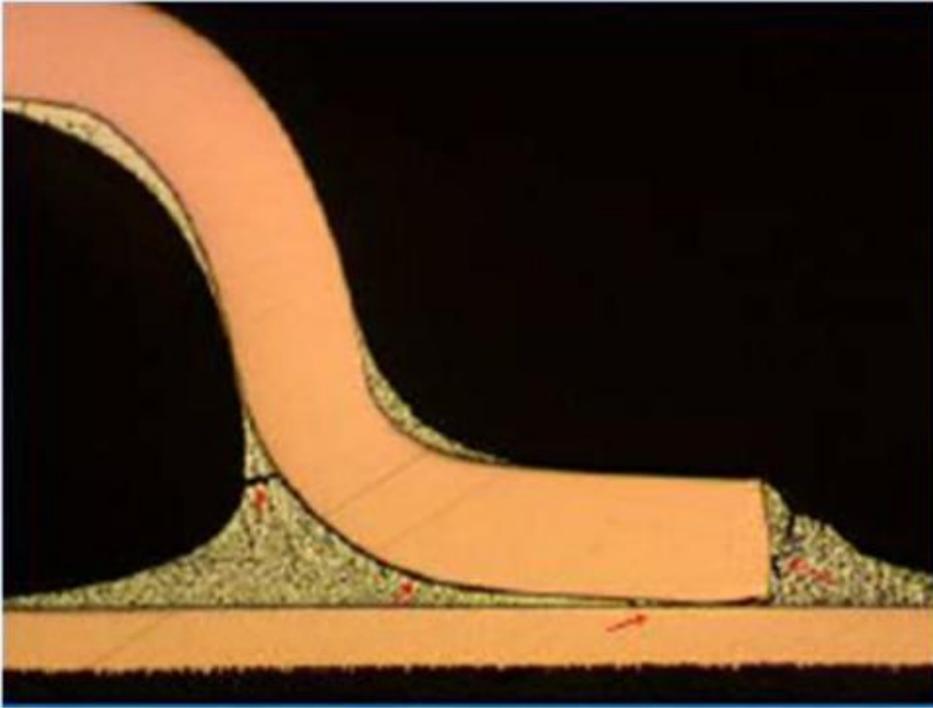
Cross-sections of TQFP-144 packages which were re-worked, either once or twice, revealed cracked solder joints in all cases. However, all of the leads on these samples survived see Figure 23 and Figure 24.

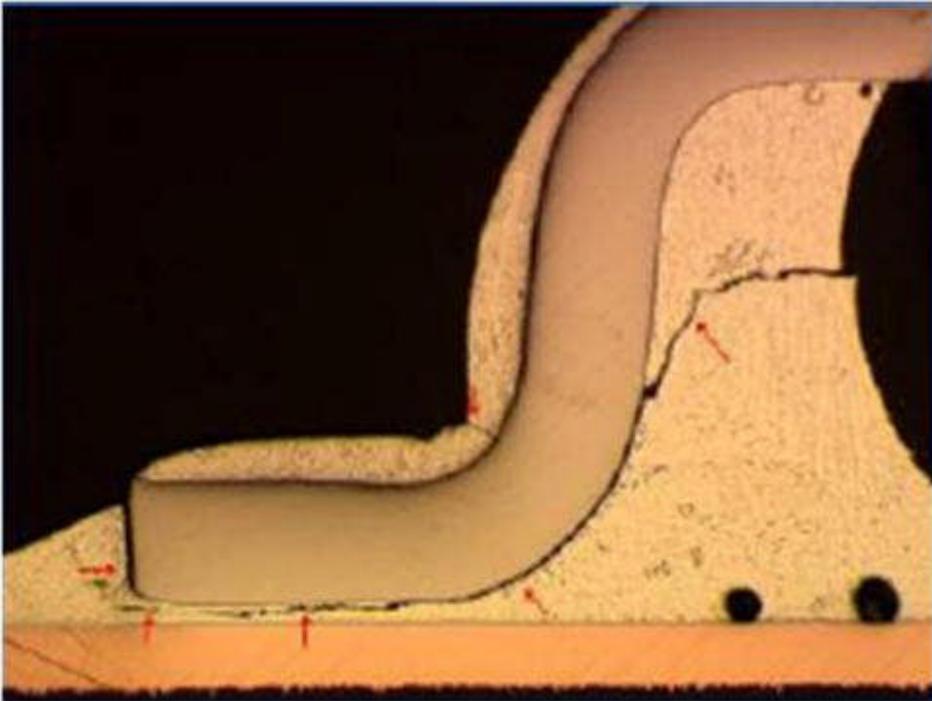
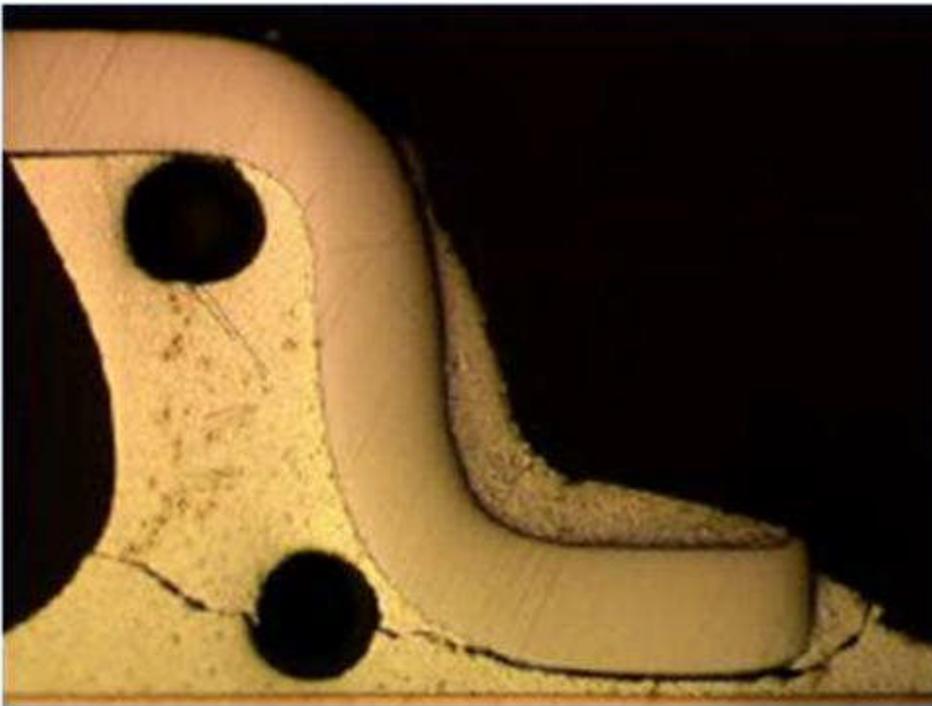
SN79 U12 (Figure 25) and SN66 U62 (Figure 26) are examples of TSOPs which did not undergo any re-work. They have Sn and SnBi finishes respectively. Both experienced severe solder joint cracking on both sides of the component.

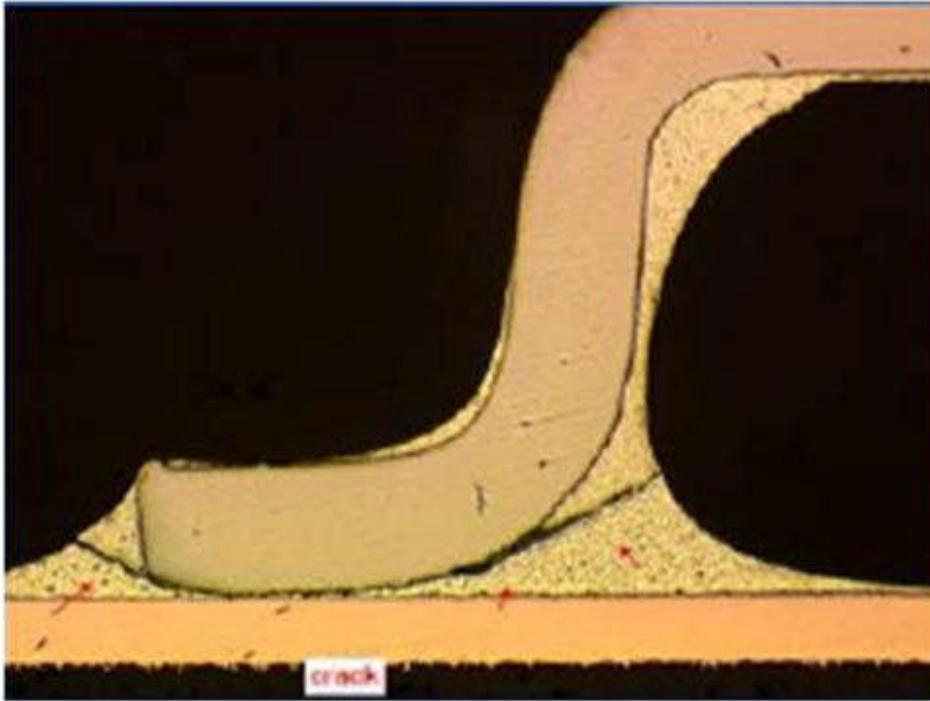
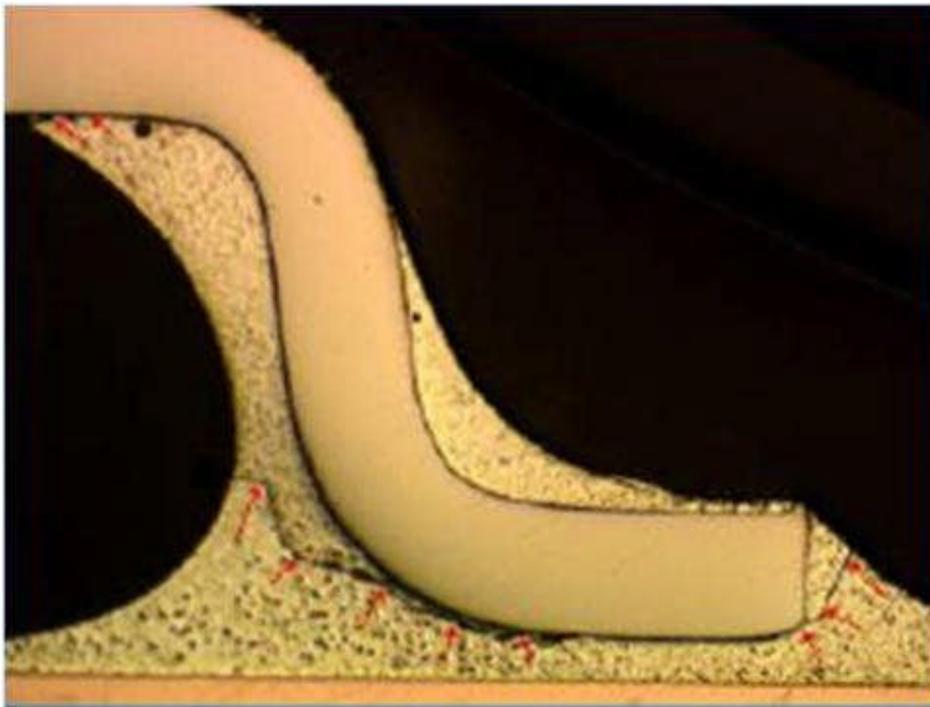
SN65 U62 (Figure 27) and SN63 U61 (Figure 28) are examples of parts which underwent one rework cycle with SnPb solder. They have Sn and SnBi finishes respectively and both components

showed significant cracking within the solder at both sides of the component. This is consistent with all parts which have undergone one re-work cycle.

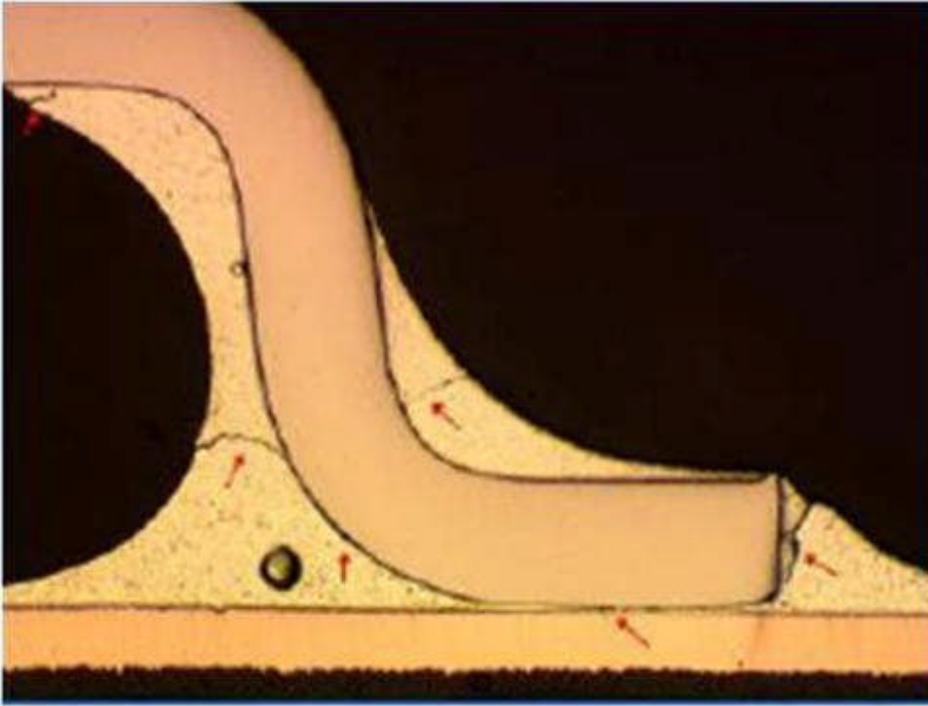
Figure 30 - SN68 U29, Right Lead

SN63 U16 (Figure 29) and SN68 U29 (Figure 30) were both re-worked twice with SnPb solder. SN63 U16 is finished with SnBi and SN68 U29 is finished with Sn. The SnBi part experienced extensive solder cracking through-out. The Sn finished part experienced solder cracking at one side of the component.

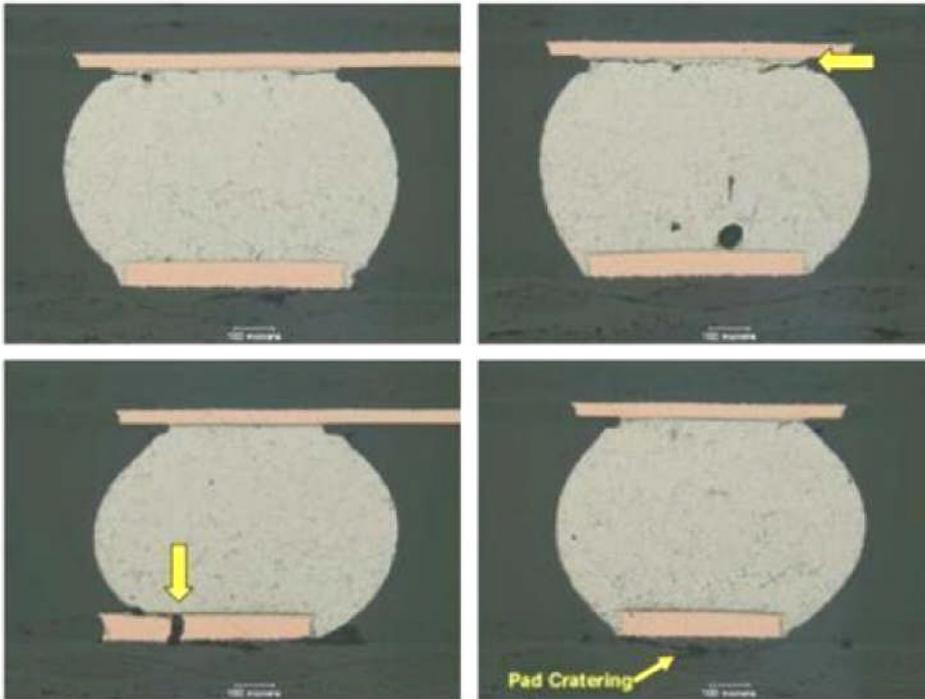
Figure 32 - Test Vehicle 34 - Four Corner Balls of BGA U6 (SnPb Solder/SnPb Balls)

Microsections made at the end of Mechanical Shock Testing showed that the corner solder joints failed first. The SnPb/SnPb sections showed pad cratering, PWB trace cracking, and solder joint cracking on the component side (Figure 32).

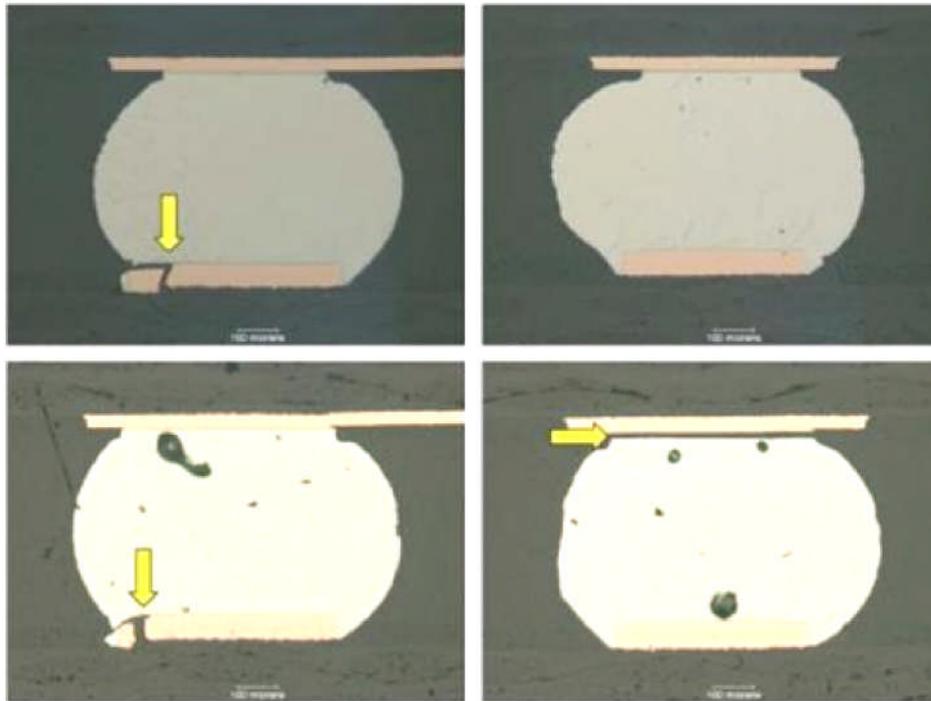
Figure 33 - Test Vehicle 89 - Four Corner Balls of BGA U2 (SAC305 Solder/SAC405 Balls)

The SAC305/SAC405 sections showed PWB trace cracking and solder joint cracking at the component side intermetallic layer (Figure 33). Which failure mechanism occurred first could not be determined from the microsections.

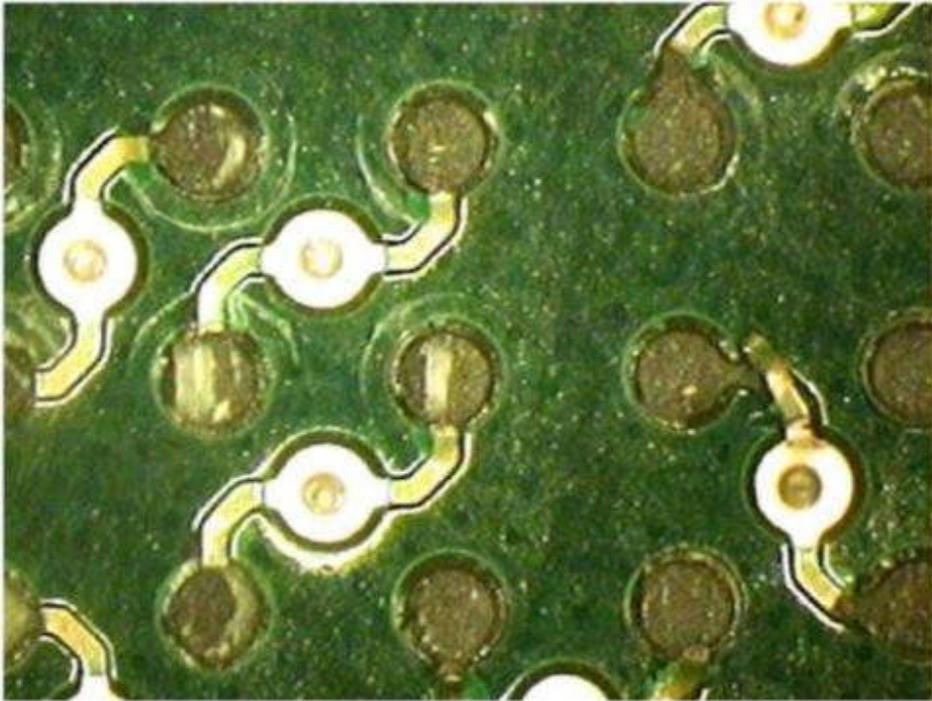
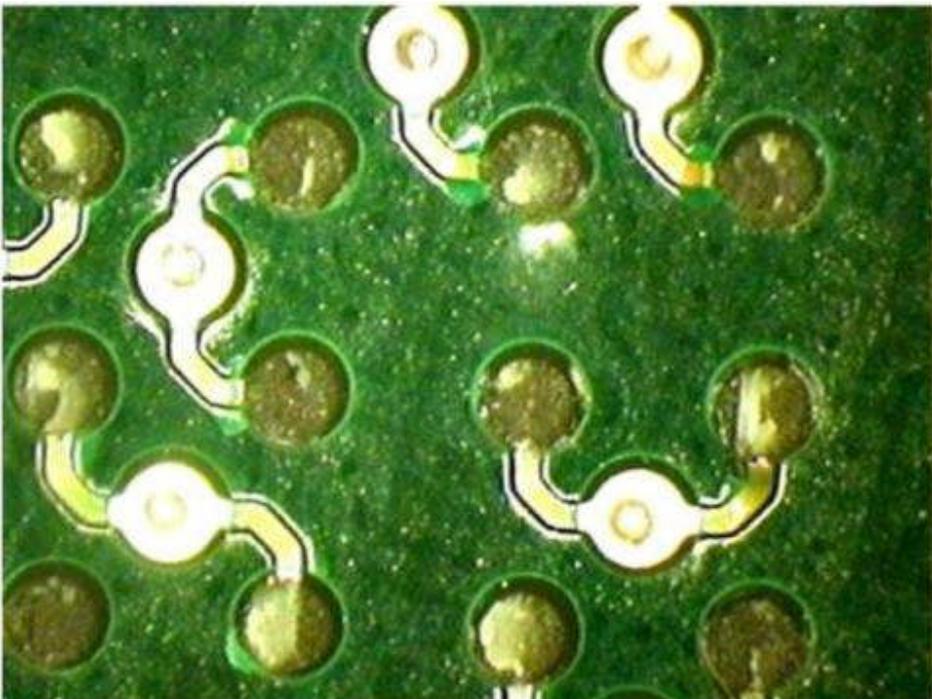
Surprisingly, on the SnPb/SnPb BGA's that fell off, almost 100% of the solder joints failed by pad cratering. The BGA balls and associated PWB copper pads were missing from the test vehicles (Figure 34 and Figure 35).

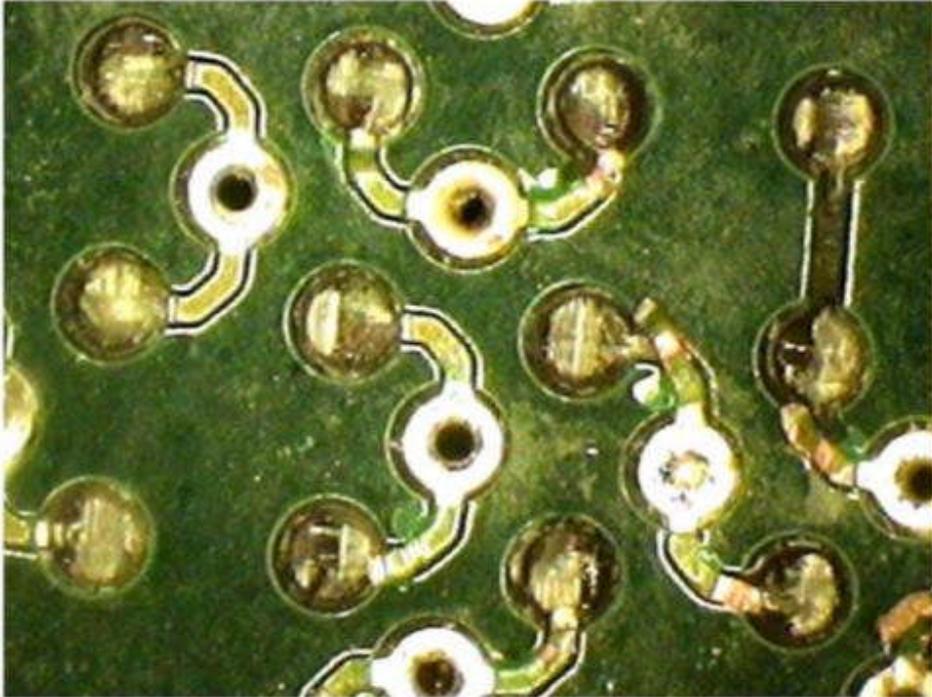
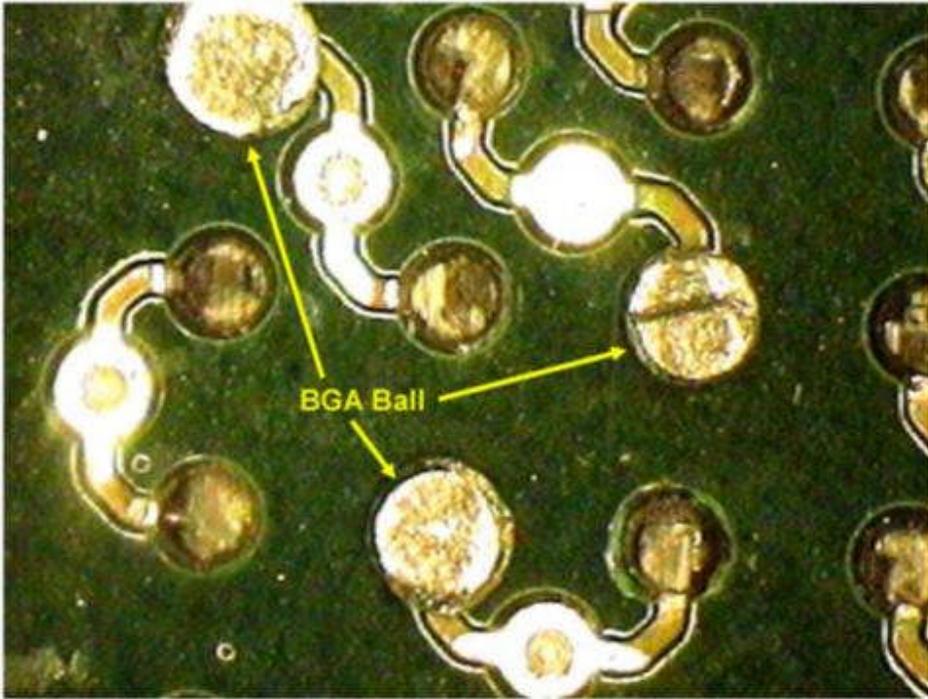
No SAC305/SAC405 BGA's fell off during the test. The only purely Pb-free BGA that fell off was one reworked using flux only and a BGA with SAC405 balls. For this BGA, 16% of the

balls remained with the PWB with the solder joints failing on the component side (although most of the remaining balls also showed signs of PWB pad cratering). The balance of the BGA balls and associated PWB copper pads were missing from the test vehicle (Figure 36 and Figure 37).

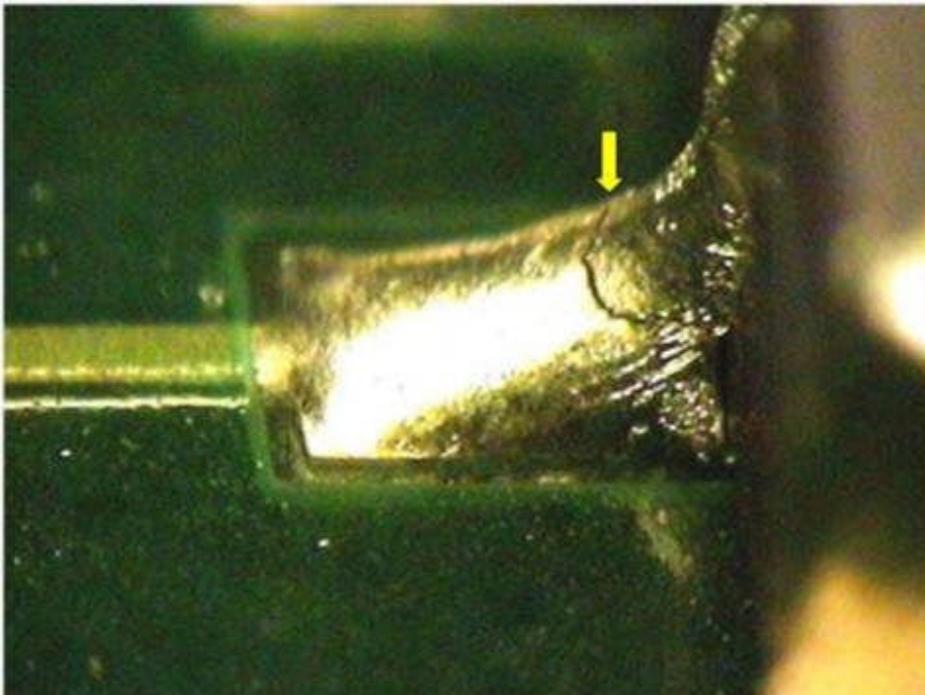
Figure 39 - Test Vehicle 191 CLCC U10 (Cracked SAC305/SnPb Solder Joint)

Test vehicle inspections made at the end of Mechanical Shock Testing showed cracks in a CLCC solder joint (Figure 39).

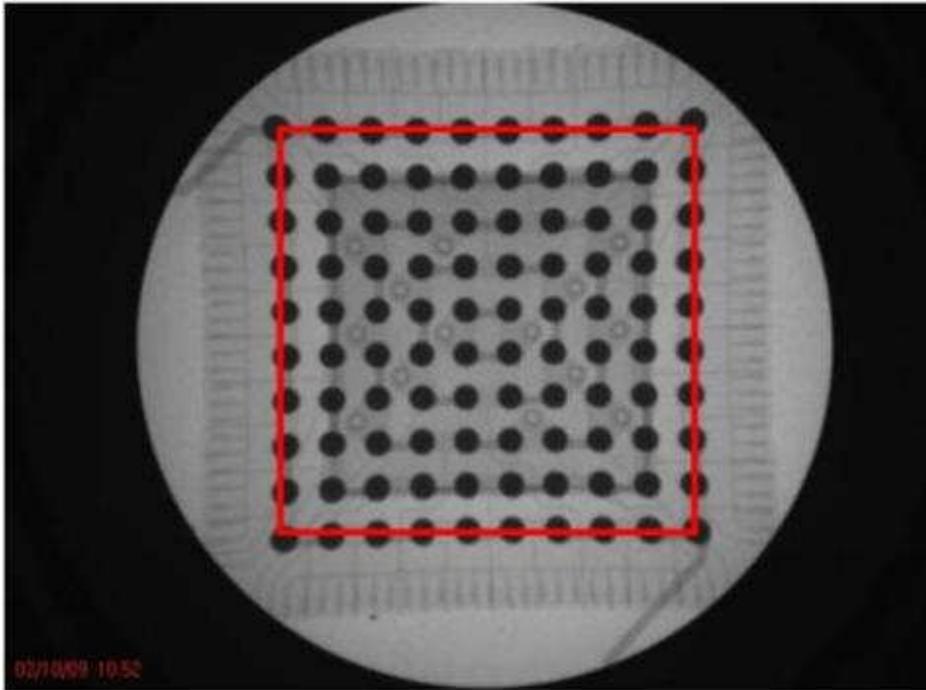
Figure 40 - X-Ray of a CSP-100 (Showing that only the outer balls form a daisy-chain (Red Lines).)

The CSP daisy chain pattern on the test vehicles was incorrect with the result that only the outer perimeter balls of each CSP formed an electrically continuous path (Figure 40). In order for a CSP to be detected as failed, both legs of the outer perimeter needed to fail.

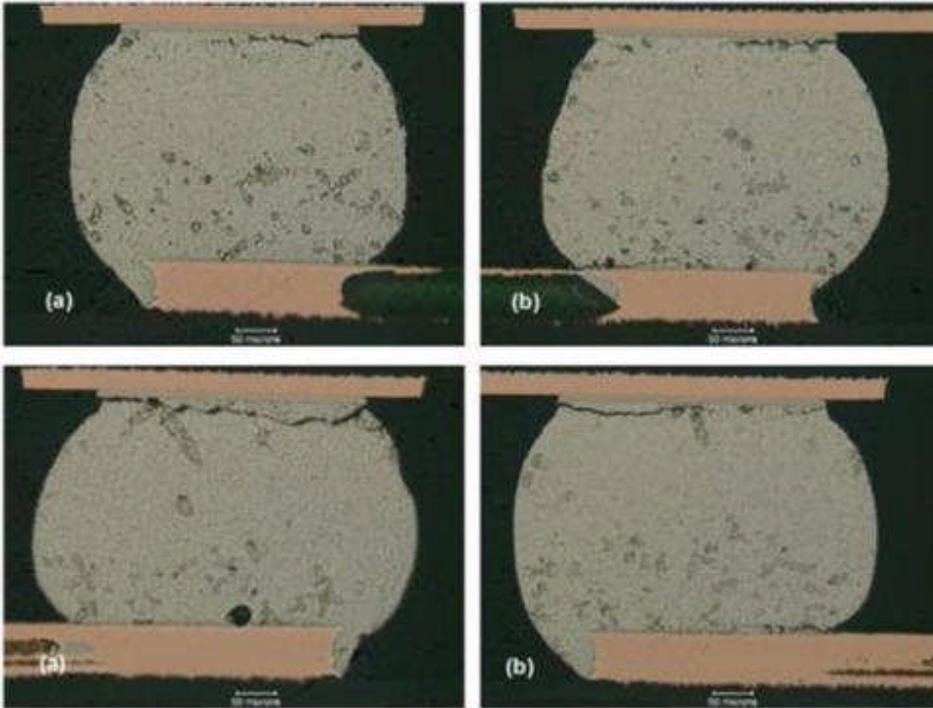
Figure 41 - Test Vehicle 34 – CSP U33
 (a) Corner Ball, (b) Ball Adjacent to Corner Ball (SnPb Solder/SnPb Balls)

The combination of SAC305 solder/SAC105 balls generally performed as well as the SnPb/SnPb controls in mechanical shock. Microsections made at the end of the test showed that the corner solder joints failed first. The SnPb/SnPb solder joints formed cracks primarily on the component side (Figure 41). The SAC305/SAC105 solder joints formed cracks primarily on the component side and also showed evidence of pad cratering (Figure 42).

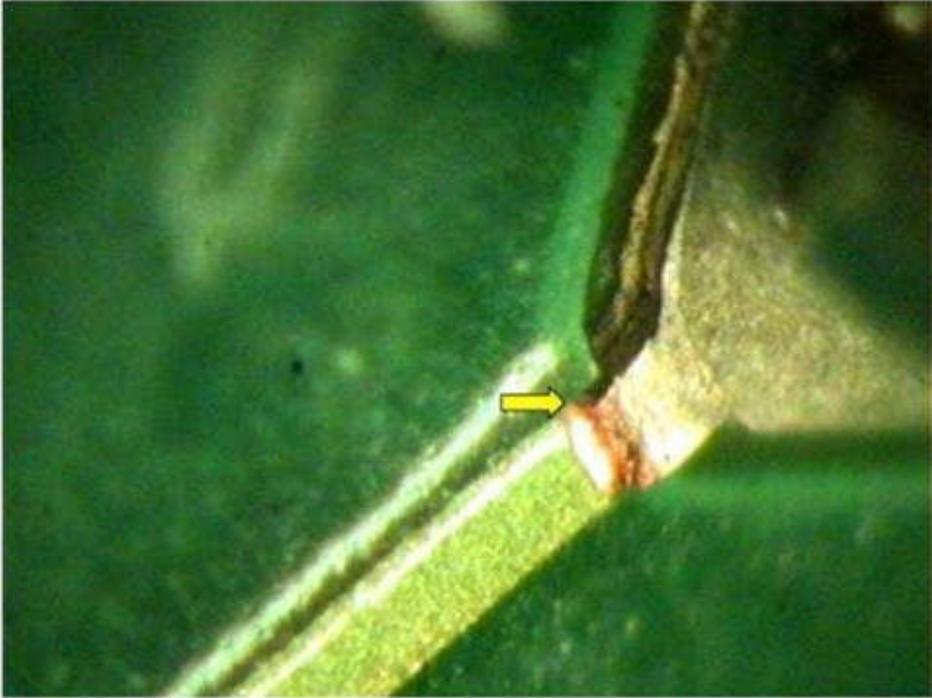
Figure 45 - Test Vehicle 89 PDIP U30 (Cracked Trace, SN100C)

Another observation is that many of the PDIP's soldered with SN100C exhibited trace cracking at the corner solder joints (Figure 45 and Figure 46). This failure mode was not observed as often with the PDIP's assembled with SnPb solder.

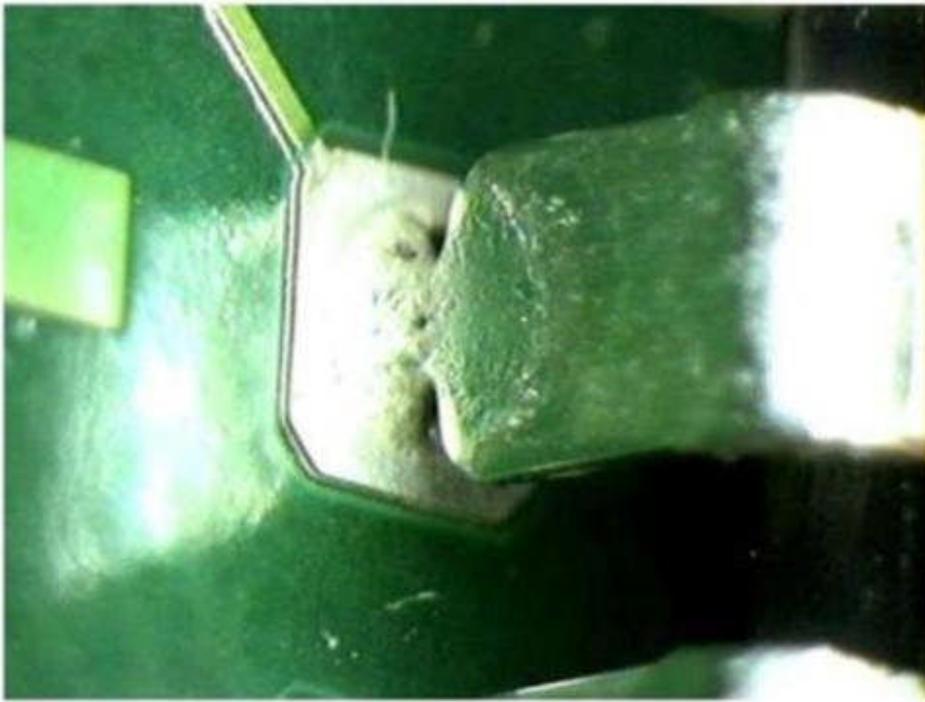
Figure 47 - Test Vehicle 89 PDIP U51 (SN100C)

Several of the earliest failures on the “Manufactured” test vehicles were SN100C/Sn solder joints. One possible cause is that some of the SN100C joints did not have a substantial topside solder filet (Figure 47). This could have resulted in a point of high stress concentration where the PDIP lead necked down resulting in premature failure of the lead. The trace cracking mentioned above is another possible cause for the early failures. Many of the PDIP’s that failed early exhibited both failure modes so it could not be definitely determined which occurred first.

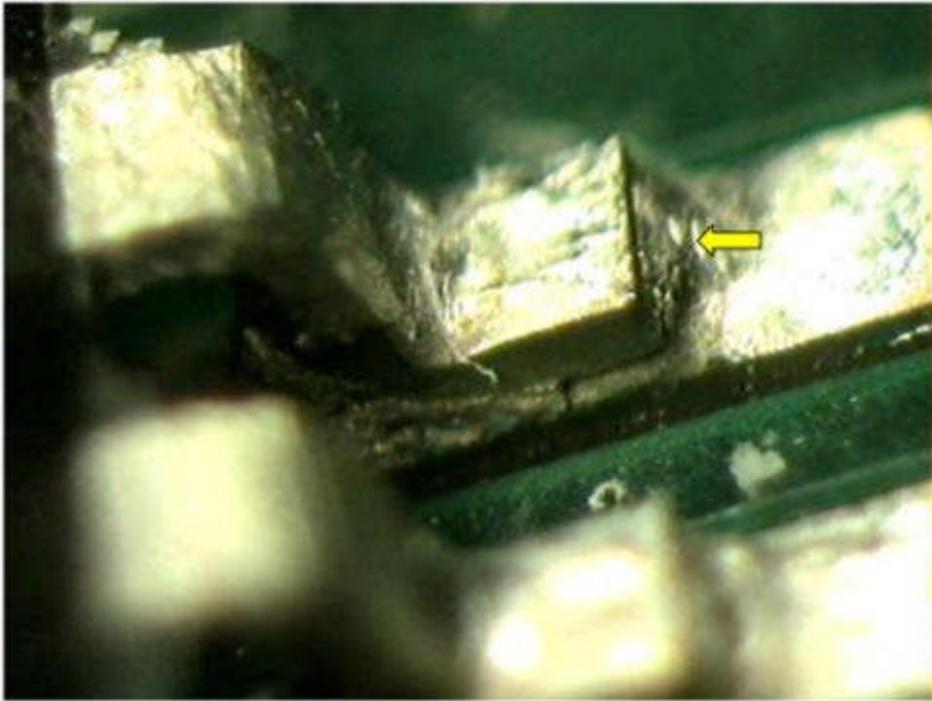
Figure 52 - Test Vehicle 34 TSOP U61 (Cracked SnPb/SnPb Solder Joint)

Test vehicle inspection made at the end of Mechanical Shock Testing showed cracks in a TSOP solder joint (Figure 52).

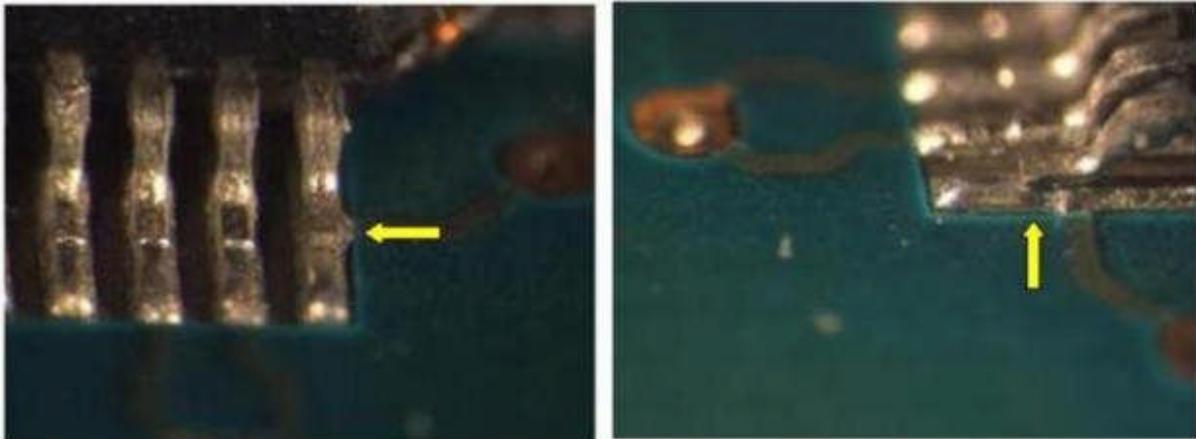
Figure 53 - TV21 U34; Optical Micrograph of Insufficient Solder Observed on Lead 72 at 49X Magnification

Component location U34 is a TQFP-144 component from SnPb manufactured (Batch C), soldered with SnPb on SnPb dip component finish. This component did not have a signal and failed before one complete cycle.
