**Technology Evaluation for Environmental Risk
Mitigation Principal Center**

NASA-DoD Lead-Free Electronics Project

Joint Test Report - Final

December 2011

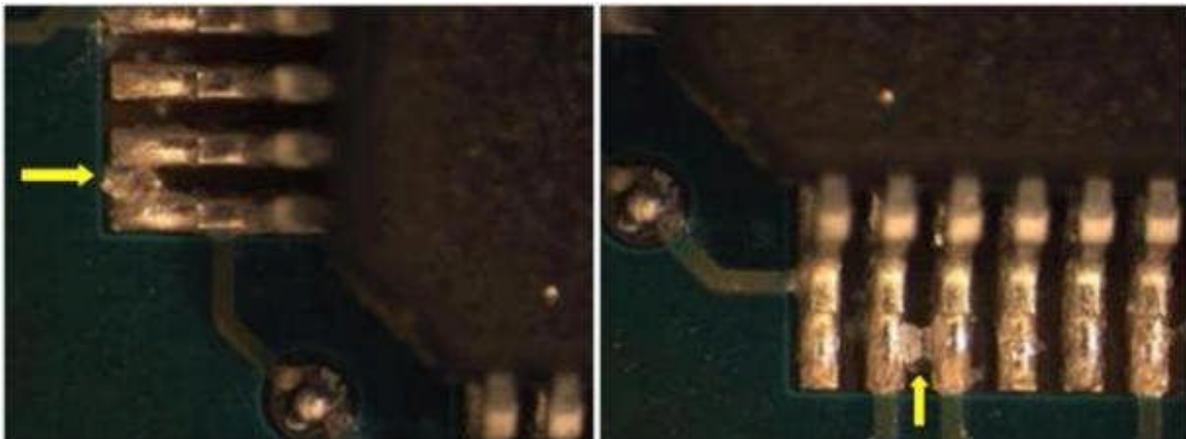
Figure 54 - TV21 U57; Optical Micrograph, Residue between Leads

Figure 54 is the optical micrograph of residue that was found between leads in two locations. The image on the left shows residue between leads 35 and 36, magnified at 38X. The image on the right shows residue between leads 38 and 39, magnified at 38X.

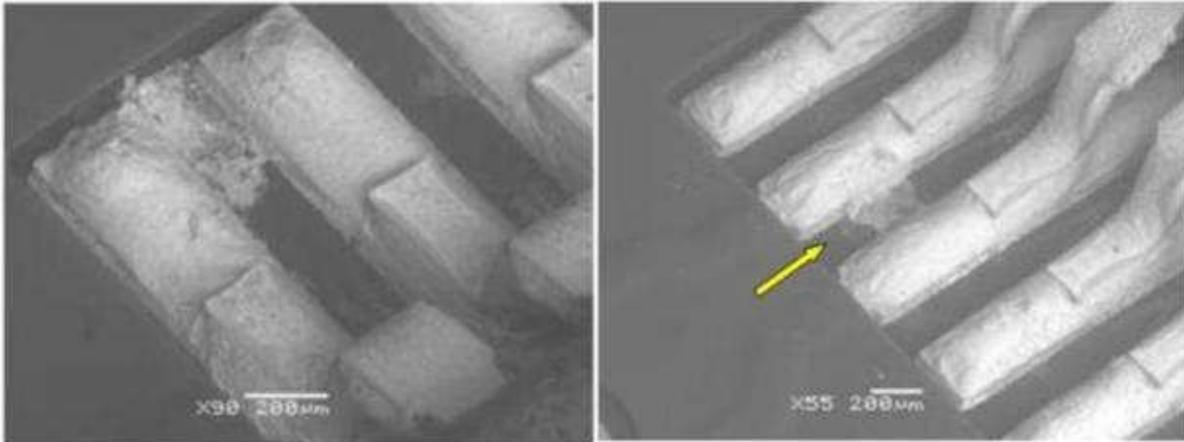
Figure 55 - TV21 U57; Optical Micrograph, Residue between Leads

Figure 55 shows Scanning Electron Microscope (SEM) images taken of the residue found from the images in Figure 54. The image on the left shows the residue that was found between leads 35 and 36, magnified at 90X. The image on the right shows the residue found between leads 38 and 39, magnified at 55X.

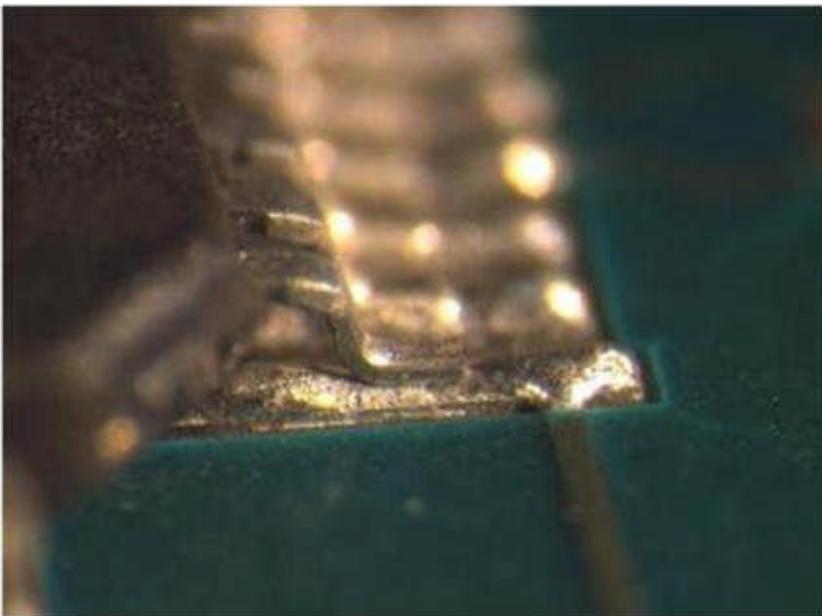
Figure 56 - TV21 U57; Optical Micrograph, Component Lead 1

The possible cause for the immediate failure at cycle one can be found in the Figure 56. The Optical micrograph shows component lead 1 does not contact solder on PWB pad at 49X magnification.

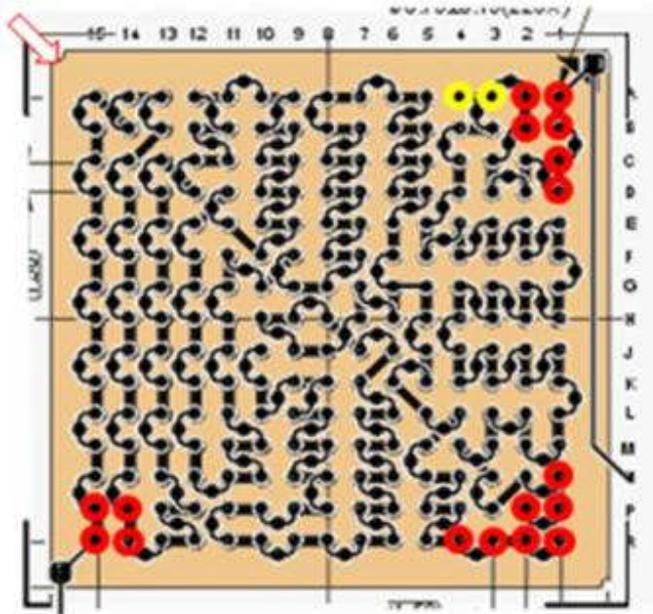
Figure 60 - TV23 U43; FA Results, BGA-225, Location U43

Component location U43 is a BGA-225 from the SnPb manufactured (Batch C), soldered with SnPb with SAC405 component finish located near the center of the test vehicle. This component failed at 120 cycles of combined environments. In Figure 60, yellow circles indicate solder joints with high resistance and red circles indicating failed solder joints that are open.

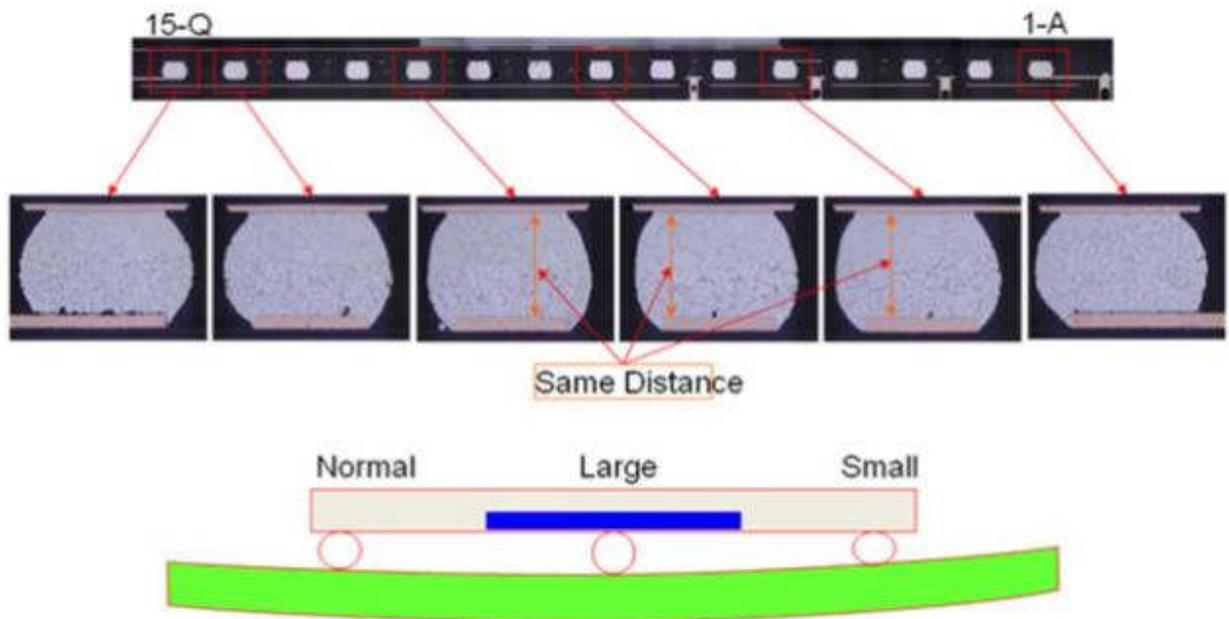
Figure 64 - TV23 U43; Cross-Sectional Micrographs Show Warping

In Figure 64 the distance between component and board at each sphere is almost the same under the chip in the center. The distance becomes smaller further to the end. Comparing the distance at [1-A] and [15-Q], [1-A] has smaller distance.

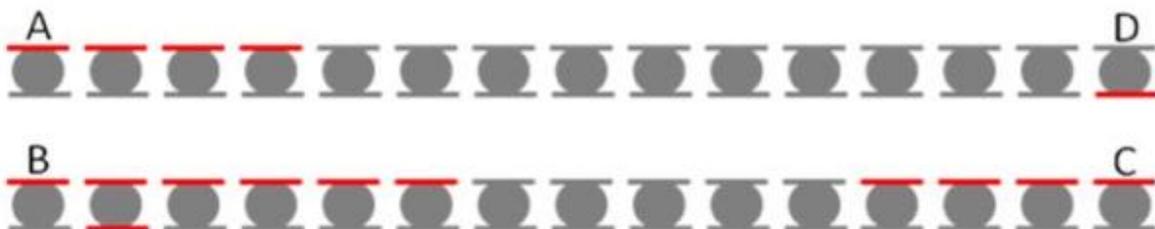
Figure 70 - TV117 U4; Diagram Showing Progression of Cracking in Component

There was a progression of cracking between sides A/D and B/C, which can be visually represented in Figure 70. Red on top of the solder ball is cracking observed at the component interface. Red on the bottom of the solder ball is cracking observed at the PWB pad interface. Red on both the top and bottom of the solder ball is cracking observed at both the component and PWB pad interface. No red indicates an intact solder joint.

For this BGA-225 component, cracking was observed on both the second and third rows in from the perimeter row. No cracking was observed on solder balls beneath the component die.

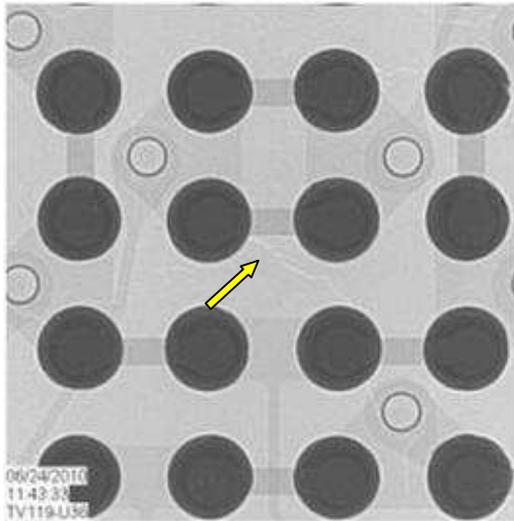
Figure 71 - TV119 U36; X-Ray Image, CSP-100

Figure 71 is an x-ray image of the center region of the CSP-100 component in location U36. The PCB solder mask has a crack and is not homogeneous.

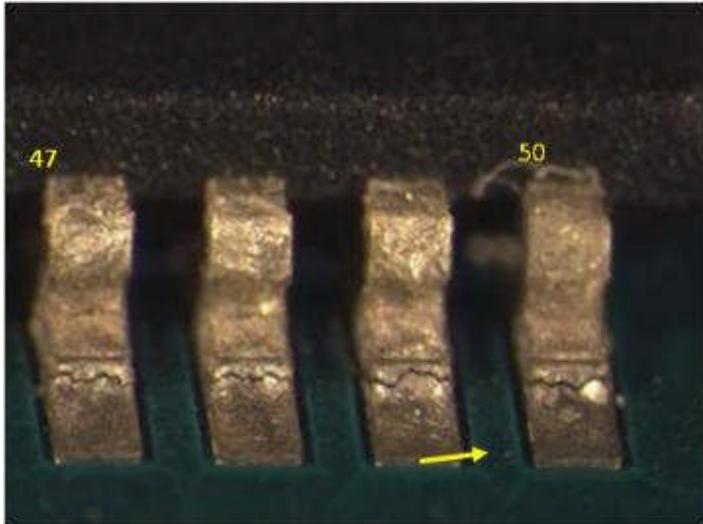
Figure 74 - TV119 U39; Optical Micrograph at 49X Magnification

Component location U39 is a TSOP-50 component from lead-free manufactured (Batch G), soldered with SN100C solder paste on SnPb component finish. This component was surrounded by components that fell off during testing and failed after 318 cycles. In Figure 74, an optical micrograph at 49X magnification showing cracked solder joints and cracks in the solder mask between leads 47 and 50.

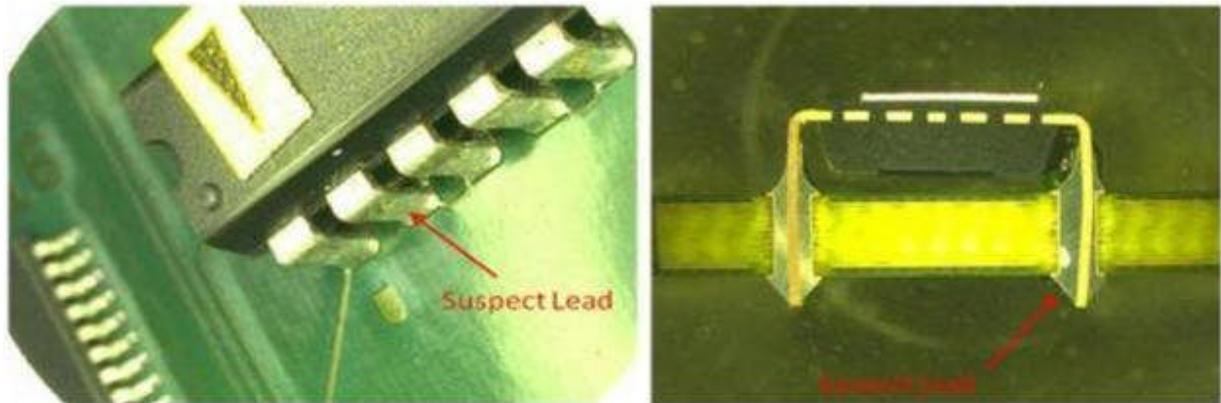
Figure 79 - TV140 U11; Optical Micrograph

Component location U11 is a PDIP-20 from SnPb rework (Batch B), soldered with SnPb on SnPb component finish. This component had a damaged pad from the rework process and failed after 398 cycles. For the optical micrograph in Figure 79, on the left shows the suspect lead. Cross-sectional micrograph on the right is the suspect lead.

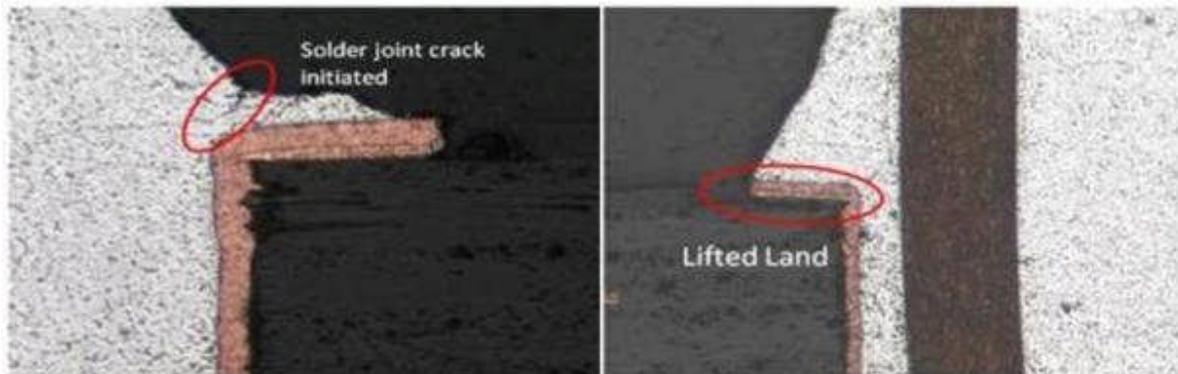
Figure 80 - TV140 U11; Cross-Sectional Micrographs, Suspect PDIP-20 Lead

Figure 80 shows the cross-sectional micrographs of the suspect lead in the PDIP-20 component showing solder joint crack initiation and lifted land.

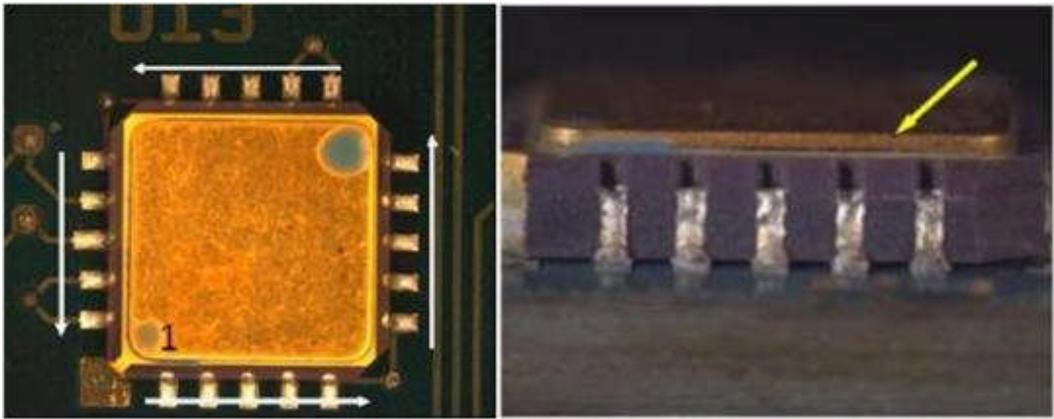
Figure 81 - TV142 U13; Optical Micrograph, CLCC Package Lead

Figure 81, optical micrograph, on the left shows the CLCC package lead numbering. Micrograph on the right shows an improperly sealed lid on the side for leads 1 – 5 where lead 1 is on the left at 19X magnification.

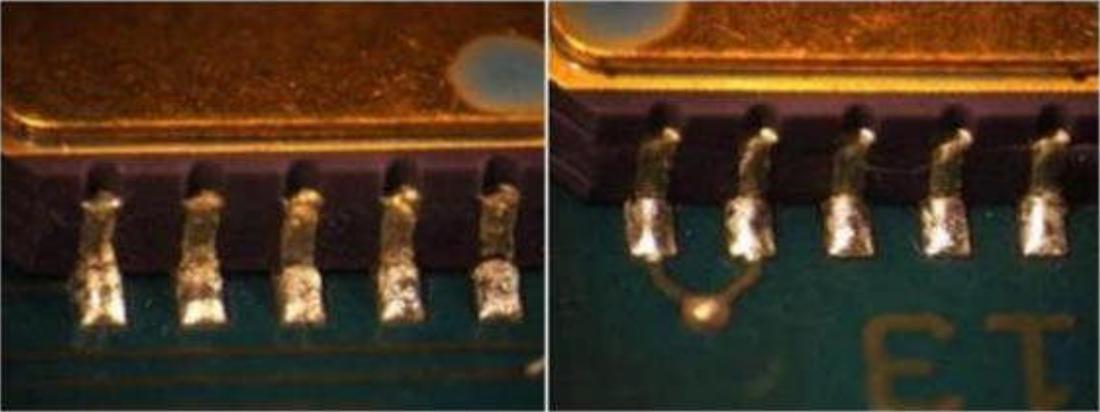
Figure 82 - TV142 U13 Optical Micrographs of CLCC-20 Leads at 24X Magnification

For Figure 82, on the left are leads 6 – 10 starting with lead 6 on the left and on the right are leads 11 – 15 starting with lead 11 on the left. Minor solder cracking is visible.

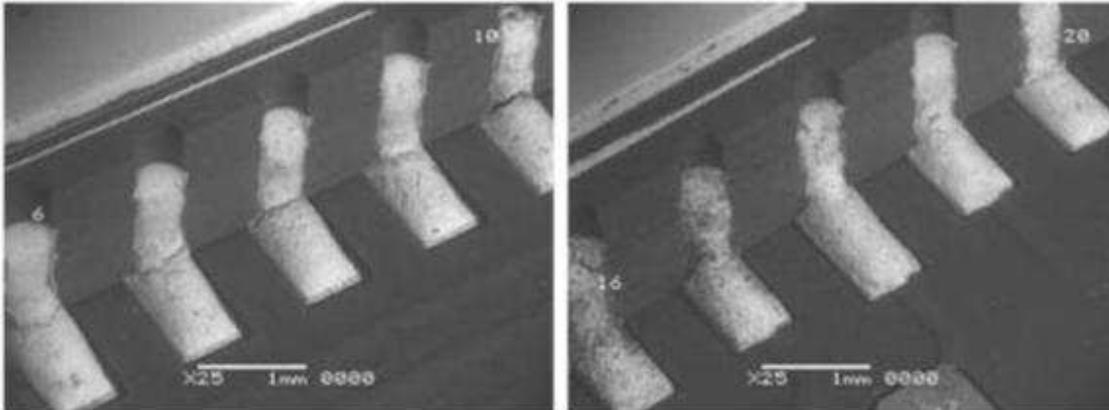
Figure 84 - TV142 U13 SEM Images of Component at 25X Magnification

In Figure 84 on the left are leads 6 – 10 which have some visible solder cracks and on the right are leads 16 – 20 and do not have solder cracks.

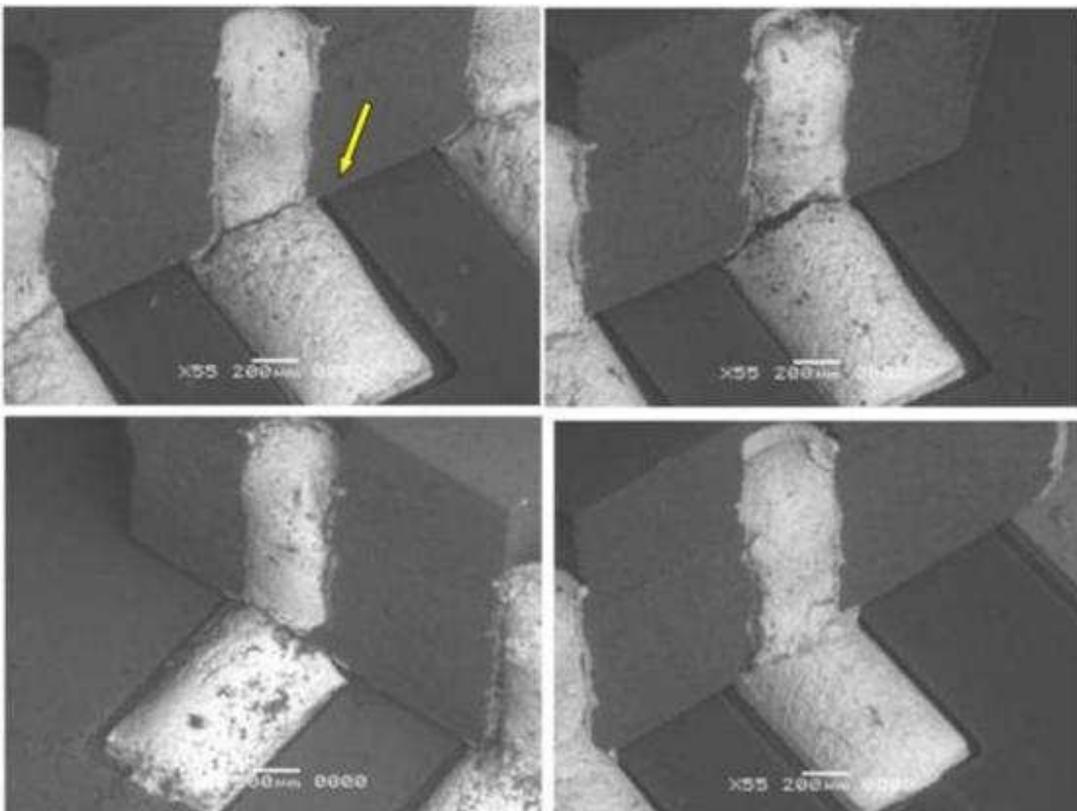
Figure 85 - TV142 U13 SEM Images of Selected Leads at 55X Magnification.

In Figure 85, the upper left image is lead 8 where the arrow indicates a solder crack. The upper right image is lead 10 where a solder crack is also visible. The lower left image is lead 11 and the lower right image is lead 20.

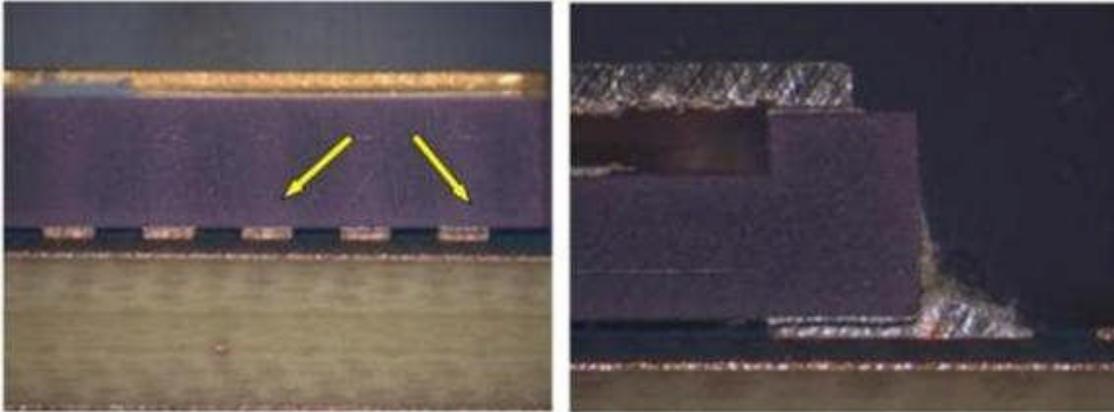
Figure 88 - TV142 U13; Cross-Sectional Micrograph

Figure 88, cross-sectional micrograph, on the left shows grinding level A of leads 1 – 5 where the arrows indicate separation of the solder joints from the copper pads at 24X magnification. Micrograph on the right is lead 6 at 38X magnification just prior to grinding to level B.

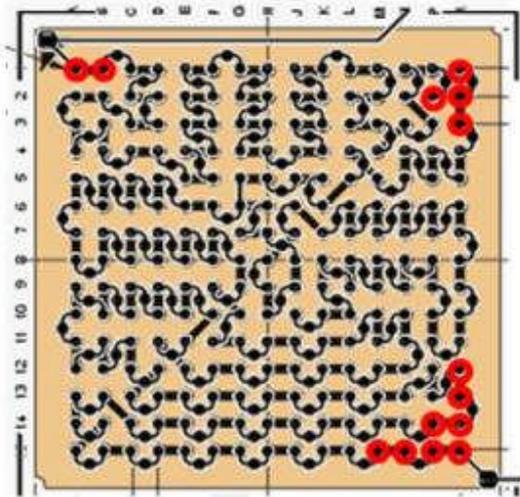
Figure 90 - TV158 U6; FA Results

Component location U6 is a reworked SnPb BGA-225 component soldered with SnPb solder paste, removed and replaced with a SAC405 BGA-225 component soldered with SnPb solder paste on an ENIG PWB. This component failed during the first cycle.

In Figure 90, the red circles indicate failed solder joints that are open.

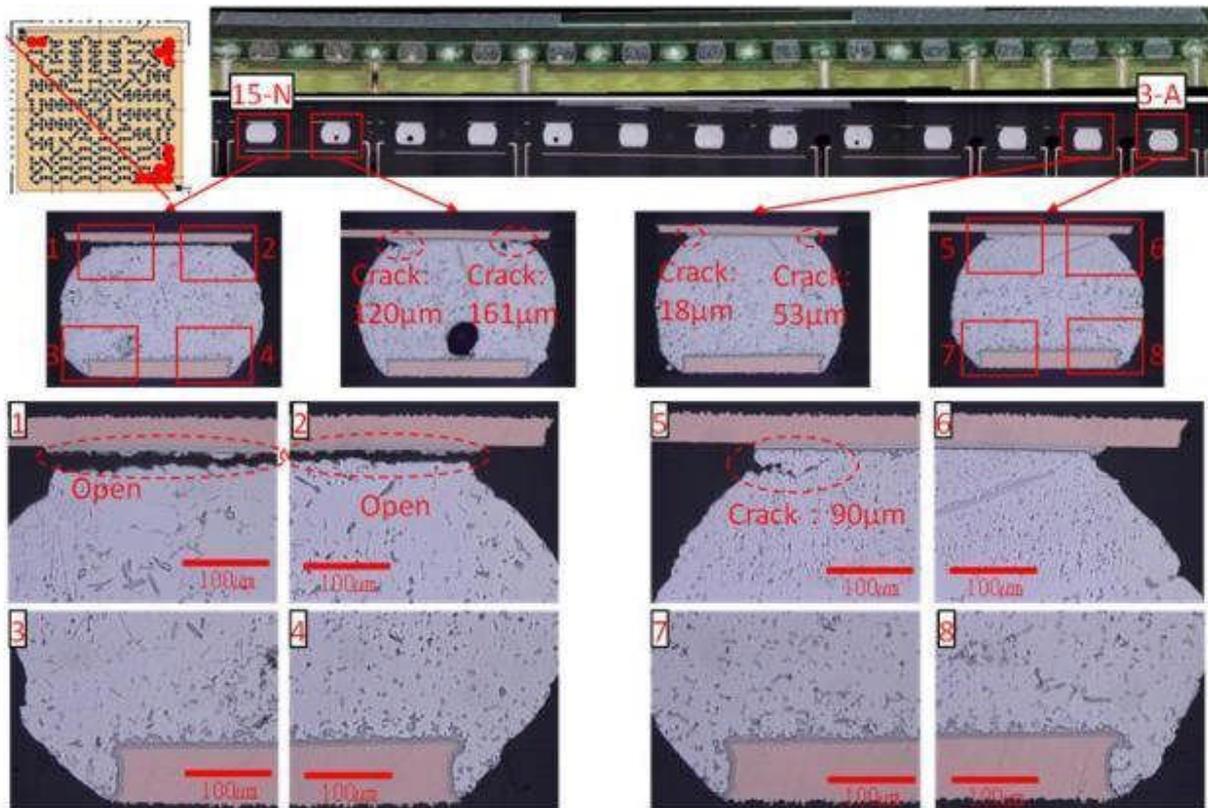
Figure 91 - TV158 U6; Cross-Sectional Micrographs

The cross-sectional micrographs in Figure 91 show different solder structure in lands on board (7, 8) and lands on component (5, 6). Cracking to open along component land observed at 15-N.

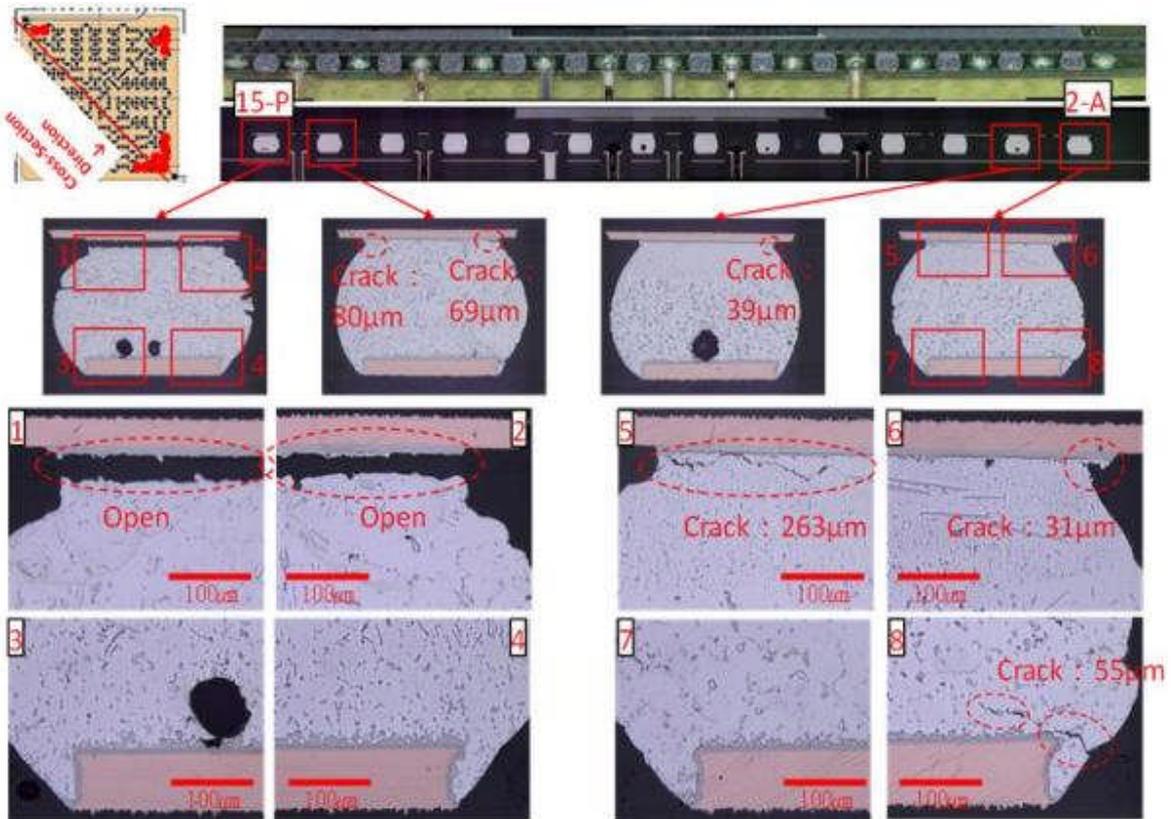
Figure 92 - TV158 U6; Cross-Sectional Micrographs

Figure 92 cross-sectional micrographs show different solder structure in lands on board (1, 2, 7, 8) and lands on component (3, 4, 5, 6). Cracking to open along PWB land found at 15-P.

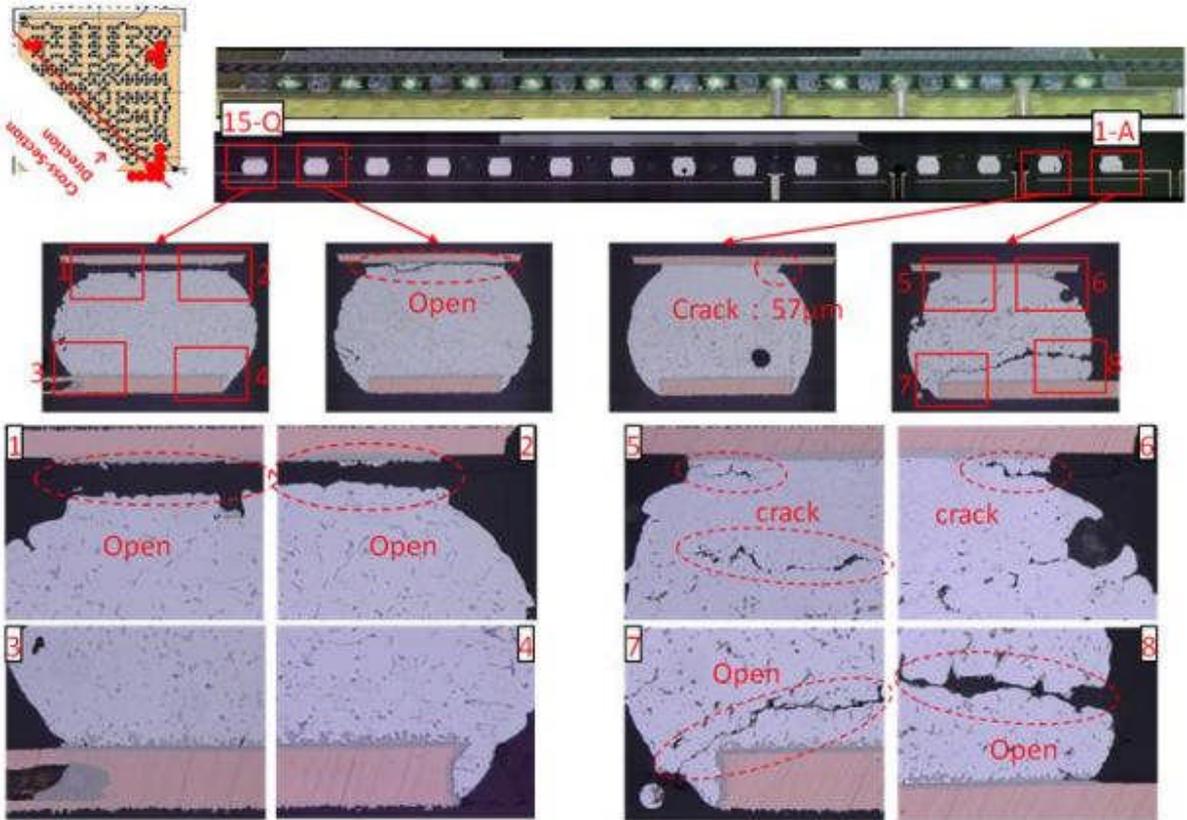
Figure 93 - TV158 U6; Cross-Sectional Micrographs

Cross-sectional micrographs in Figure 93 show different solder structure in lands on board (7, 8) and lands on component (5, 6). Cracking to open inside solder found at 1-A. Open joint along land on component found at 15-N.

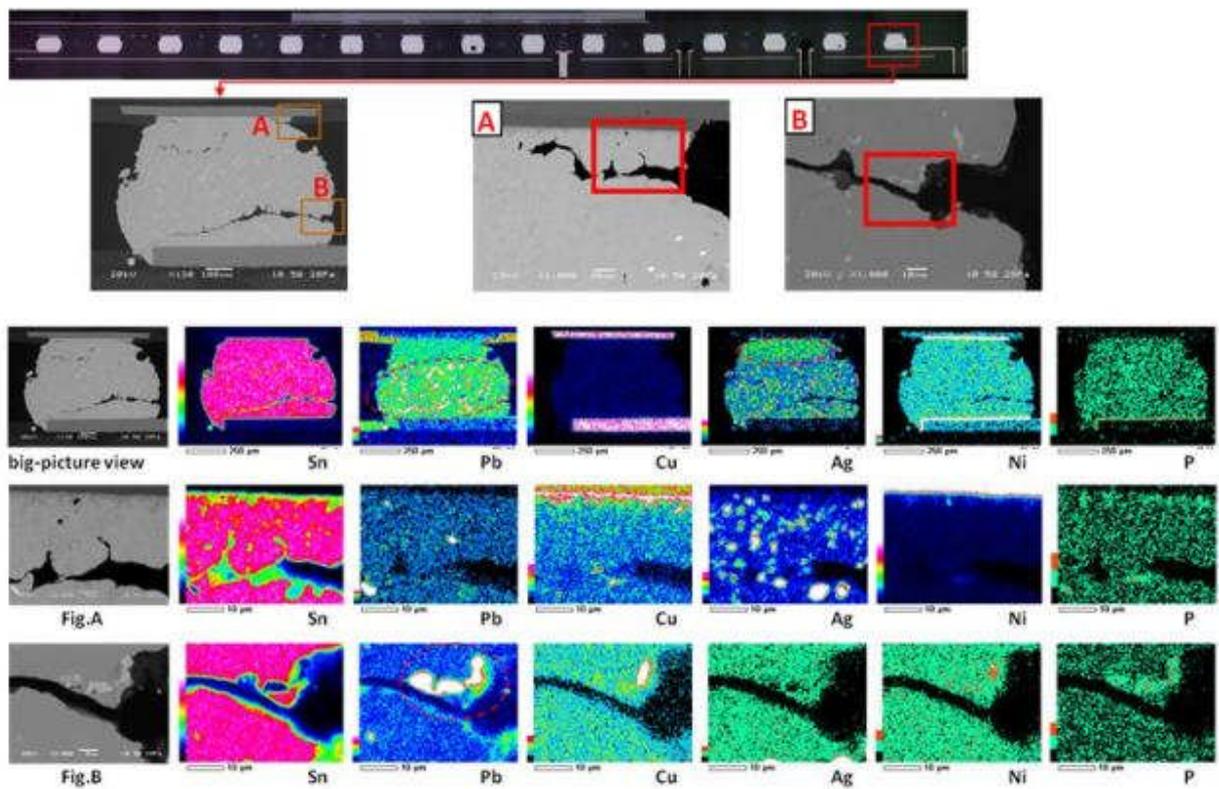
Figure 94 - TV158 U6; SEM Mapping

SEM mapping in Figure 94 shows segregation of Ag around land on component and segregation of Pb around PWB land. Higher concentrations of Pb detected in the cracking / breaking area.

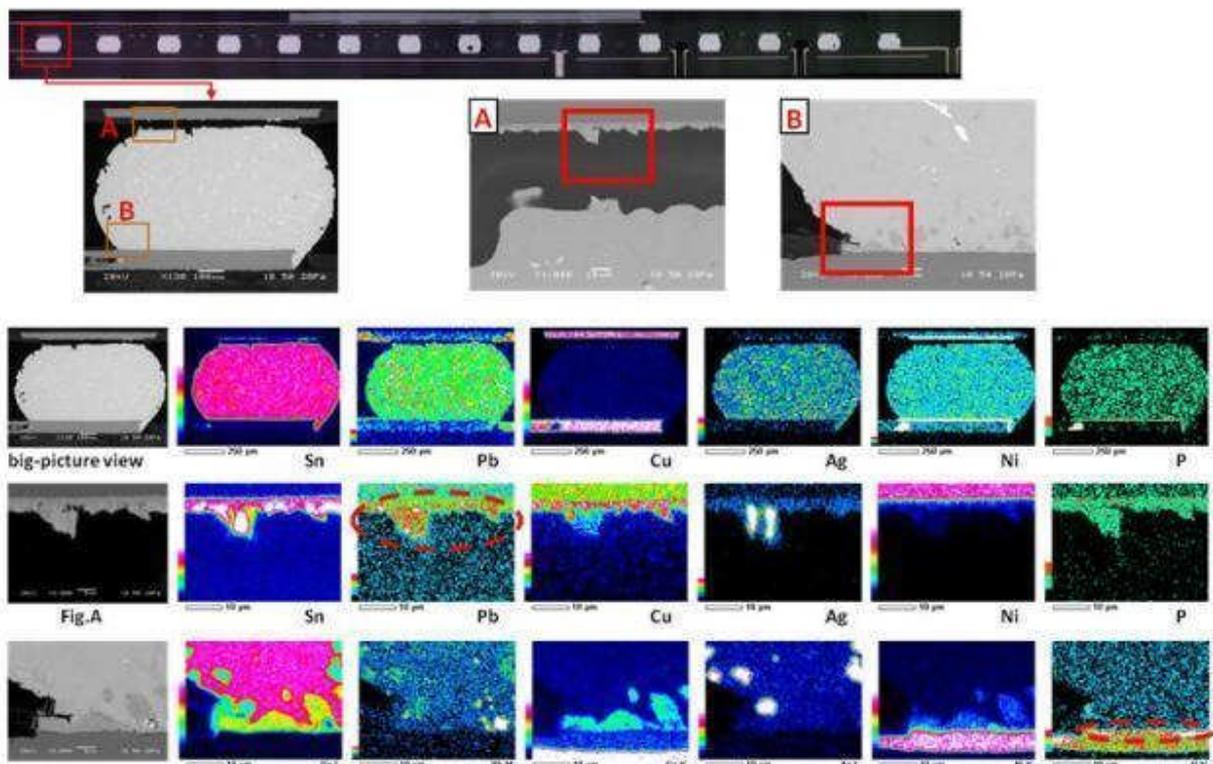
Figure 95 - TV158 U6; SEM Mapping

SEM mapping in Figure 95 shows solder is well blended over all except around component land where higher levels of Pb and cracking were found. Segregation of P from the ENIG board finish, however, no cracking detected.

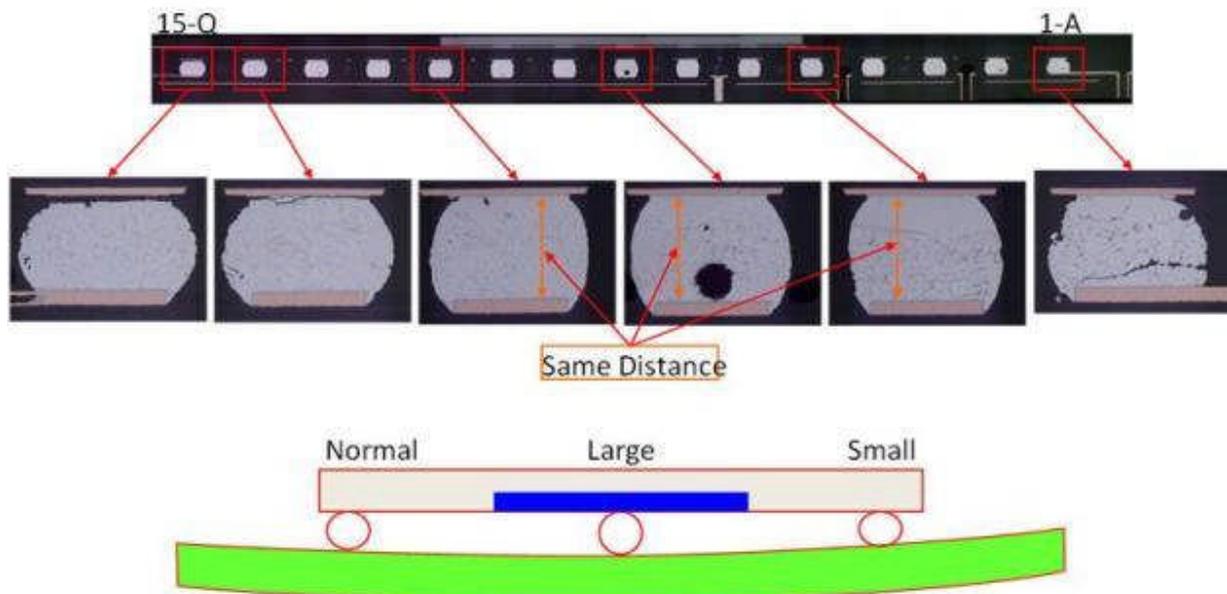
Figure 96 - TV158 U6; Cross-Sectional Micrographs Show Warping on BGA-225

In Figure 96 the distance between component and board at each sphere is almost the same under the chip in the center. The distance becomes smaller further to the end. Comparing the distance at [1-A] and [15-Q], [1-A] has smaller distance.

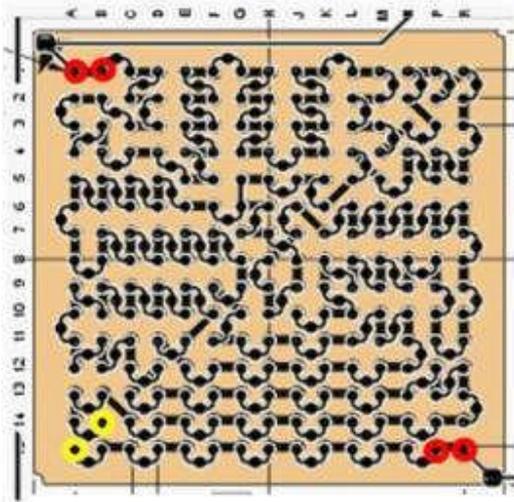
Figure 97 - TV180 U21; FA Results

Component location U21 is a reworked BGA-225 soldered with SAC305 on SAC405 component finish and replaced with SAC405 BGA-225 soldered with flux only. This component failed on cycle one and was reworked prior to combine environments testing.

In Figure 97 the yellow circles are solder joints with high resistance and red circles are failed solder joints that are open.

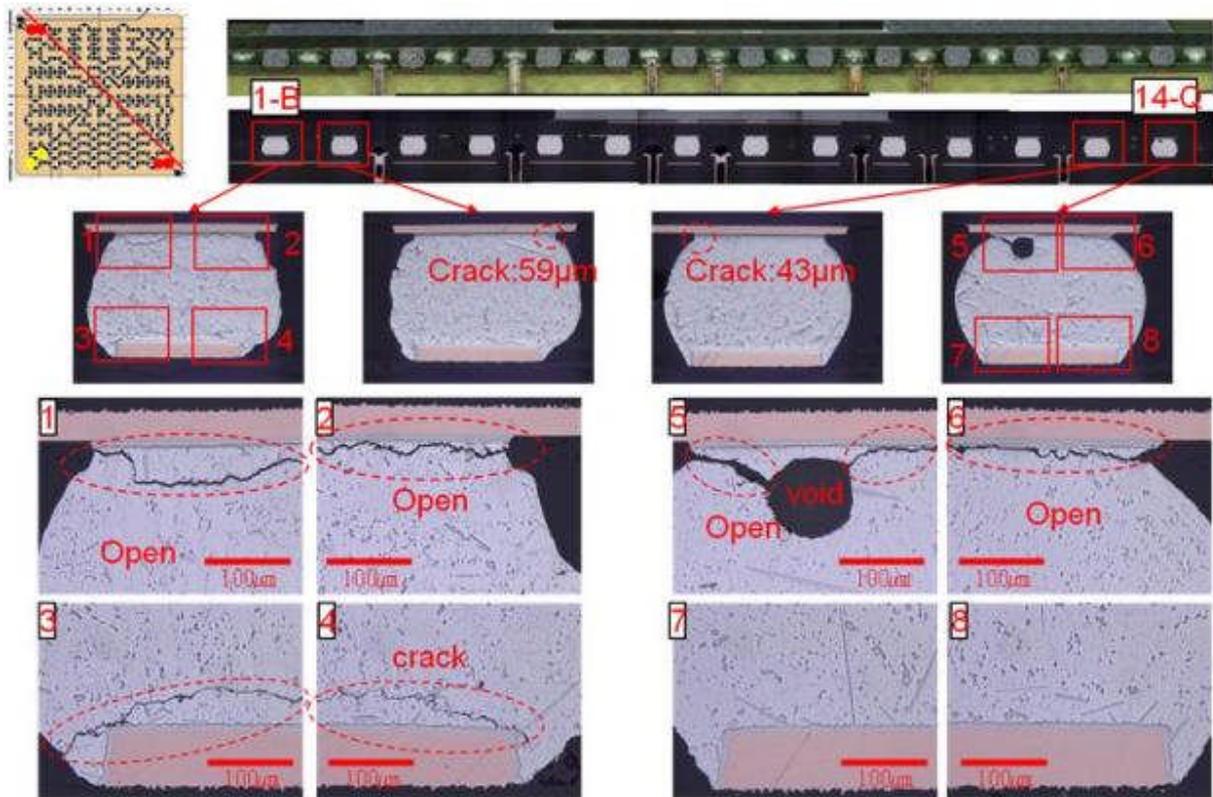
Figure 98 - TV180 U21; Cross-Sectional Micrographs

In Figure 98 the cross-sectional micrographs show cracking to opens on board side (1, 2, 5, 6).

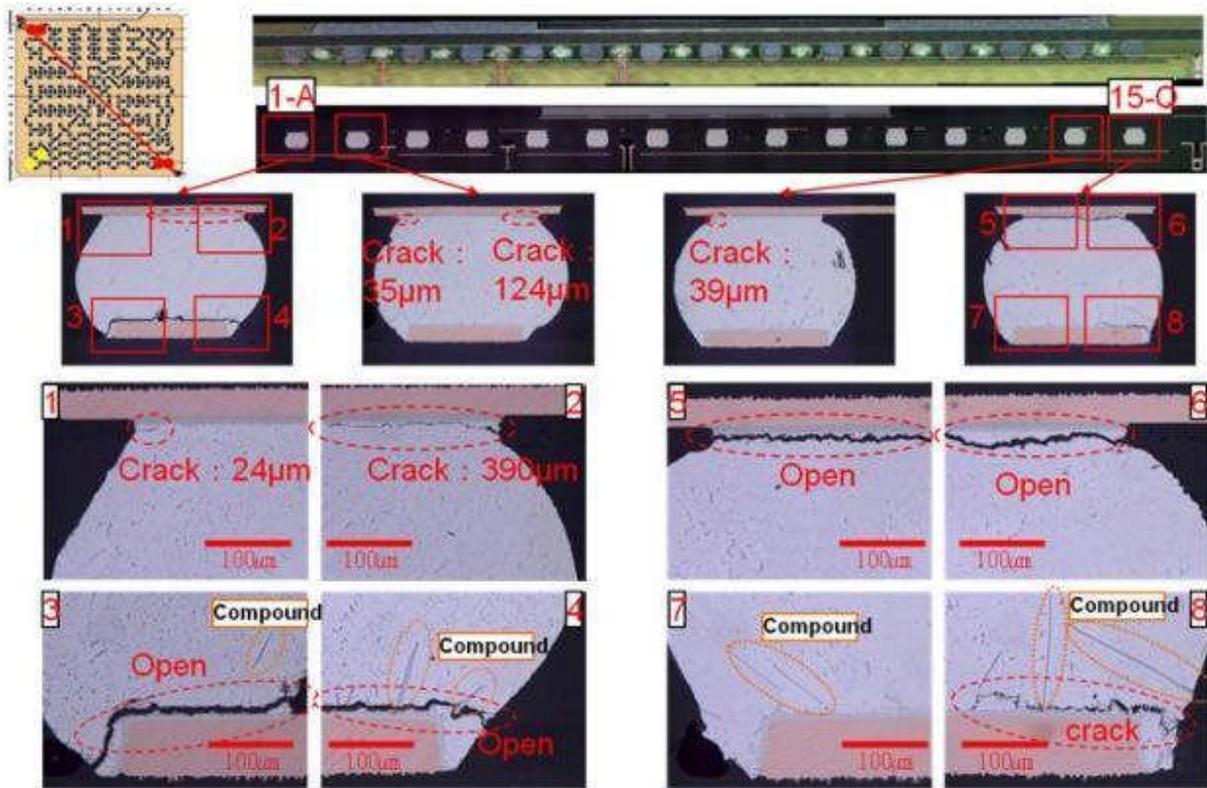
Figure 99 - TV180 U21; Cross-Sectional Micrographs

In Figure 99 the cross-sectional micrographs show cracking to open solder joints around both land on board and component (3, 4, 5, 6). Large intermetallic compounds observed around land on board (3, 4, 7, 8).

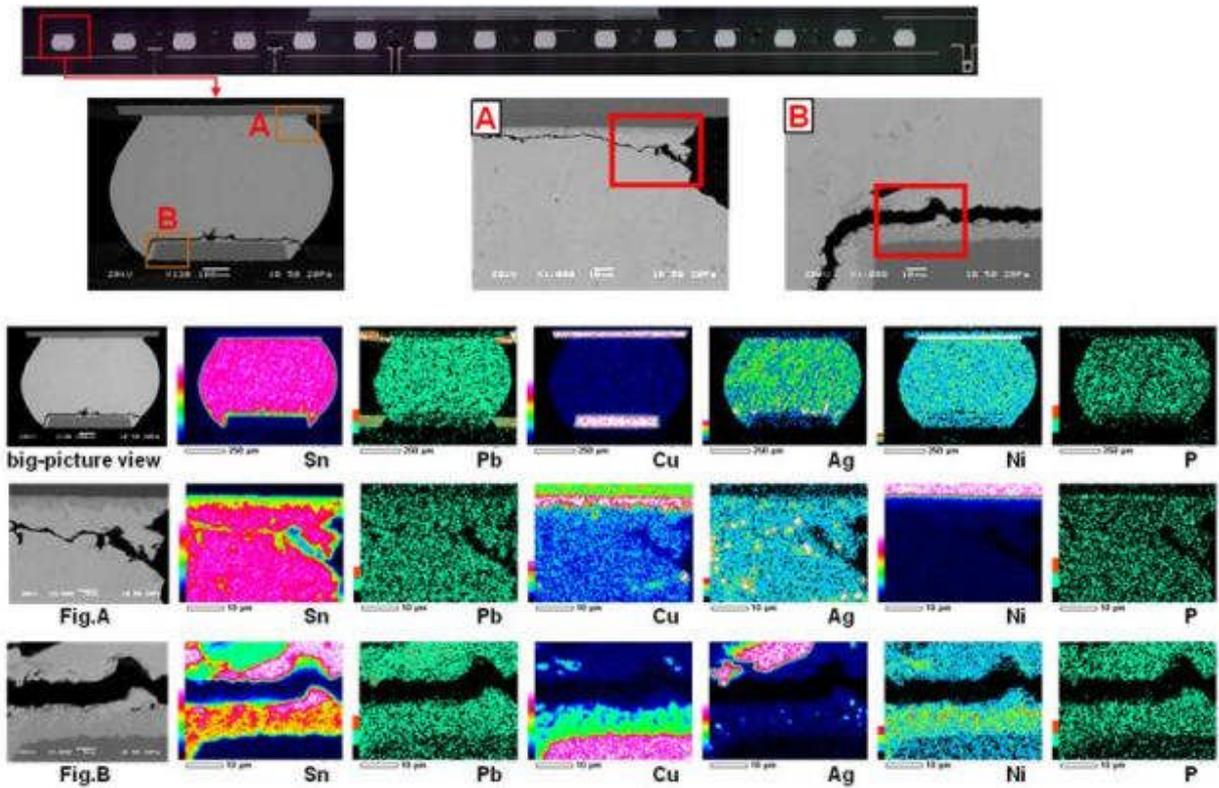
Figure 100 - TV180 U21; SEM Mapping

SEM mapping in Figure 100 shows cracks inside solder as well as cracking to open between IMC and solder, or inside solder.

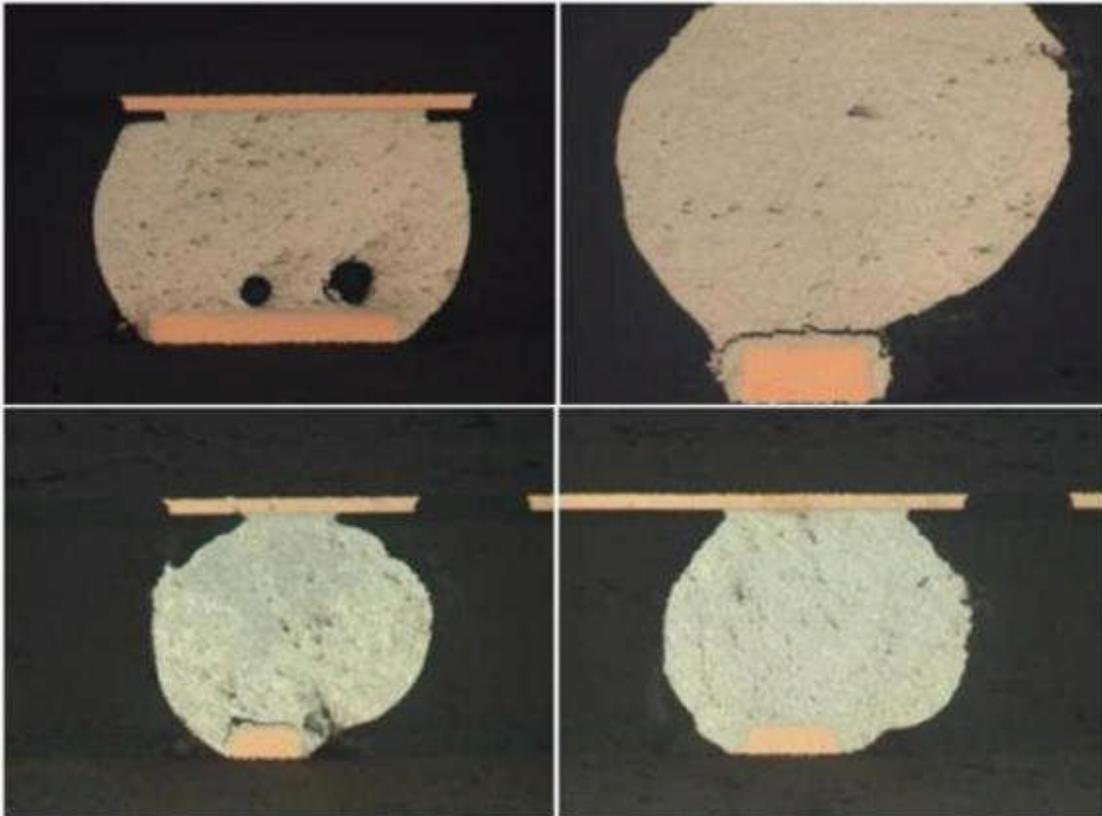
Figure 104 - TV181 U56; Cross-Sectional Micrographs of Solder Balls

In Figure 104 the image on the top left is solder ball A1 at 136X magnification. The image on the top right is solder ball A7 at 274X magnification. On the bottom left, is solder ball A9 and on the bottom right is solder ball A11, both at 136X magnification.

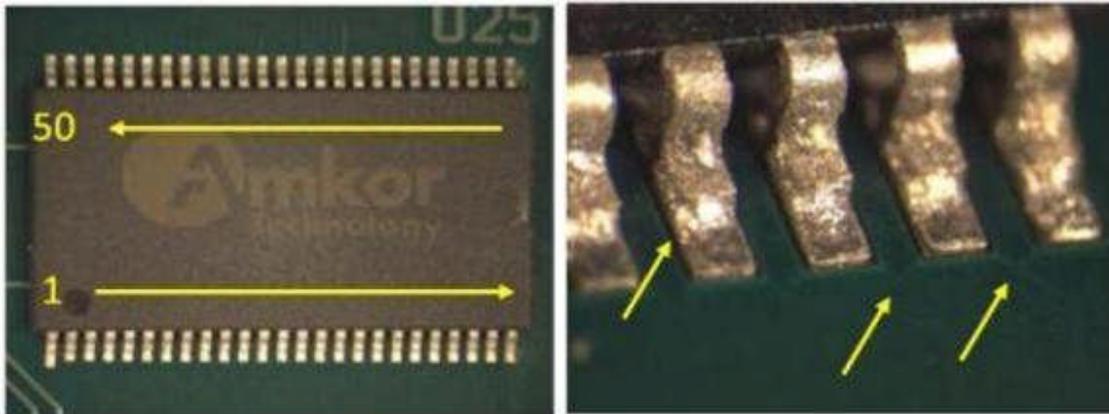
Figure 106 - TV181 U25; Optical Micrographs

Component location U25 is a TSOP-50 from the Pb-free rework (Batch A), soldered with SAC305 on tin component finish. This component failed on cycle one and was reworked prior to combine environments testing.

In Figure 106 the optical micrograph on the left is the lead numbering and the image on the right is of leads 21-25. The arrows indicate cracked solder mask and the arrow on lead 22 indicates a solder disturbance at 49X magnification.

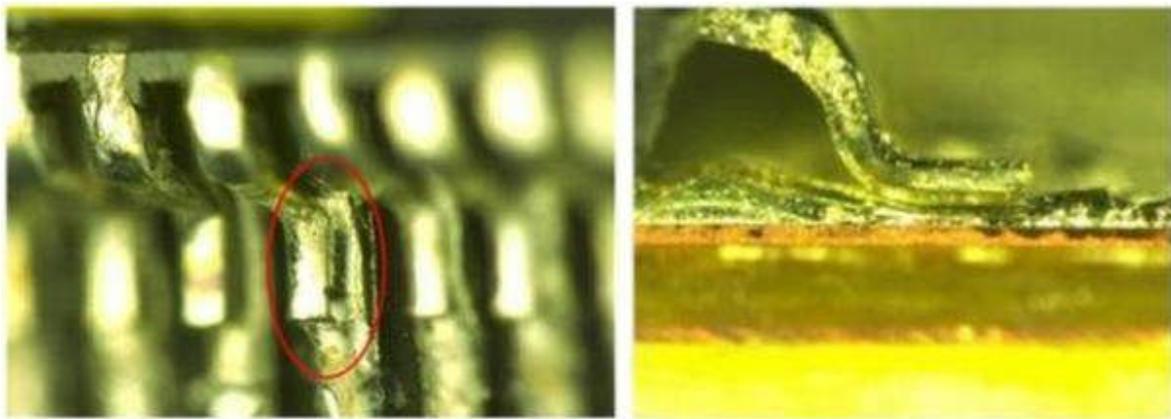
Figure 112 - TV183 U 41; Optical Micrographs of Suspect Lead

Component location U41 is a TQFP-144 from Pb-free rework (Batch A), soldered with SAC 305 on SAC305 dip component finish. This component failed on cycle one and was not reworked.

Figure 112 shows inadequate solder joint resulting in no connection between the lead and the pad.

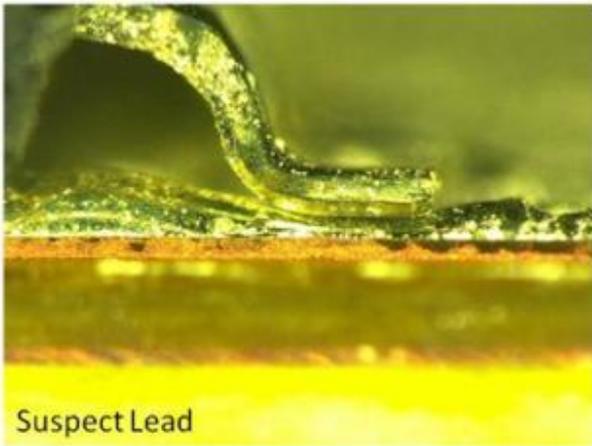
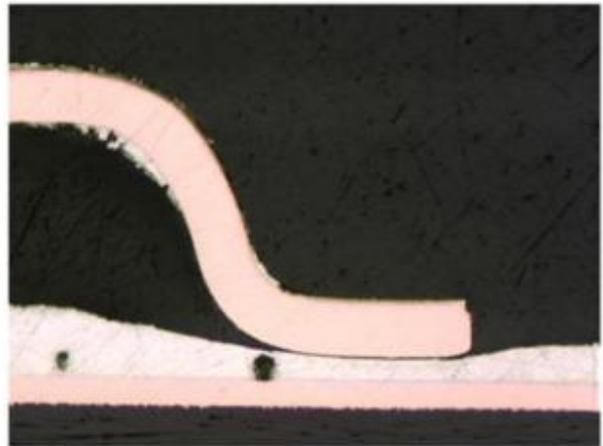
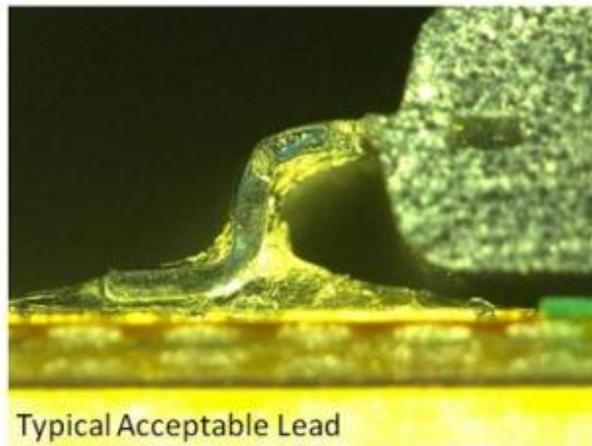
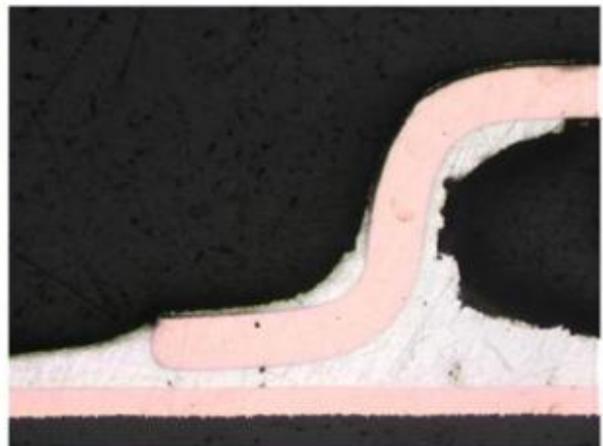
Figure 113 - TV183 U 41; Cross-Sectional Micrographs

Figure 113 shows cross-sectional micrographs of component leads comparing suspect lead to a typical acceptable lead.

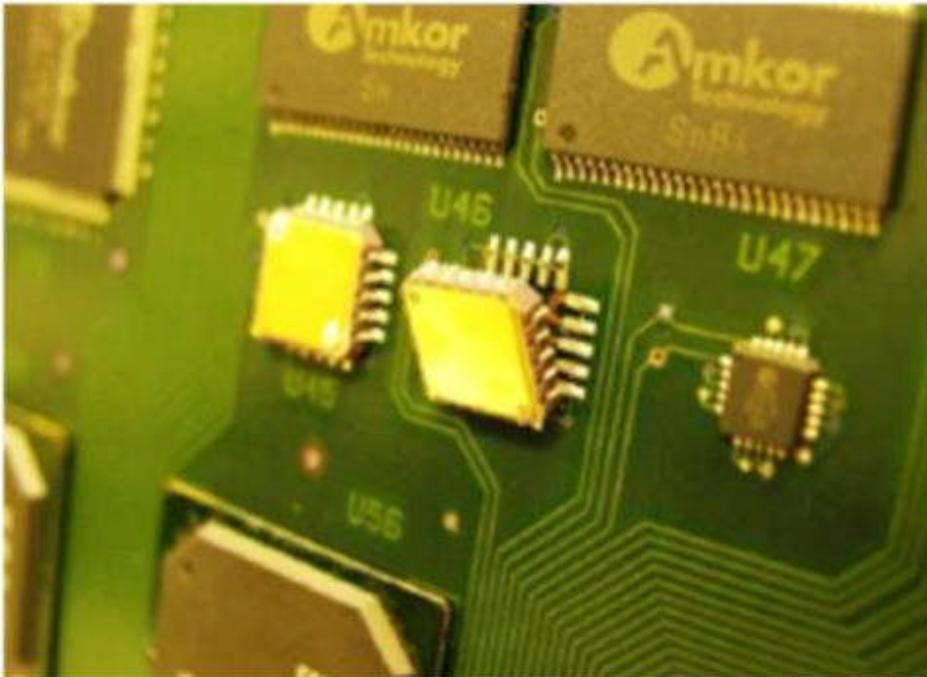
- The cracks in the solder joints initiated under the components and traversed at a 45° angle thru the solder fillets. The crack formation and location are in agreement with industry published data of CLCC failure modes (2), (3).
- The solder joint geometries and wetting angles were acceptable and met industry workmanship criteria
- The solder joint microstructures were reasonably homogenous with no segregation regions observed in the mixed metallurgy cases

Figure 117 - CLCC-20 Component on Test Vehicle after 4068 Thermal Cycles

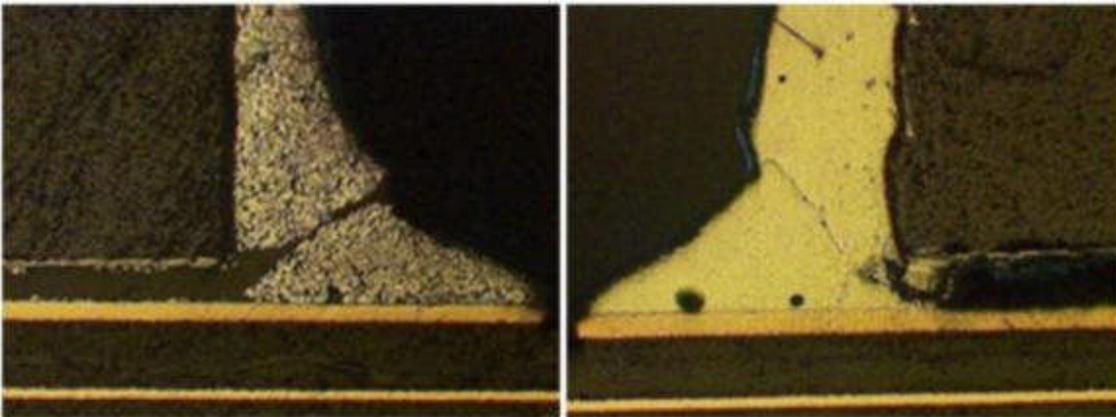
Figure 118 - CLCC-20 Solder Joints; Left - Board 5, Component U14, SnPb/SnPb, Failed @ 2625 Cycles; Right - Board 43, Component U14, SAC305/SAC305, Failed @ 513 Cycles
