**Technology Evaluation for Environmental Risk
Mitigation Principal Center**

NASA-DoD Lead-Free Electronics Project

Joint Test Report - Final

December 2011

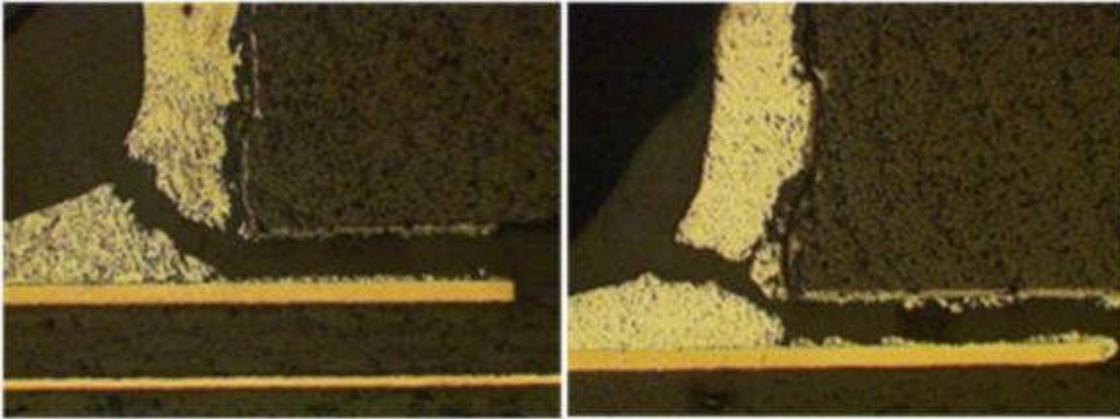
Figure 119 - CLCC-20 Solder Joints; Left - Board 164, Component U14, SAC305/SnPb, Failed @ 1248 Cycles; Right - Board 126, Component U14, SnPb/SAC305, Failed @ 2064 Cycles

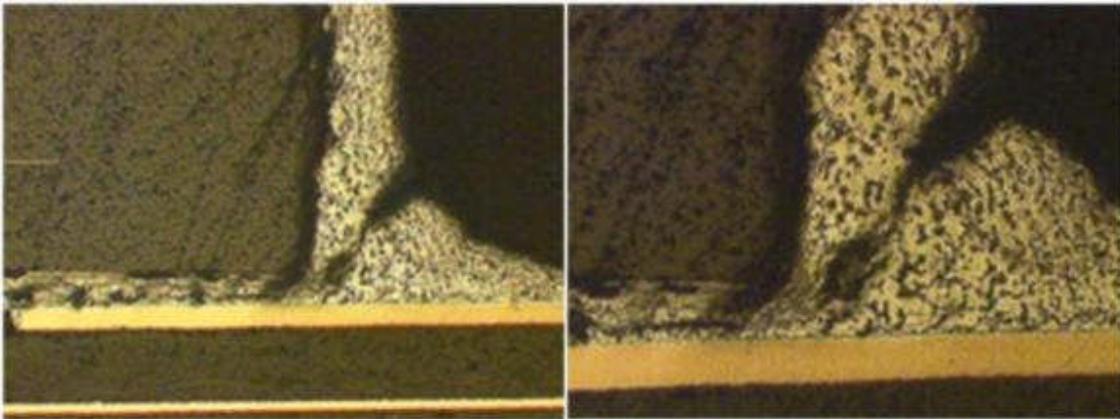
Figure 120 - CLCC-20 Solder Joints, Board 103, Component U22, SN100C/SnPb, Failed @ 828 Cycles

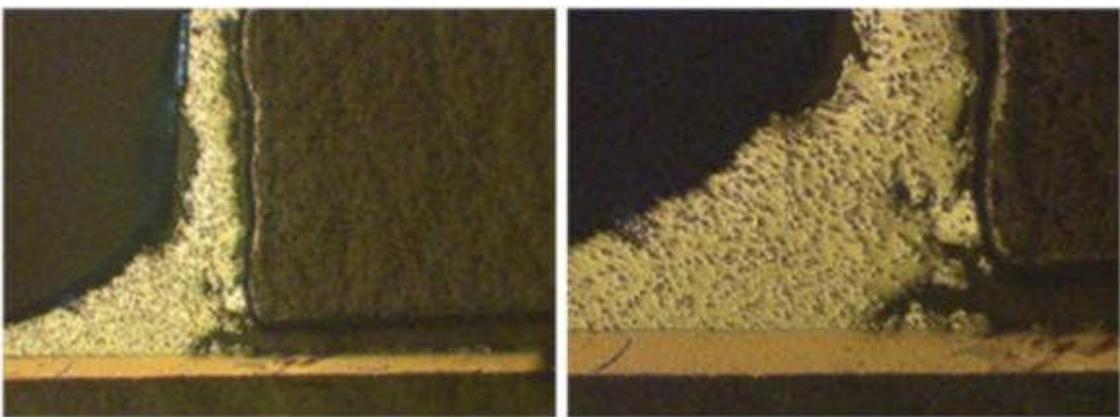
Figure 121 - CLCC-20 Solder Joints, Board 104, Component U14, SN100C/SAC305, Failed @ 304 Cycles

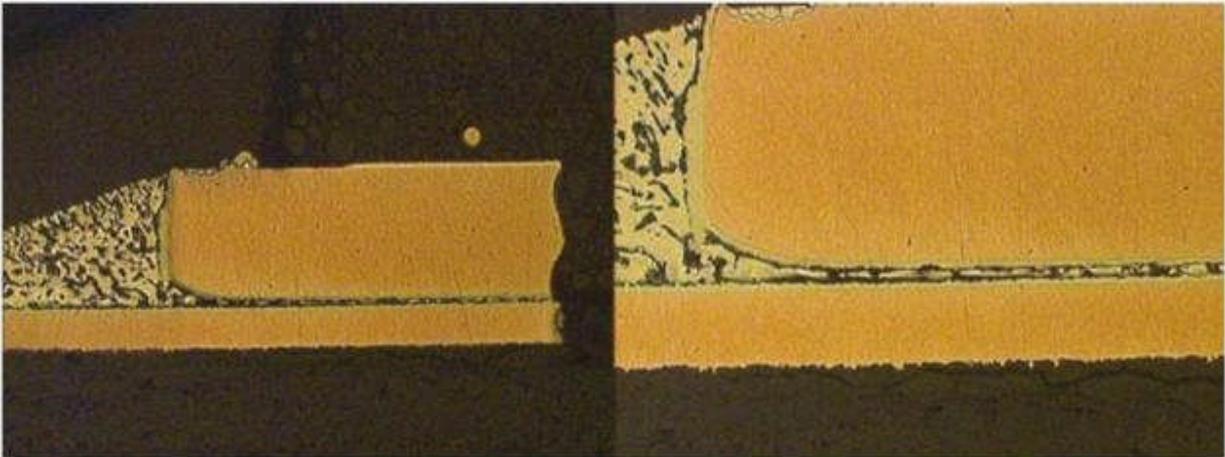
- The cracks in the solder joints initiated in the bottom terminated pads and traversed towards the lead toe. The crack formation and location are in agreement with industry published data of QFN failure modes (4), (5).
- The solder joint geometries and wetting angles were acceptable and met industry workmanship criteria. The ground pad on the QFN-20 components achieved 50% minimum solder coverage and no cracking was observed in that solder joint.
- The solder joint microstructures were homogenous with no segregation regions observed. The solder paste alloy completely dominated the solder joint microstructure regardless of the component surface finish.
- The Stencil Quik reworked solder joints were significantly thicker than the traditionally reworked solder joints (Figure 130 and Figure 131).

Figure 128 - QFN-20 Solder Joints, Board 107, Component U28, SN100C/Sn, Reworked with SnPb Paste, 1 Rework Failed @ 277 Cycles

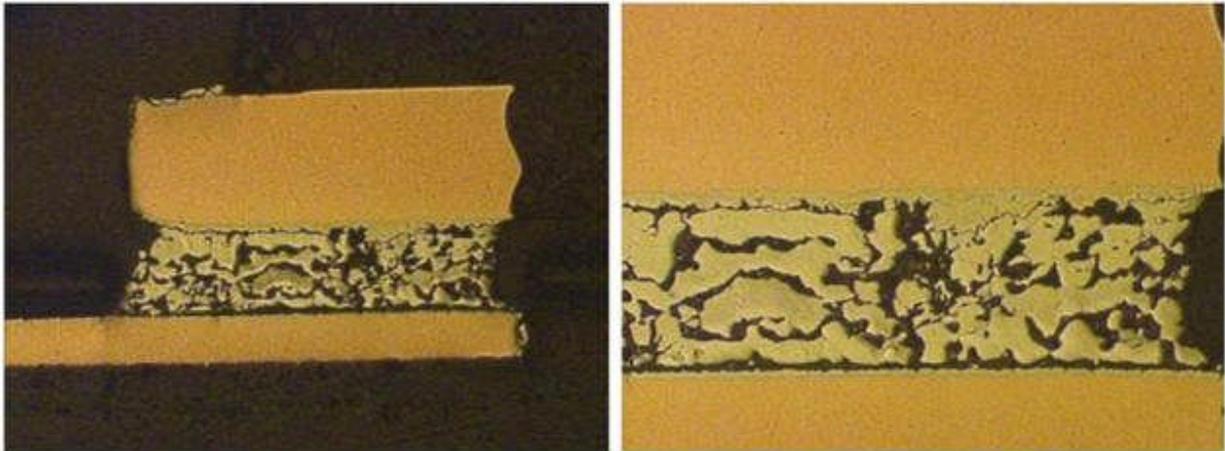
Figure 130 - QFN-20 Solder Joints, Board 109, Component U28, SN100C/Sn, Reworked with Stencil Quik, 1 Rework, DNF

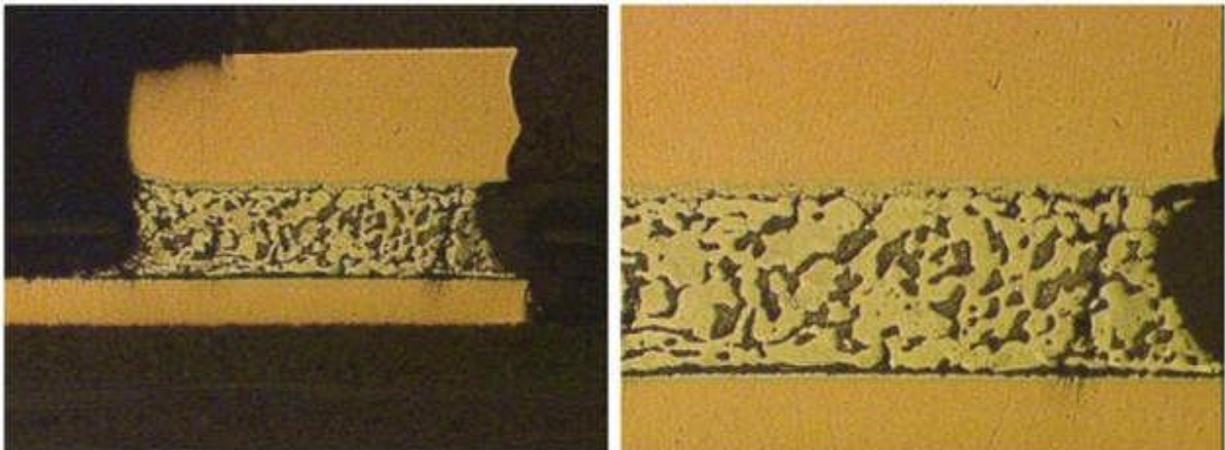
Figure 131 - QFN-20 Solder Joints, Board 47, Component U15, SAC305/Sn, Reworked with Stencil Quik, 1 Rework, Failed @ 3660 Cycles

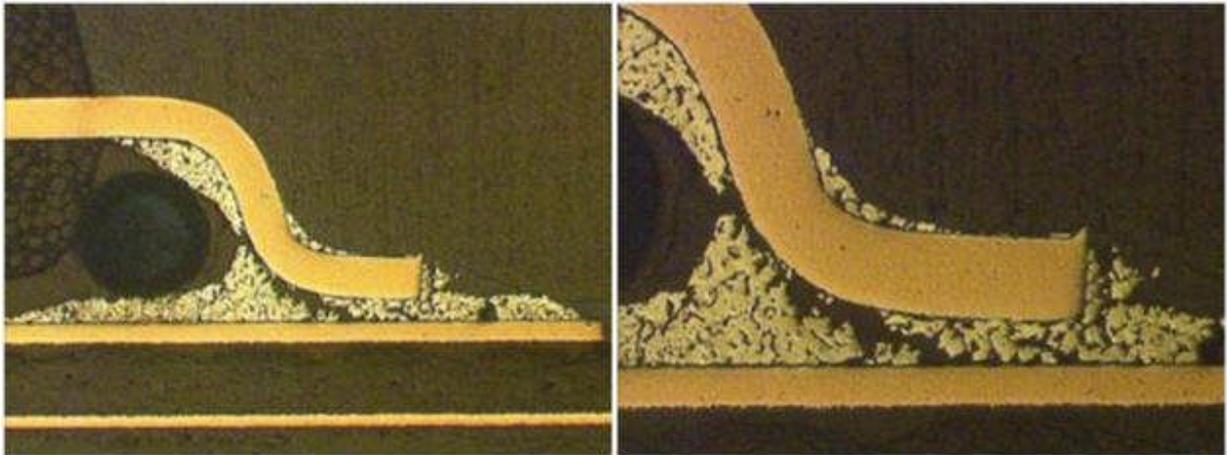
- The cracks in the solder joints initiated in the heel fillet region and traversed under the foot towards the lead toe. The crack formation and location are in agreement with industry knowledge of QFP failure modes (1).
- The solder joint geometries and wetting angles were acceptable and met industry workmanship criteria. There were a number of instances where the solder did flow into the upper lead bend region which is acceptable per industry standards.
- The solder joint microstructures were reasonably homogenous with no segregation regions observed in the mixed metallurgy cases.

Figure 135 - TQFP-144 Solder Joints, Board 9, Component U48, SnPb/SnPb Dipped, Failed @ 2648 Cycles

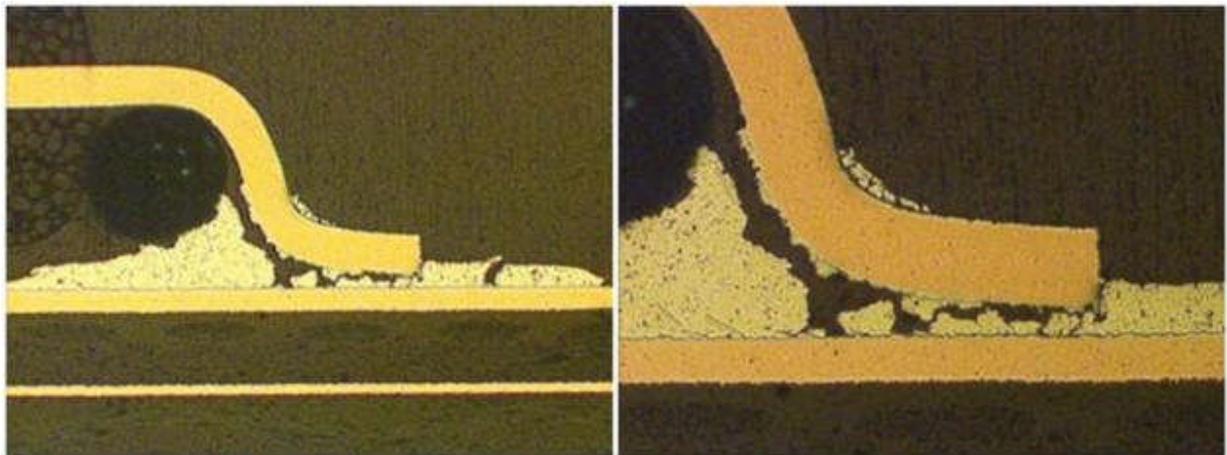
Figure 136 - TQFP-144 Solder Joints, Board 41, Component U20, SAC305/SnPb Dipped, Failed @ 3541 Cycles

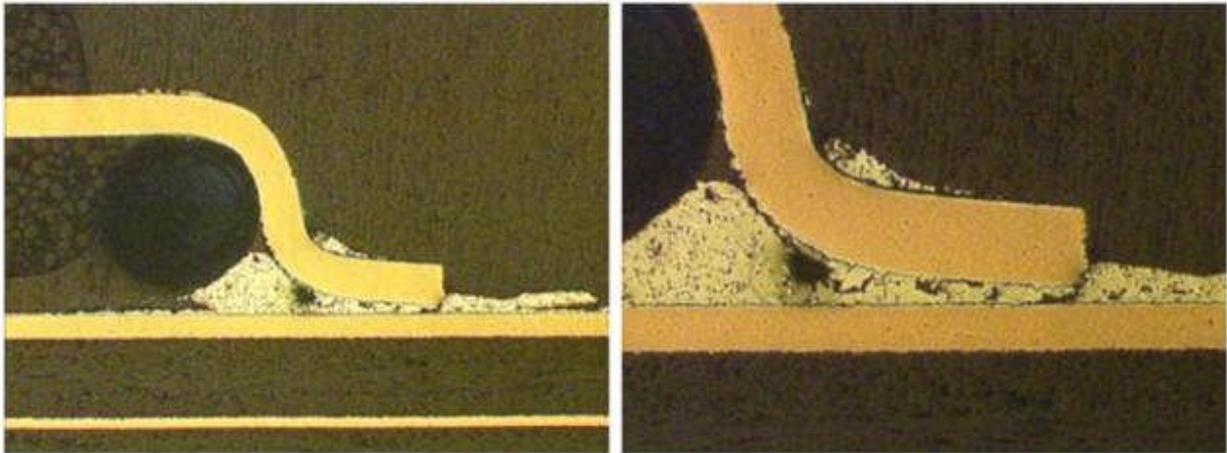
Figure 137 - TQFP-144 Solder Joints, Board 106, Component U20, SN100C/SnPb Dipped, Failed @ 3258 Cycles

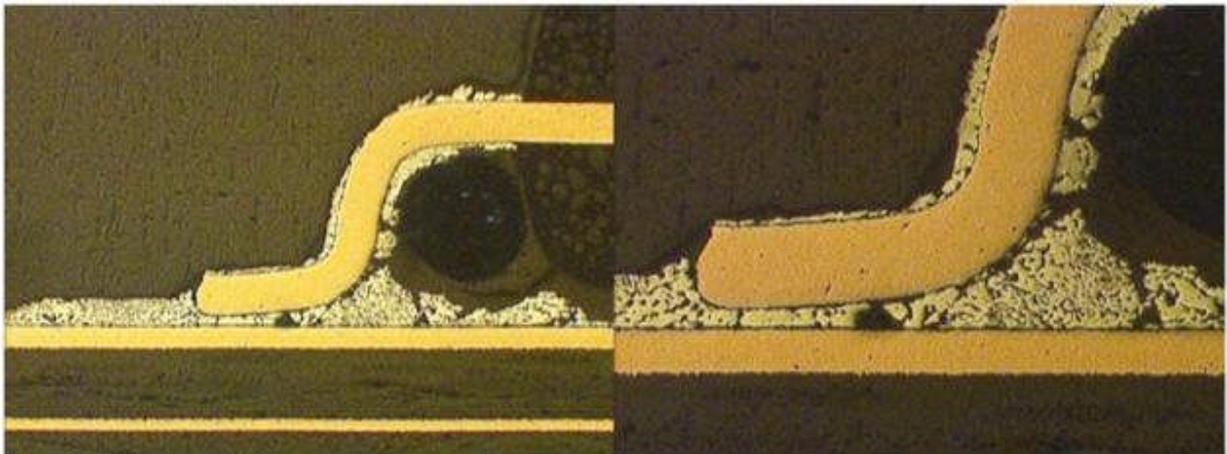
Figure 138 - TQFP-144 Solder Joints, Board 9, Component U1, SnPb/Sn, Failed @ 1 Cycle

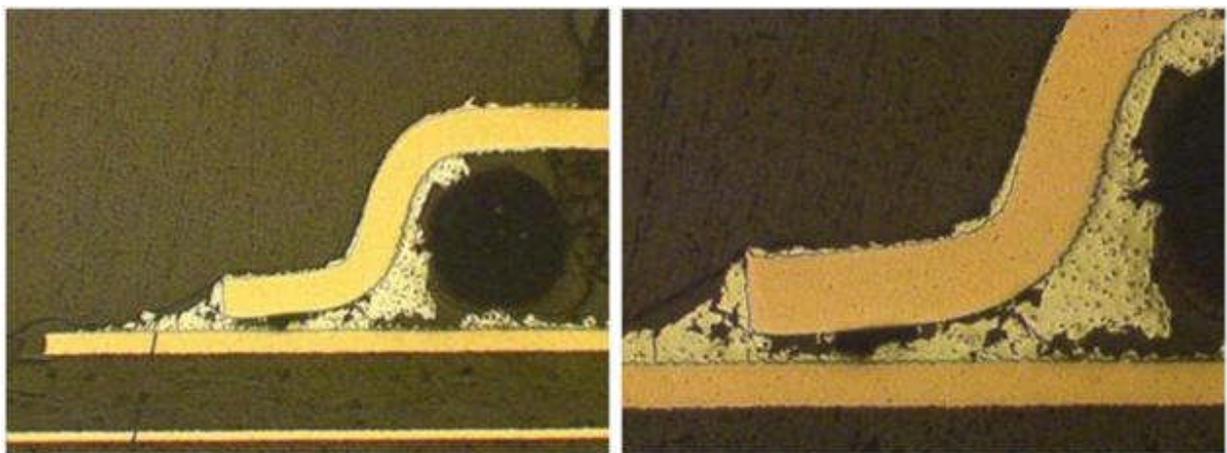
Figure 139 - TQFP-144 Solder Joints, Board 49, Component U57, SAC305/Sn, Failed @ 1430 Cycles

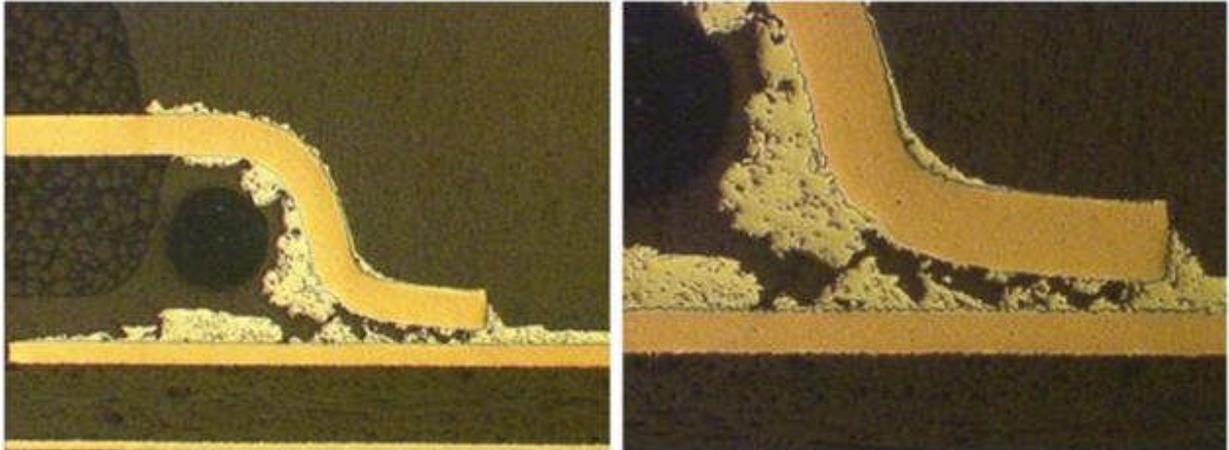
Figure 140 - TQFP-144 Solder Joints, Board 103, Component U48, SN100C/Sn, Failed @ 1712 Cycles

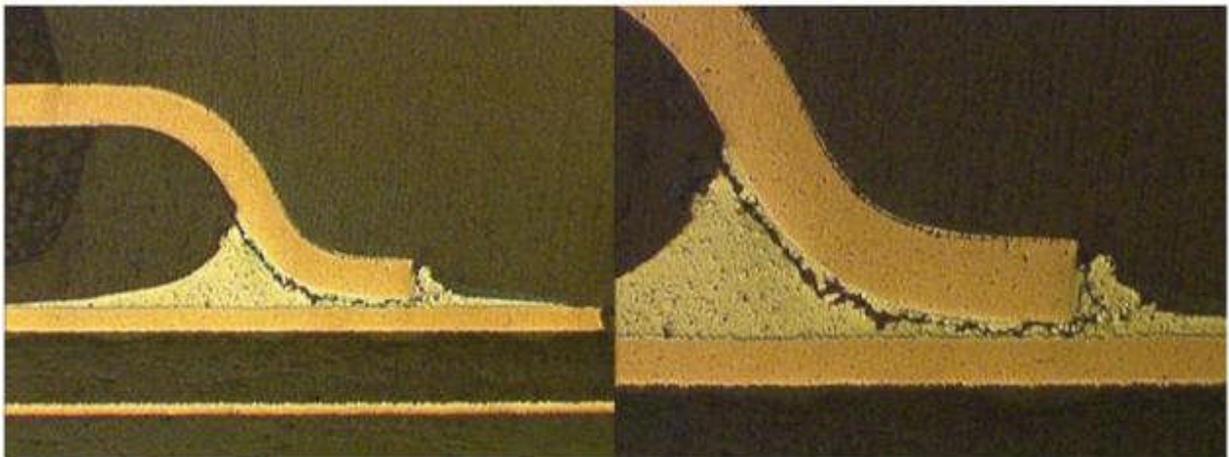
Figure 141 - TQFP-144 Solder Joints, Board 167, Component U57, SAC305/NiPdAu, Failed @ 3478 Cycles

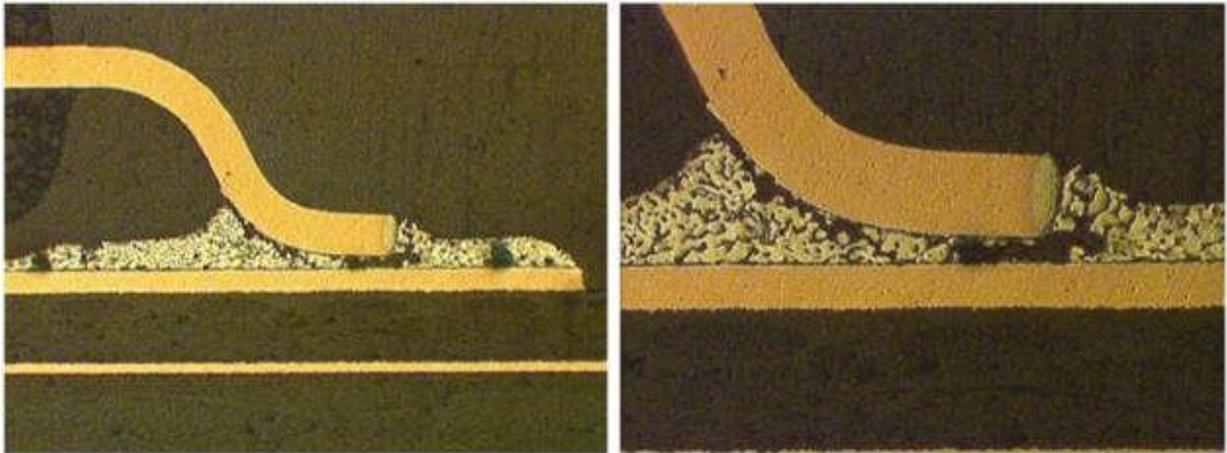
Figure 142 - TQFP-144 Solder Joints, Board 127, Component U3, SnPb/NiPdAu, Failed @ 1744 Cycles

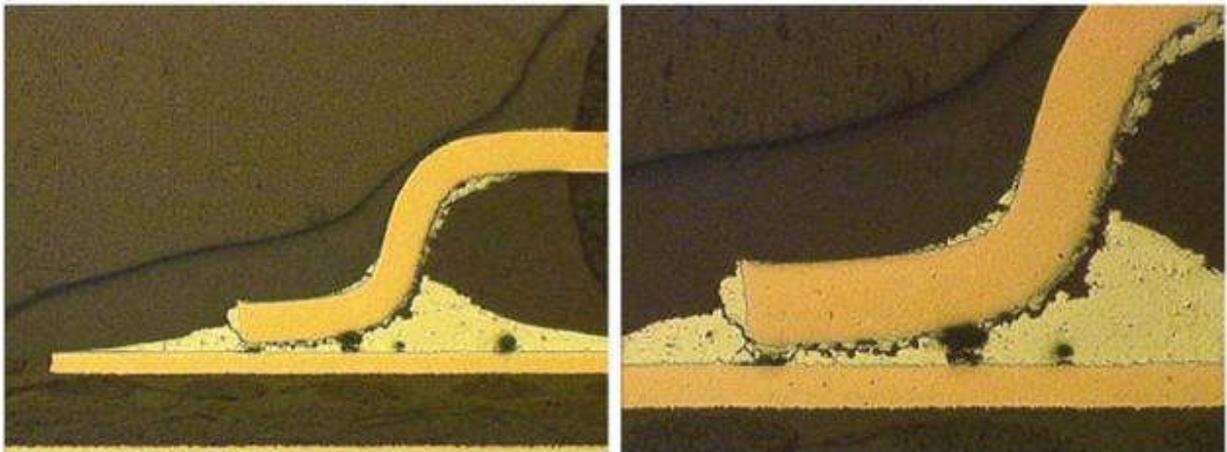
Figure 143 - TQFP-144 Solder Joints, Board 164, Component U7, SAC305/SAC305, Failed @ 2359 Cycles

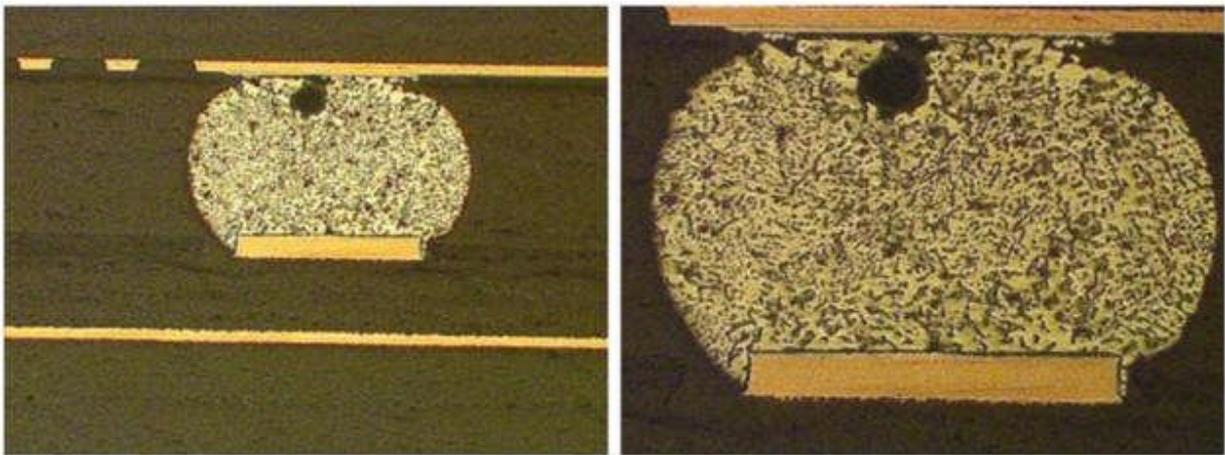
- The cracks in the solder joints initiated at the solder joint/component pad interface. The crack formation and location are in agreement with industry knowledge of PBGA failure modes(6), (7).

- The manufactured test vehicle solder joint microstructures were homogenous with no segregation regions and the solder ball alloy (i.e. SnPb or SAC405) dominated the microstructure as it provided the largest material contribution to the solder joint formation. Some instances of large intermetallic compound (IMC) phases were observed but they typically have minimal interaction with the crack failure path.

Figure 148 - PBGA-225 Solder Joints, Board 8, Component U5, SnPb/SnPb, Failed @ 2431 Cycles

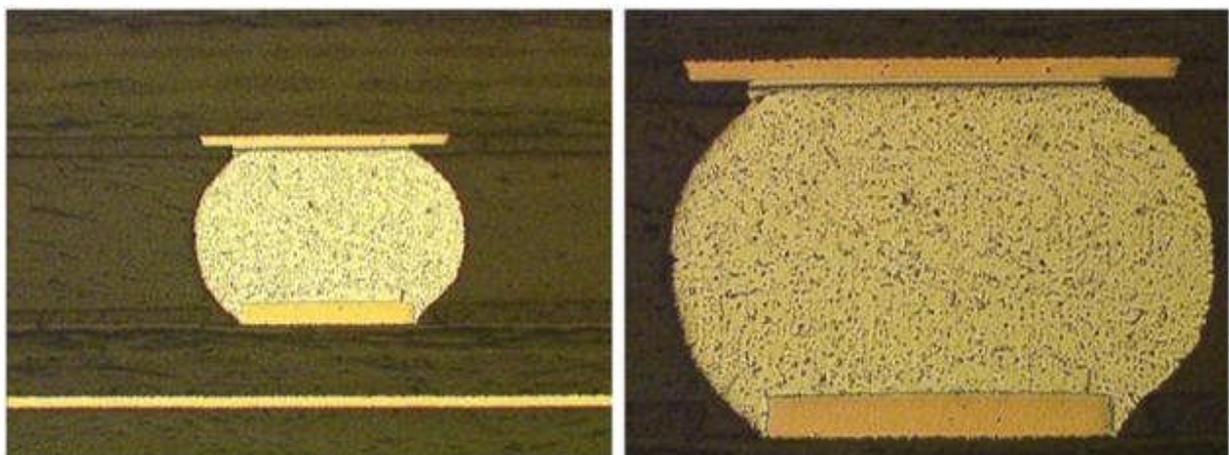
Figure 149 - PBGA-225 Solder Joints, Board 127, Component U5, SnPb/SAC405, DNF

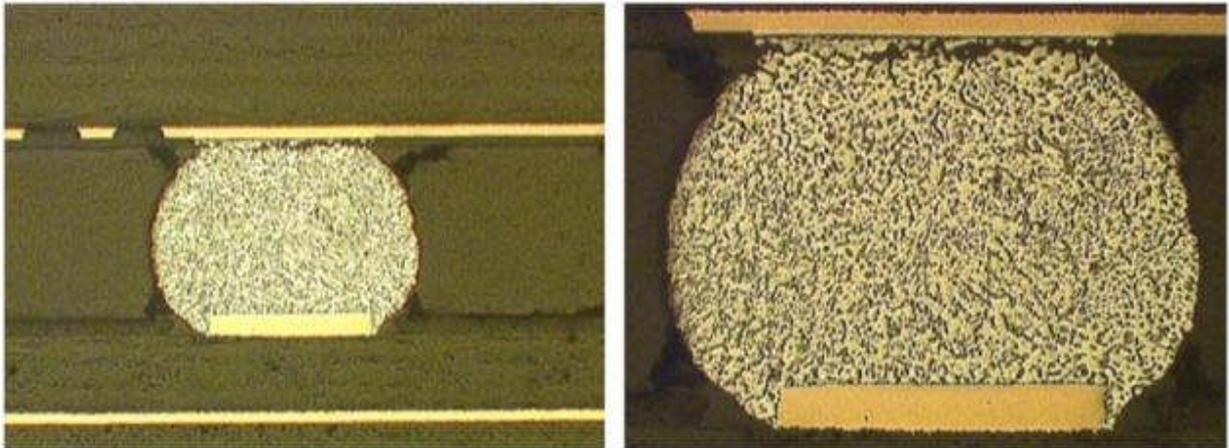
Figure 150 - PBGA-225 Solder Joints, Board 168, Component U5, SAC305/SnPb, Failed @ 1926 Cycles

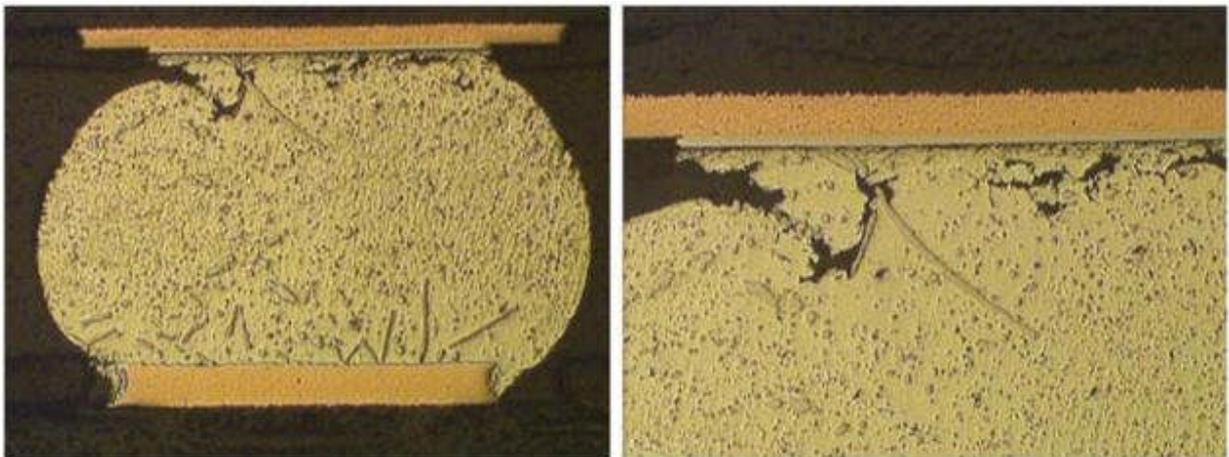
Figure 151 - PBGA-225 Solder Joints, Board 49, Component U6, SAC305/SAC405, Failed @ 2763 Cycles

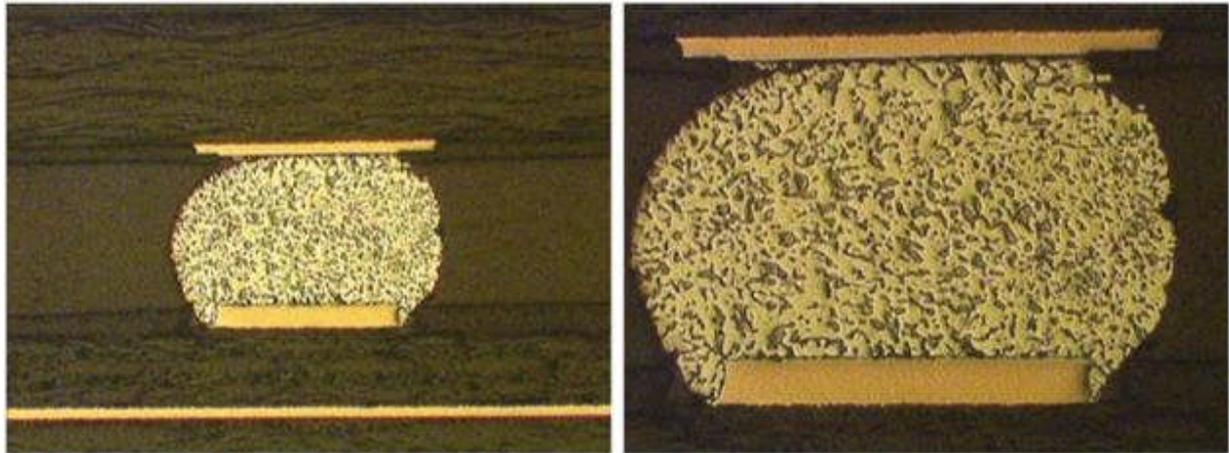
Figure 152 - PBGA-225 Solder Joints, Board 106, Component U55, SN100C/SnPb, Failed @ 1064 Cycles

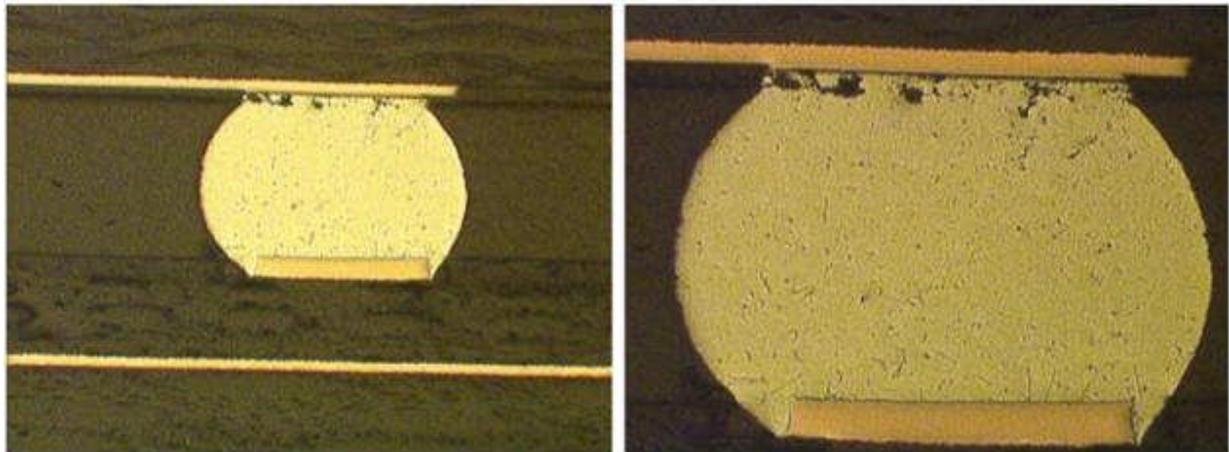
Figure 153 - PBGA-225 Solder Joints, Board 104, Component U21, SN100C/SAC405, Failed @ 3812 Cycles

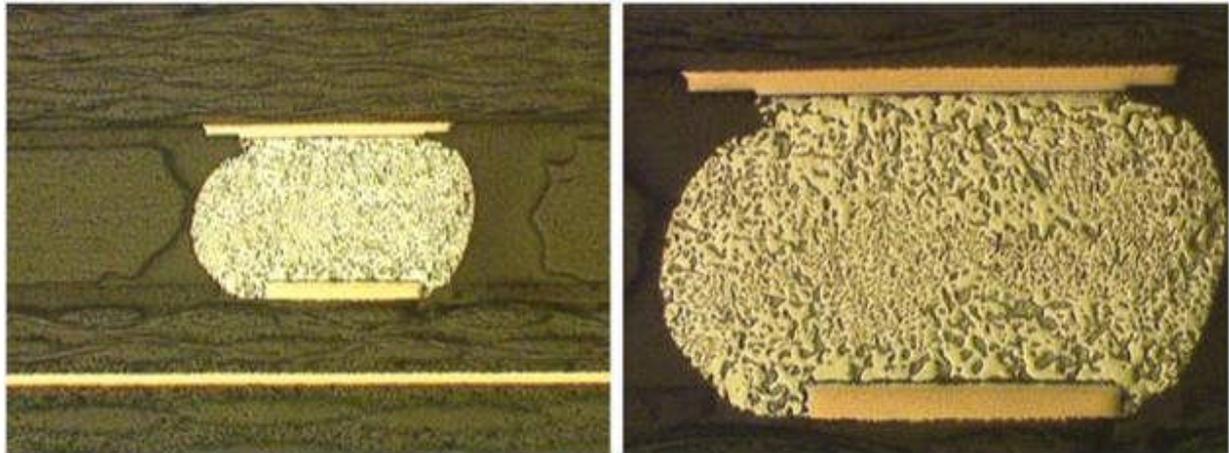
- The reworked test vehicle solder joint microstructures had a number of mixed metallurgy cases where the solder joint was not homogenous. These solder joints tended to fail at the solder joint/test vehicle pad interface with lead (Pb) segregated in the crack interface. This failure mode previously documented in the JCAA/JGPP testing program (8).

Figure 154 - Reworked PBGA-225 Solder Joints, Board 127, Component U56, Initially SnPb/SnPb, 1 rework Flux Only/SnPb, Failed @ 2349 Cycles

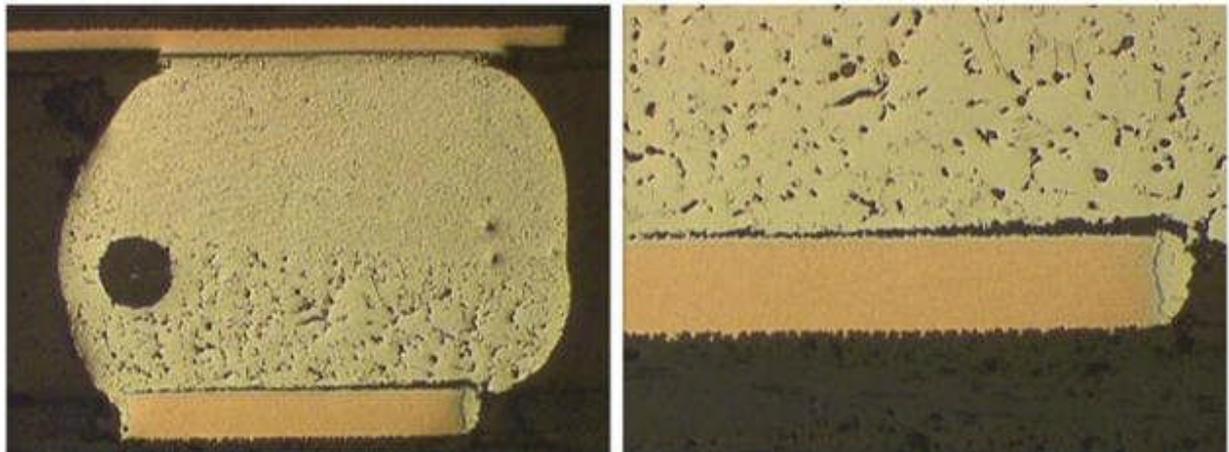
Figure 155 - Reworked PBGA-225 Solder Joints, Board 124, Component U6, Initially SnPb/SnPb, 1 rework SnPb/SAC405, Failed @ 2137 Cycles

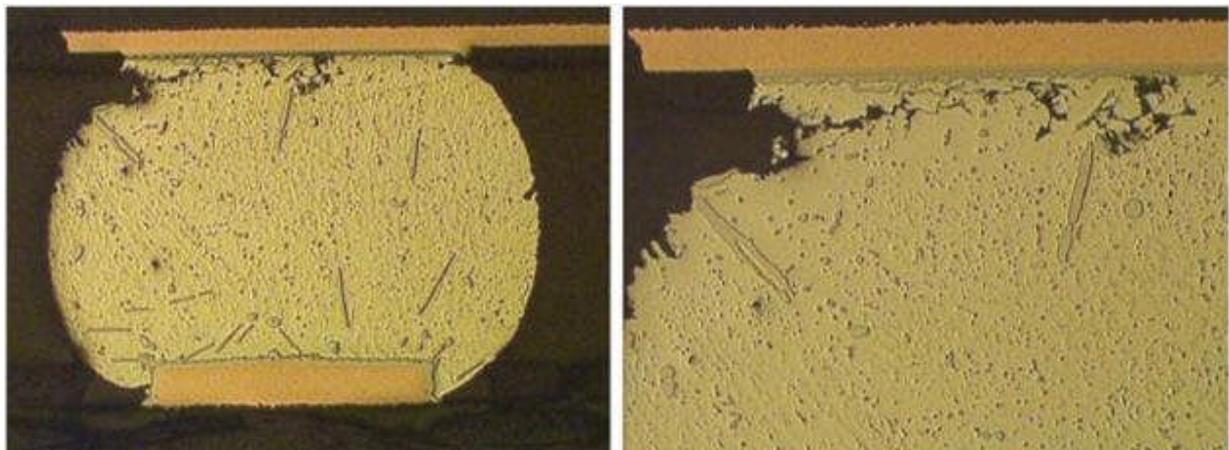
Figure 156 - Reworked PBGA-225 Solder Joints, Board 127, Component U56, Initially SAC305/SAC405, 1 rework Flux Only/SAC405, Failed @ 2349 Cycles

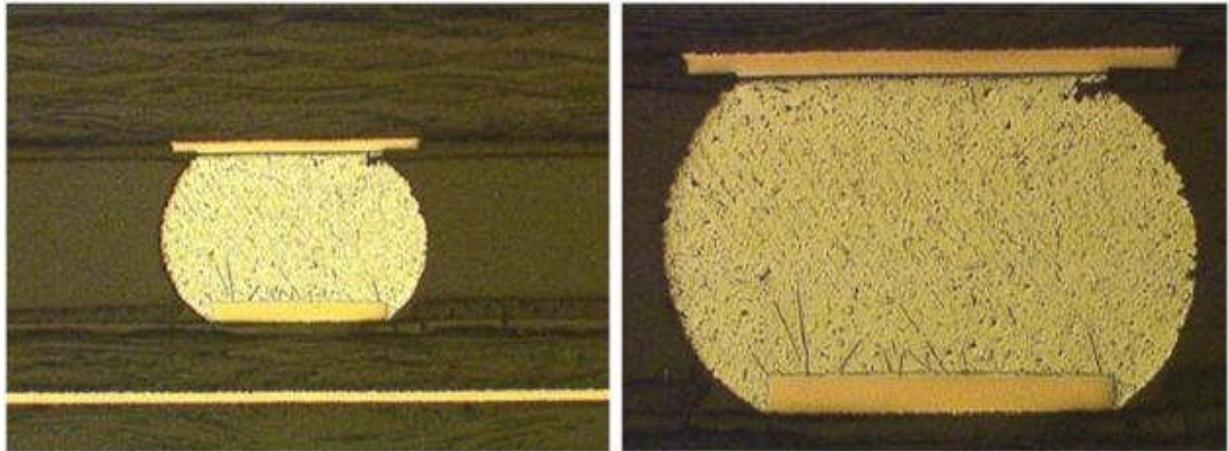
Figure 157 - Reworked PBGA-225 Solder Joints, Board 164, Component U18, Initially SAC305/SAC405, 1 rework SnPb/SAC405, DNF

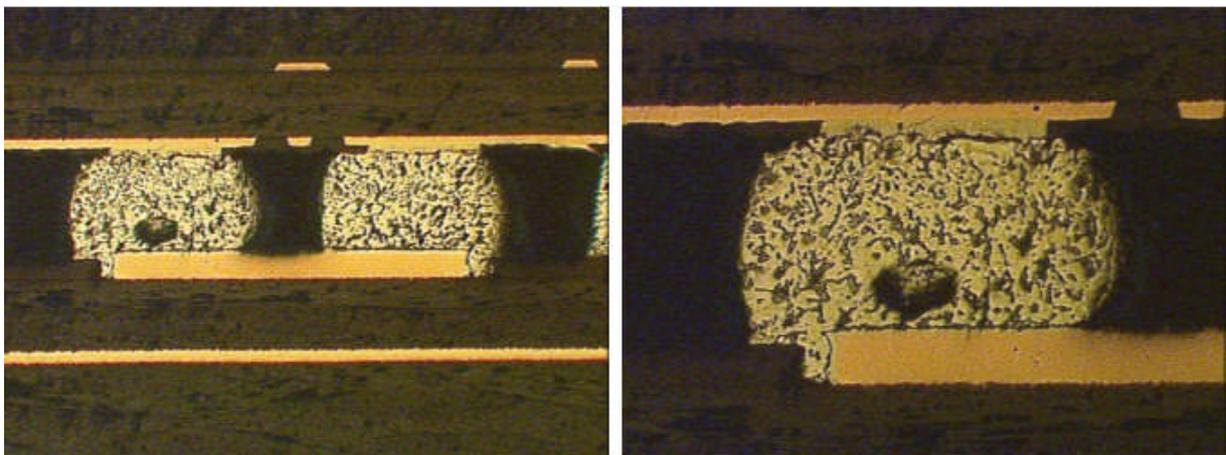
- The cracks in the solder joints were observed to have to failure modes: (1) initiation at the solder joint/component pad interface; (2) significant solder ball deformation with cracks at either solder joint component pad or solder joint/test vehicle pad interface.

Figure 162 - CSP-100 Solder Joints, Board 7, Component U37, SnPb/SnPb, Failed @ 2837 Cycles

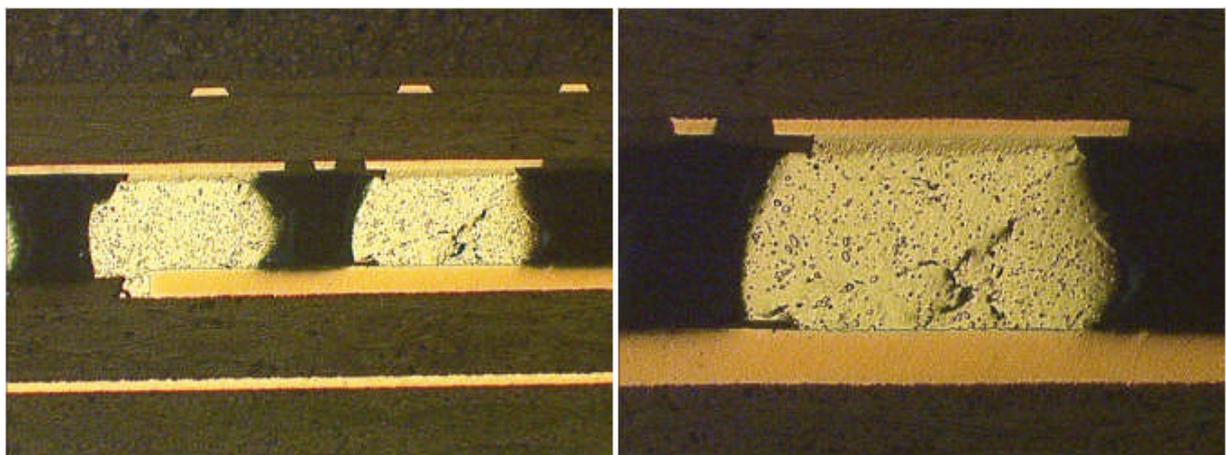
Figure 163 - CSP-100 Solder Joints, Board 124, Component U32, SnPb/SAC105, Failed @ 287 Cycles

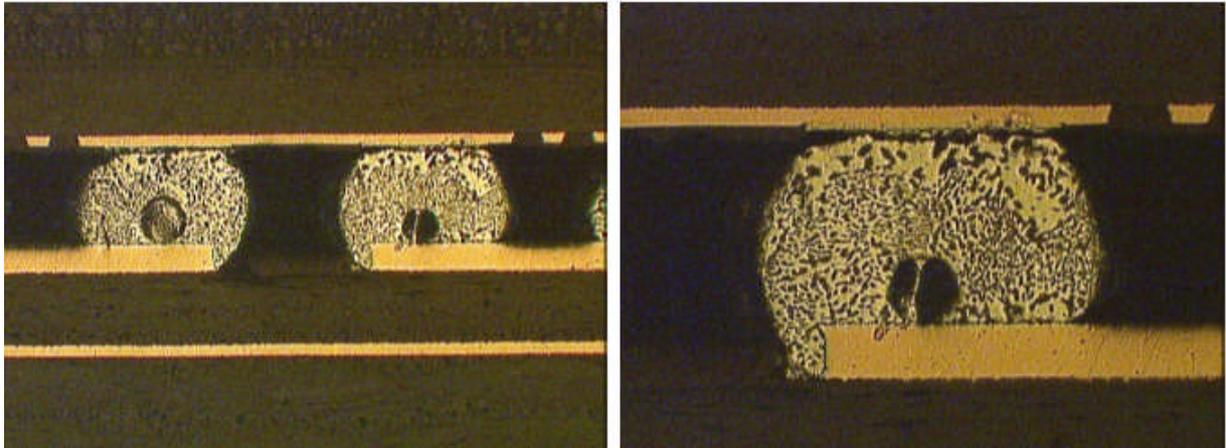
Figure 164 - CSP-100 Solder Joints, Board 166, Component U32, SAC305/SnPb, Failed @ 3417 Cycles

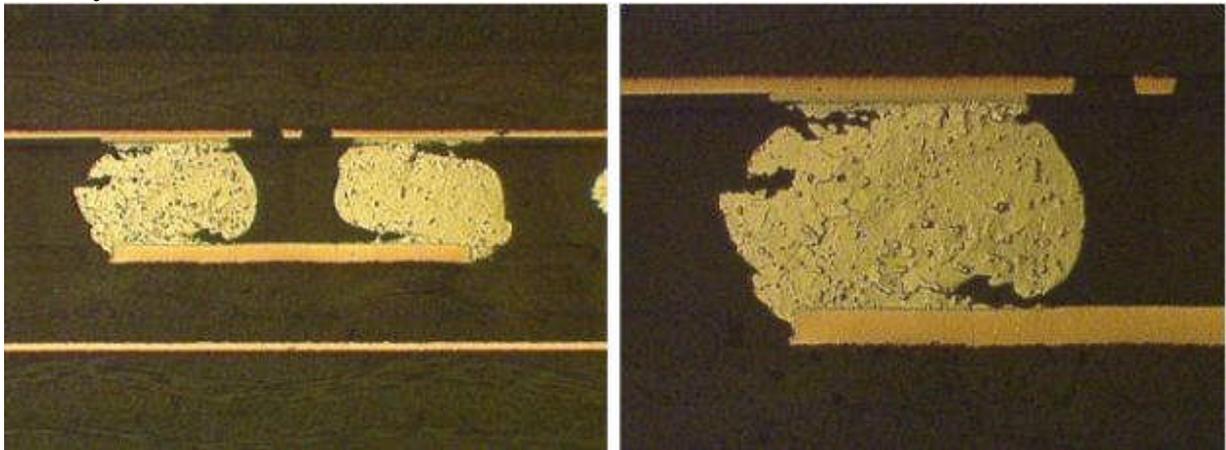
Figure 165 - CSP-100 Solder Joints, Board 49, Component U60, SAC305/SAC105, Failed @ 3908 Cycles

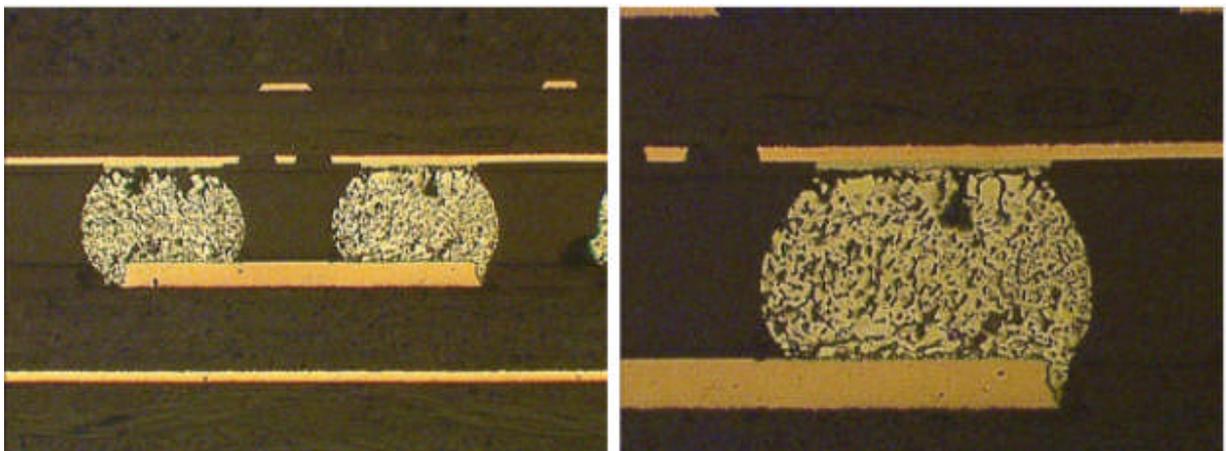
Figure 166 - CSP-100 Solder Joints, Board 103, Component U33, SN100C/SnPb, Failed @ 2932 Cycles

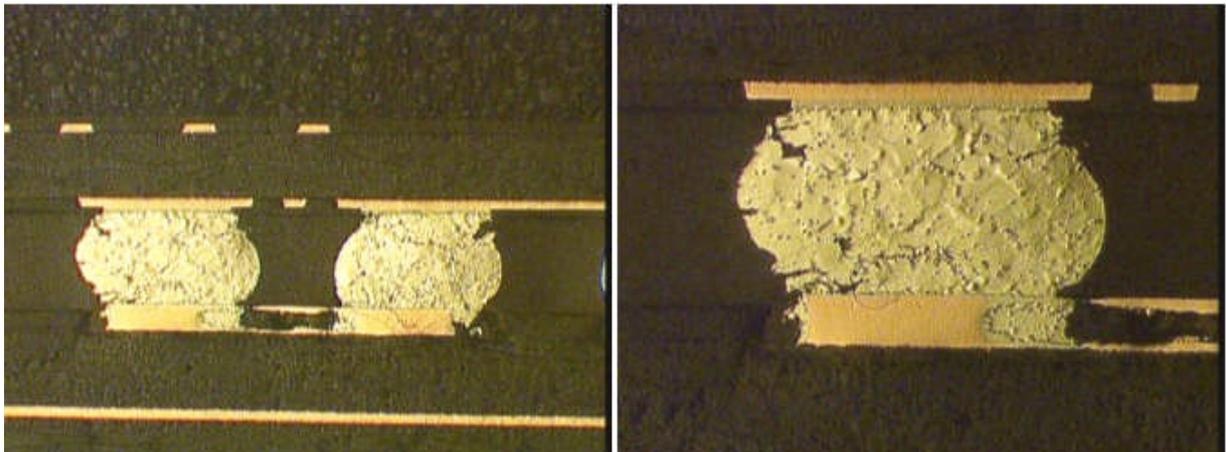
Figure 167 - CSP-100 Solder Joints, Board 106, Component U36, SN100C/SAC105, Failed @ 3908 Cycles

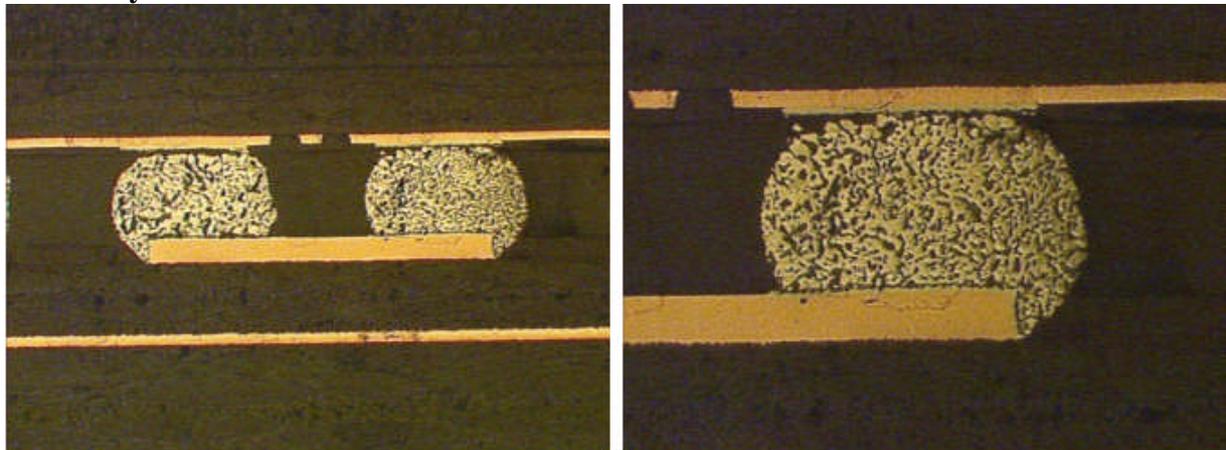
Figure 168 - Reworked CSP-100 Solder Joints, Board 128, Component U19, Initially SnPb/SnPb, 1 rework Flux Only/SnPb, Failed @ 3012 Cycles

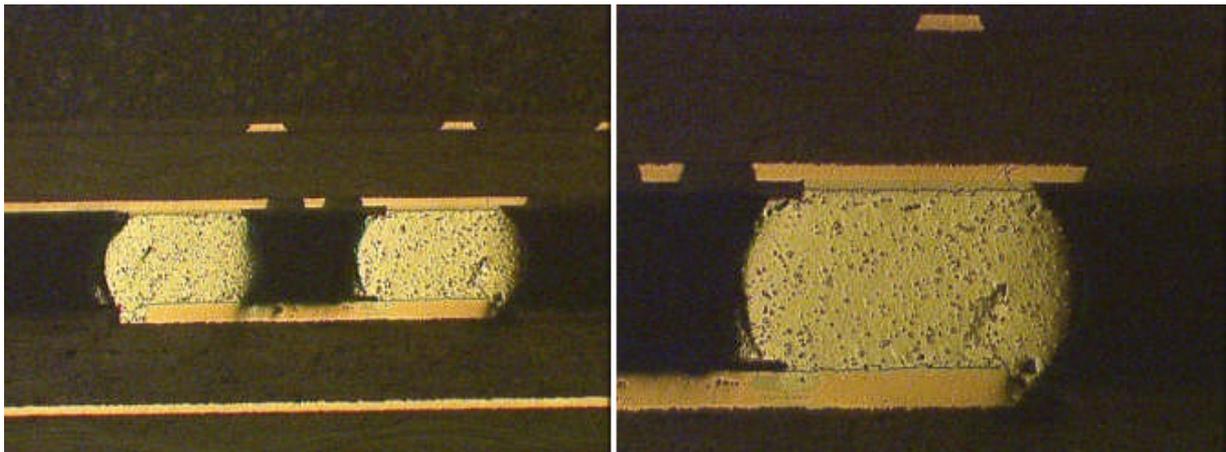
Figure 169 - Reworked CSP-100 Solder Joints, Board 126, Component U60, Initially SnPb/SnPb, 1 rework SnPb/SAC105, DNF

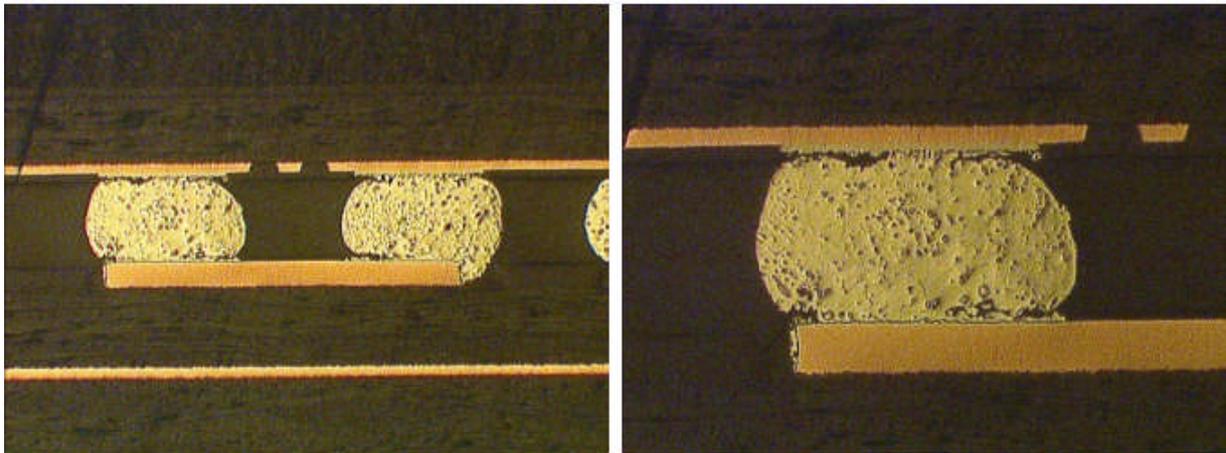
Figure 170 - Reworked CSP-100 Solder Joints, Board 168, Component U19, Initially SAC305/SAC105, 1 rework Flux Only/SAC105, DNF

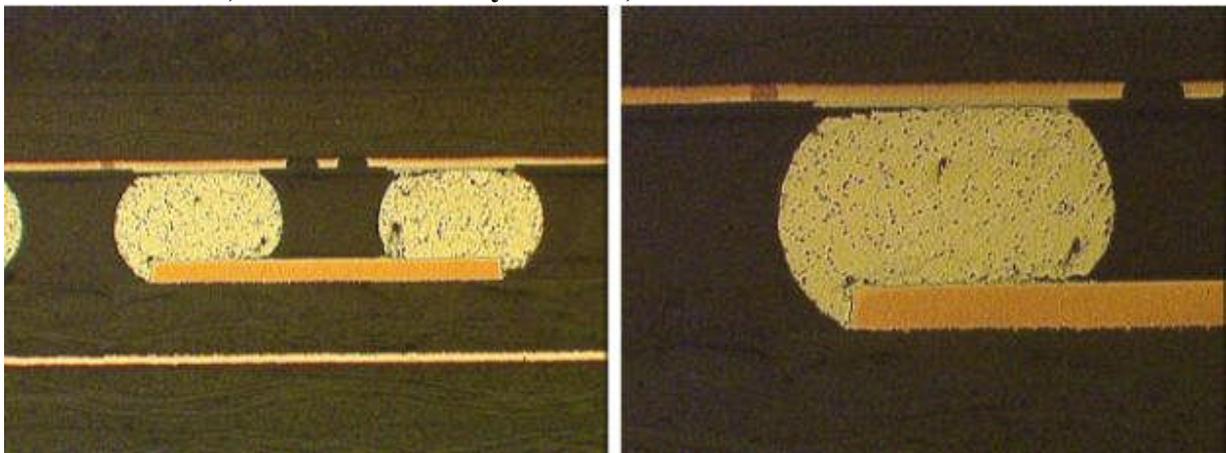
Figure 171 - Reworked CSP-100 Solder Joints, Board 164, Component U33, Initially SAC305/SAC105, 1 rework SnPb/SAC105, DNF

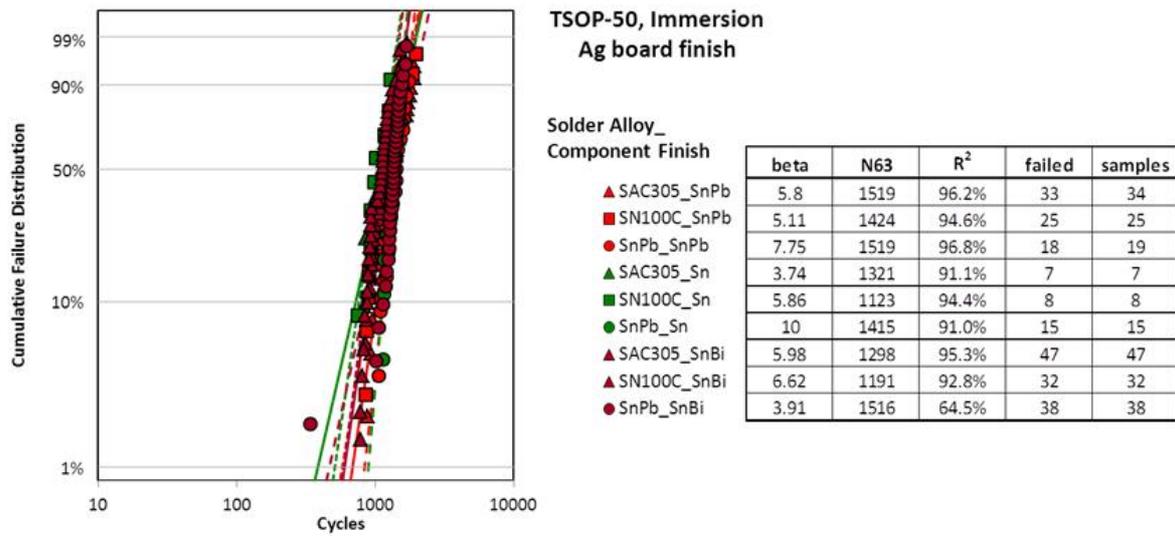
The TSOP-50 components had accumulated 99% population failure after the completion of 4068 thermal cycles. TSOP-50 components had nine different combinations (SAC/SnPb, SAC/SnBi, SAC/Sn, SN100C/SnPb, SN100C/SnBi, SN100C/Sn, SnPb/SnBi, SnPb/Sn, SnPb/SnPb) tested. This result is not surprising as TSOP components which use an Alloy 42 lead material are known to have solder joint integrity issues in High Performance electronics applications (9). The solder alloy/component finish combinations were statistically indistinguishable from each other thus no best performing combination was identified. The results populations were very well behaved. The small number of solder joint failures for the ENIG test vehicles was very small and therefore no conclusions were made.

Figure 172 - TSOP-50 Weibull Plot for Immersion Silver PWB Finish

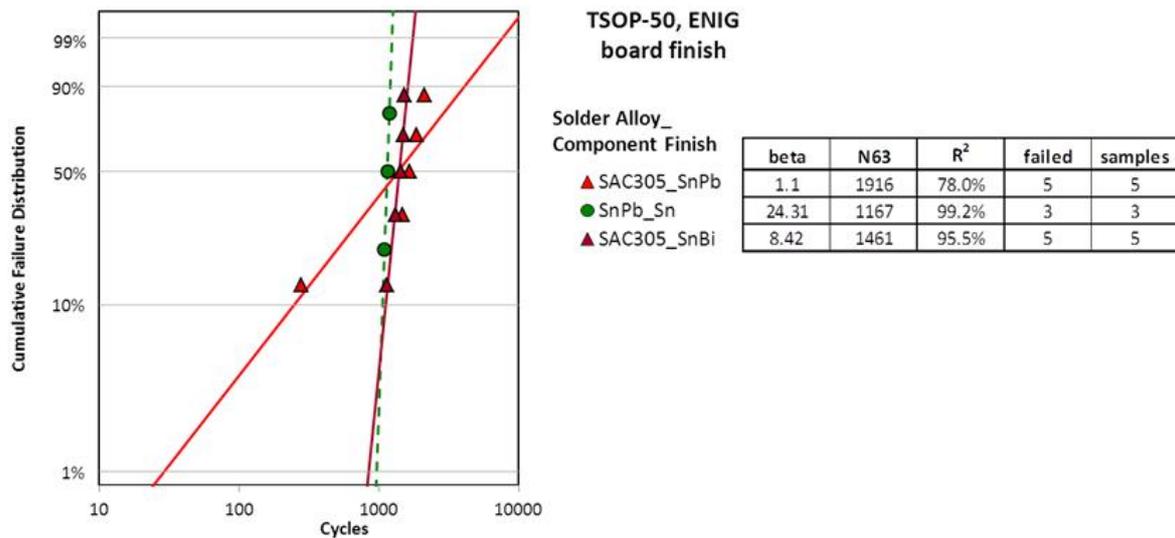
Figure 173 - TSOP-50 Weibull Plot for ENIG PWB Finish
