**Technology Evaluation for Environmental Risk
Mitigation Principal Center**

NASA-DoD Lead-Free Electronics Project

Joint Test Report - Final

December 2011

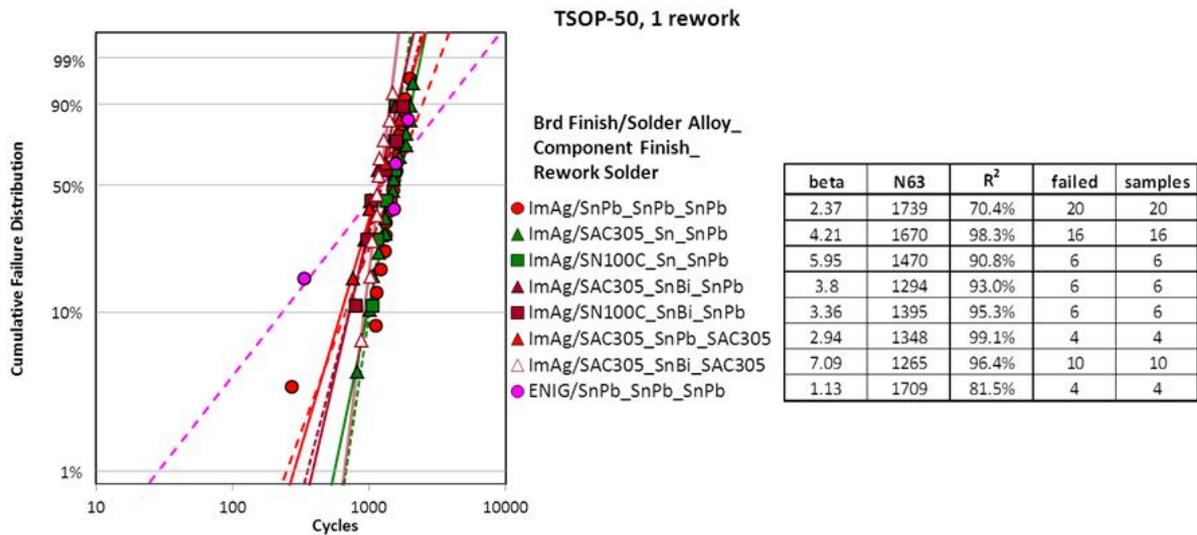
The reworked TSOP-50 components had accumulated 100% population failure after the completion of 4068 thermal cycles. The results show that no preferred alloy/component finish combination could be selected from the data as the combination populations were statistically indistinguishable from each other for both the 1 Rework and 2 Rework cases.

Figure 174 - TSOP-50 Rework Weibull Plot for 1 Rework

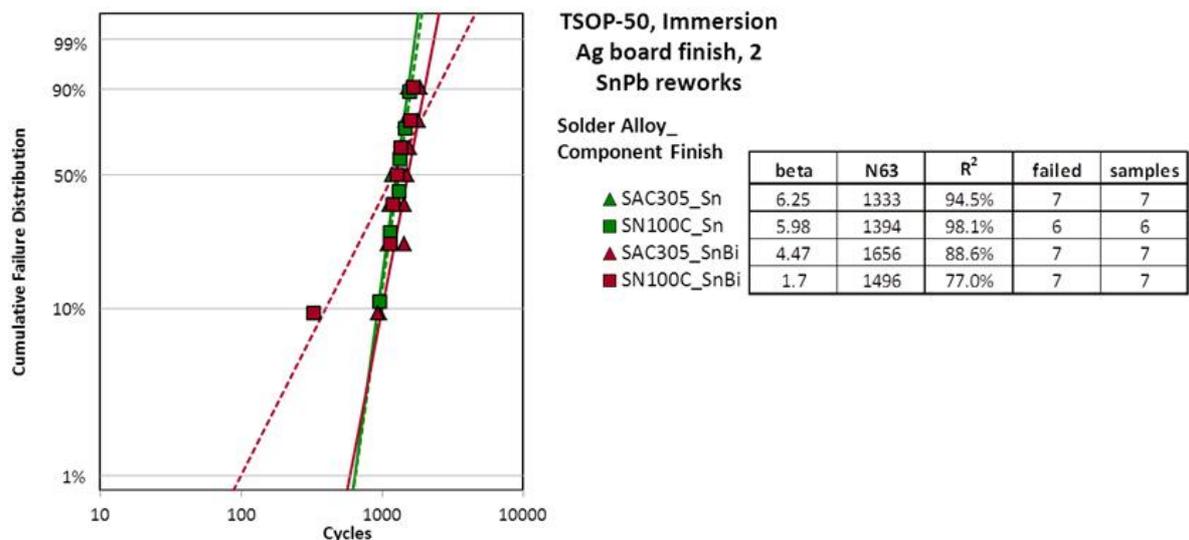
Figure 175 - TSOP-50 Rework Weibull Plot for 2 Rework

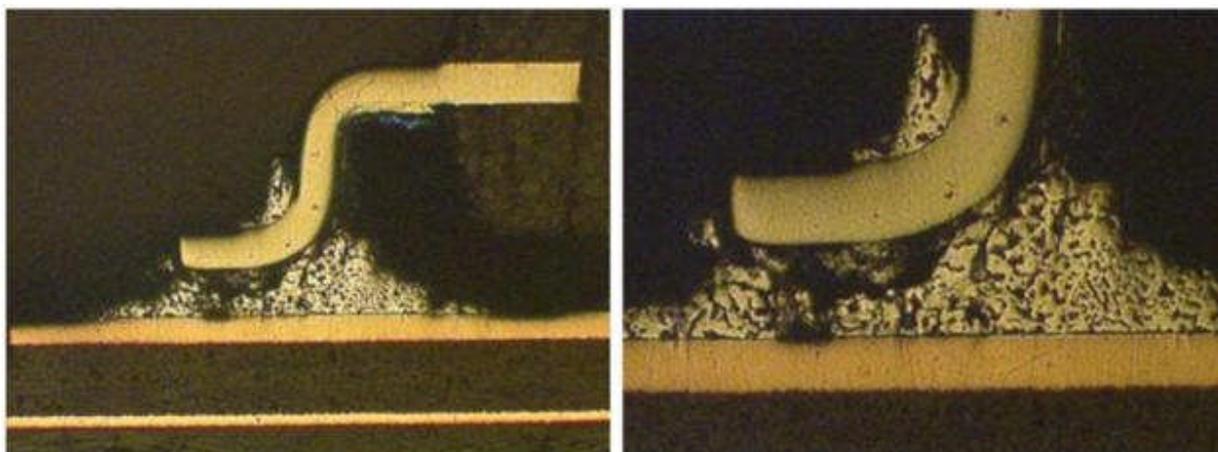
- The cracks in the solder joints initiated in the heel fillet region and traversed under the foot towards the lead toe. The crack formation and location are in agreement with industry knowledge of Alloy 42 TSOP failure modes (9).

- The solder joint geometries and wetting angles were acceptable and met industry workmanship criteria (IPC J-STD-001D “Requirements for Soldered Electrical and Electronic Assemblies”, end-product Class 3 “High Performance Electronics Products”). There were a number of instances where the solder did flow into the upper lead bend region. In most cases this condition is acceptable per industry standards. However several solder joints, primarily reworked cases, were observed with excessive solder in the upper lead bend which violated industry standards. Rockwell Collins has conducted internal studies demonstrating that solder material located between the component lead and the component body does not cause solder joint integrity issues for plastic bodied components (10).

- The solder joint microstructures were reasonably homogenous with no segregation regions observed in the mixed metallurgy cases.

Figure 176 - TSOP-50 Solder Joints, Board 8, Component U40, SnPb/SnPb, Failed @ 1252 Cycles

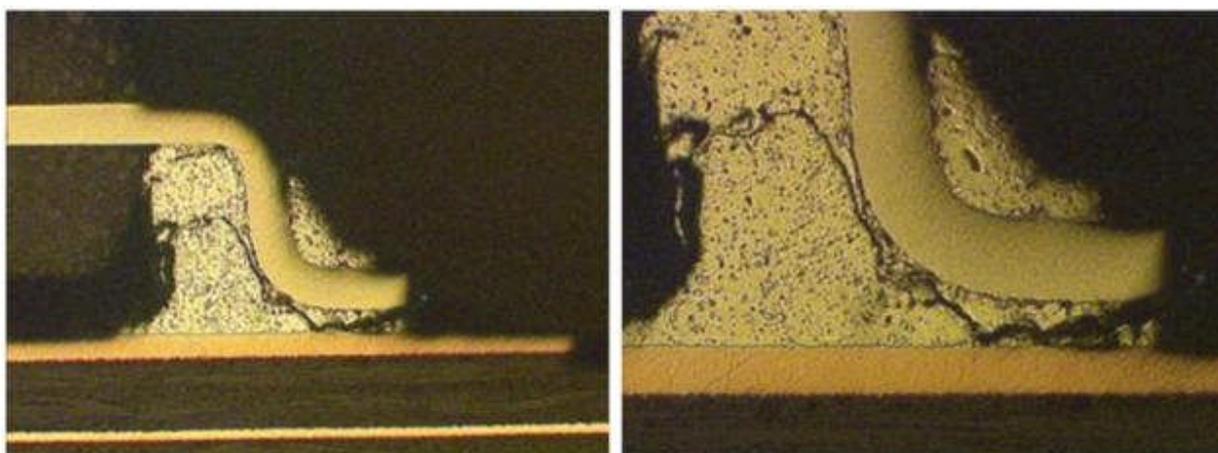
Figure 177 - TSOP-50 Solder Joints, Board 44, Component U25, SAC305/SnPb, Failed @ 1787 Cycles

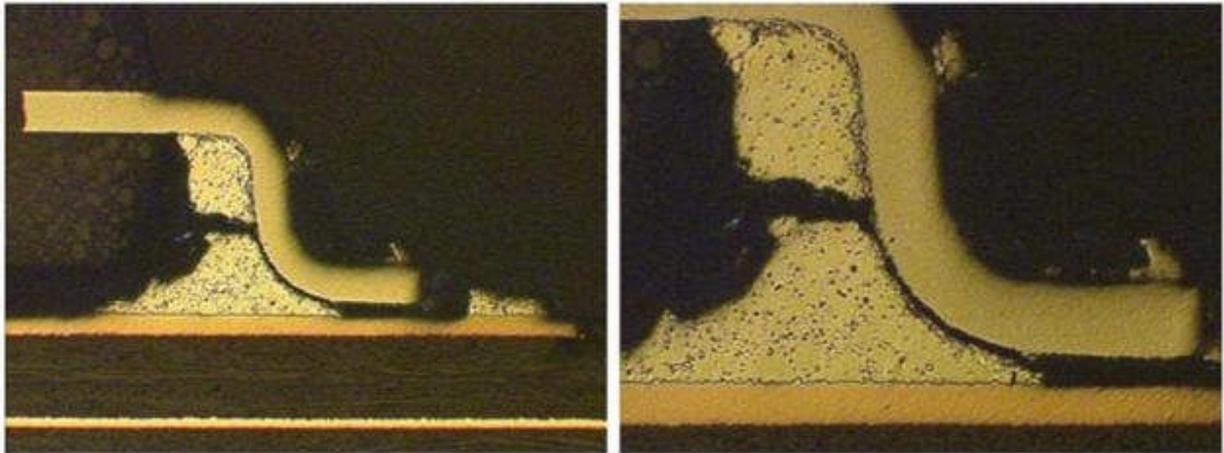
Figure 178 - TSOP-50 Solder Joints, Board 103, Component U39, SN100CSnPb, Failed @ 851 Cycles

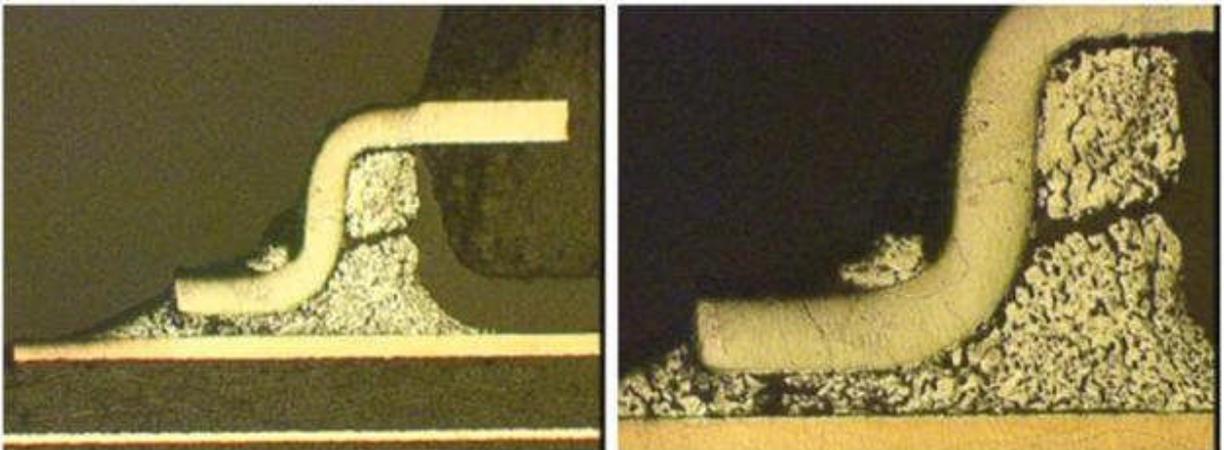
Figure 179 - TSOP-50 Solder Joints, Board 8, Component U29, SnPb/SnBi, Failed @ 1424 Cycles

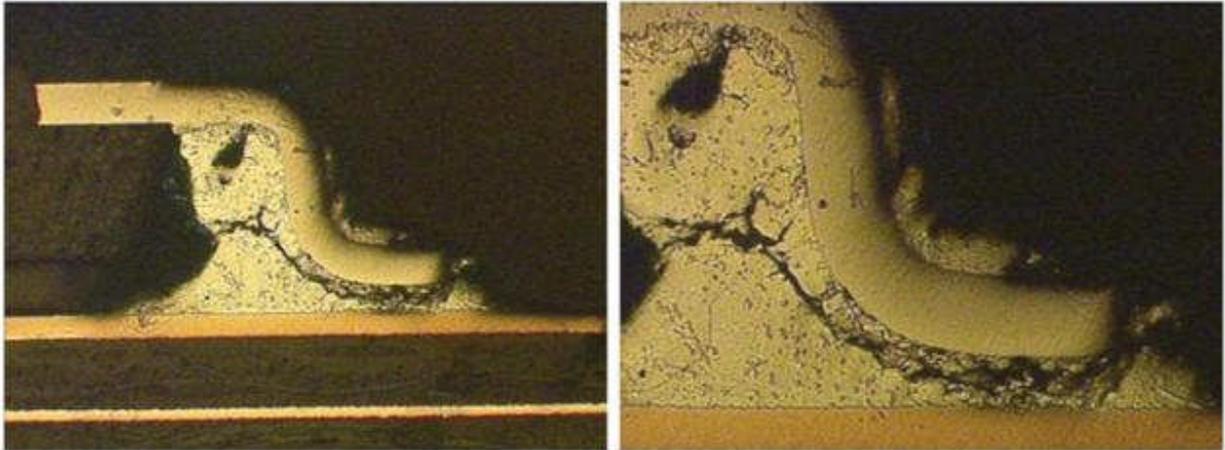
Figure 180 - TSOP-50 Solder Joints, Board 166, Component U39, SAC305/SnBi, Failed @ 1594 Cycles

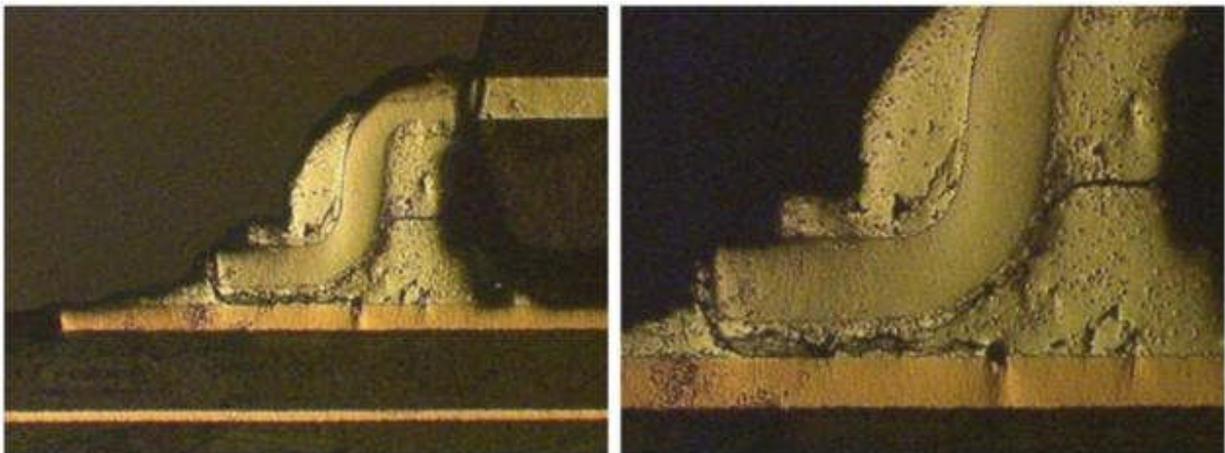
Figure 181 - TSOP-50 Solder Joints, Board 102, Component U34, SN100C/SnBi, Failed @ 1985 Cycles

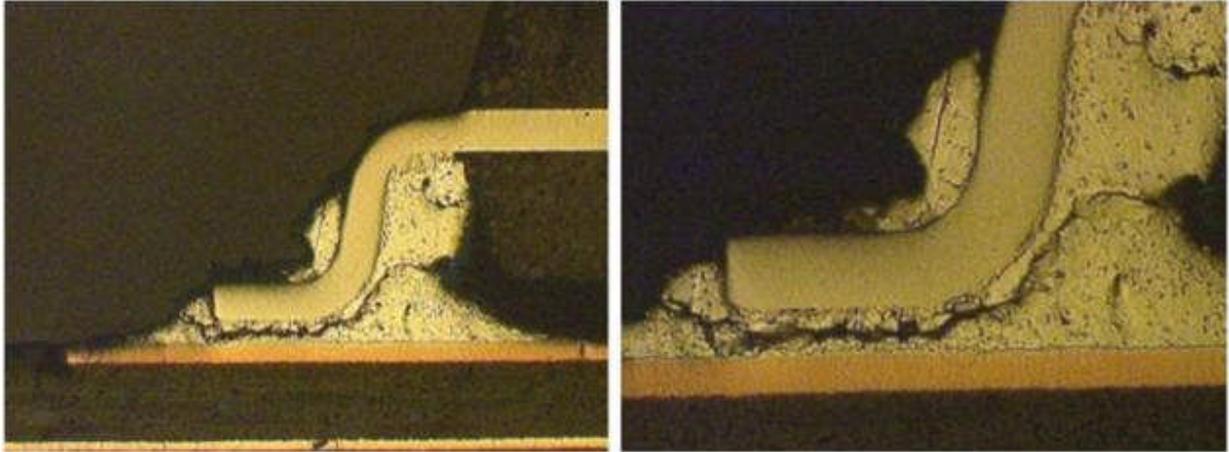
Figure 182 - TSOP-50 Solder Joints, Board 107, Component U61, SN100C/Sn, Failed @ 1258 Cycles

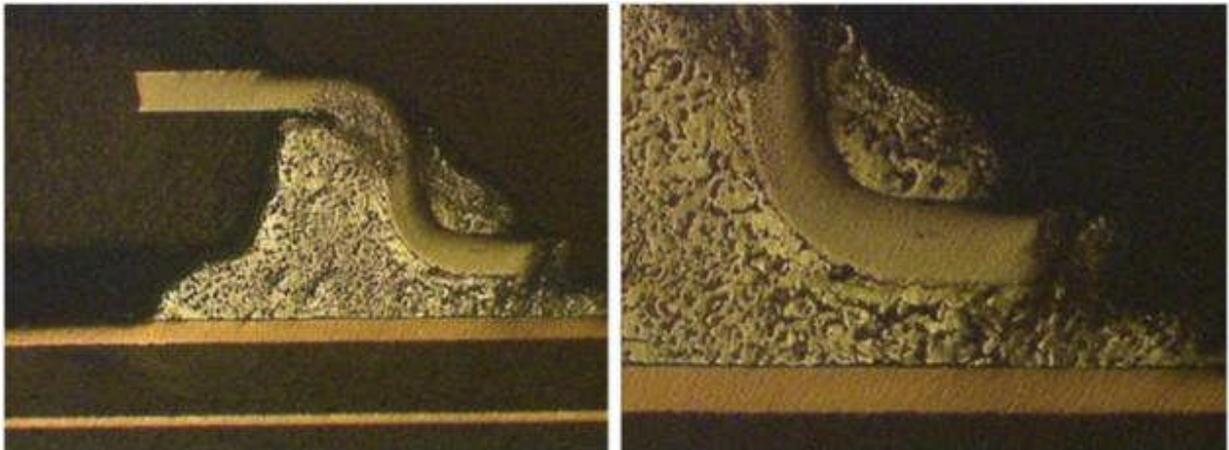
Figure 183 - Reworked TSOP-50 Solder Joints, Board 127, Component U12, Initially SnPb/SnPb, 1 rework SnPb/SnPb, Failed @ 1443 Cycles

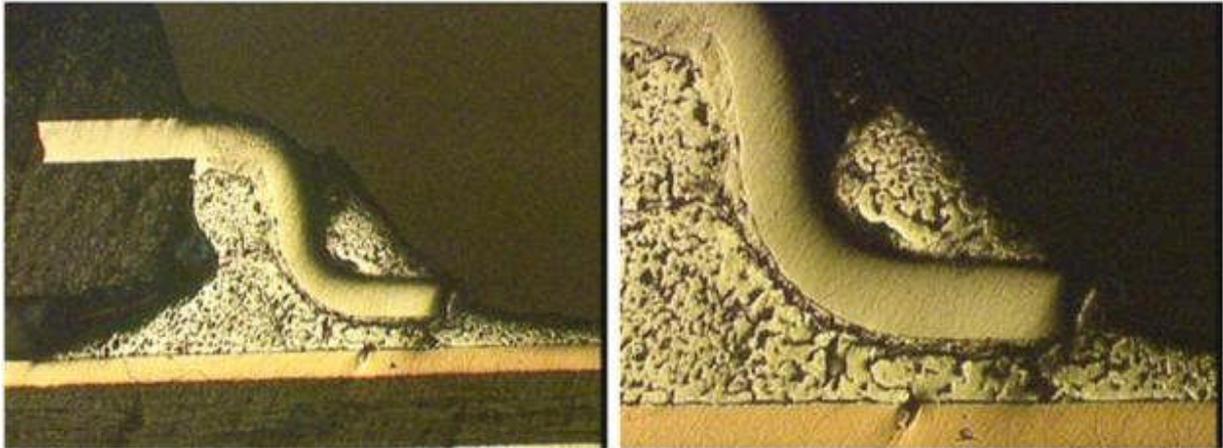
Figure 184 - Reworked TSOP-50 Solder Joints, Board 47, Component U24, Initially SAC305/SnBi, 2 rework SnPb/SnBi, Failed @ 1810 Cycles

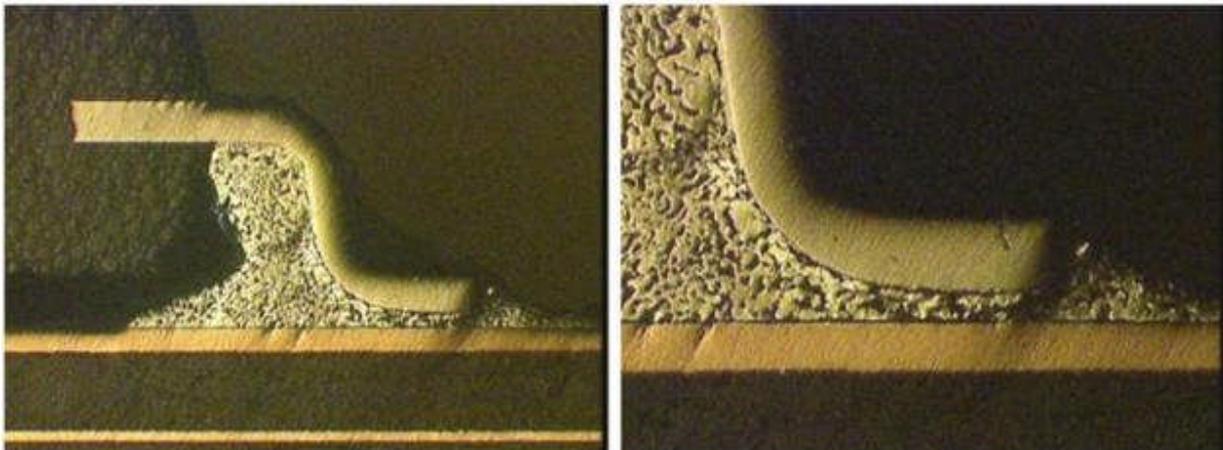
Figure 185 - Reworked TSOP-50 Solder Joints, Board 47, Component U29, Initially SAC305/Sn, 1 rework SnPb/Sn, Failed @ 1010 Cycles

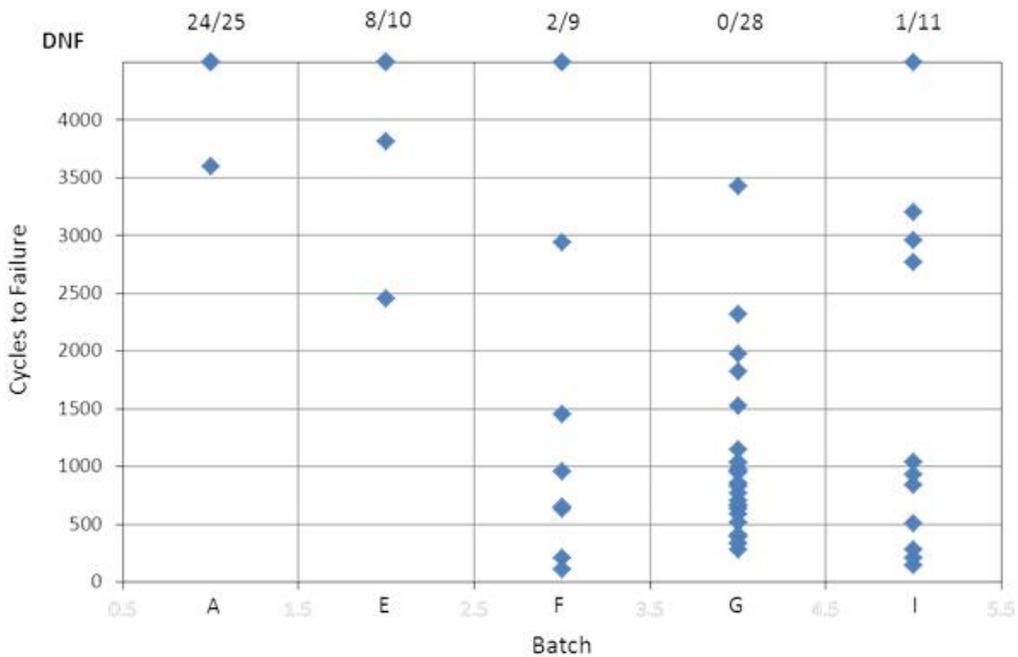
The PDIP-20 components had accumulated 38% population failure after the completion of 4068 thermal cycles. The solder joint failure behavior of the PDIP-20 components was a surprise to the consortium team as the PDIP-20 failure rate documented in the JCAA/JGPP investigation results was only 8% after 4743 total thermal cycles. Physical failure analysis of the failed PDIP-20 components revealed a test vehicle fabrication error as the root cause of the dramatically different failure rates. In-depth statistical analyses of test vehicles that contained and did not contain the fabrication defect reveal a significant difference in the results (see Table 32). Plotting of the PDIP-20 components by assembly lot designation conducted by Aaron Pedigo, NSWC Crane, is shown in Figure 186 and Figure 187. The plotted data is in agreement with Table 32 data and illustrates how assembly lots F, G, and I were compromised by the fabrication defect.

Figure 186 - Cycles to failure for as-manufactured Sn finished PDIP's soldered with SN100C as a function of production batch showing a faster rate of failure for batches F, G, and I.

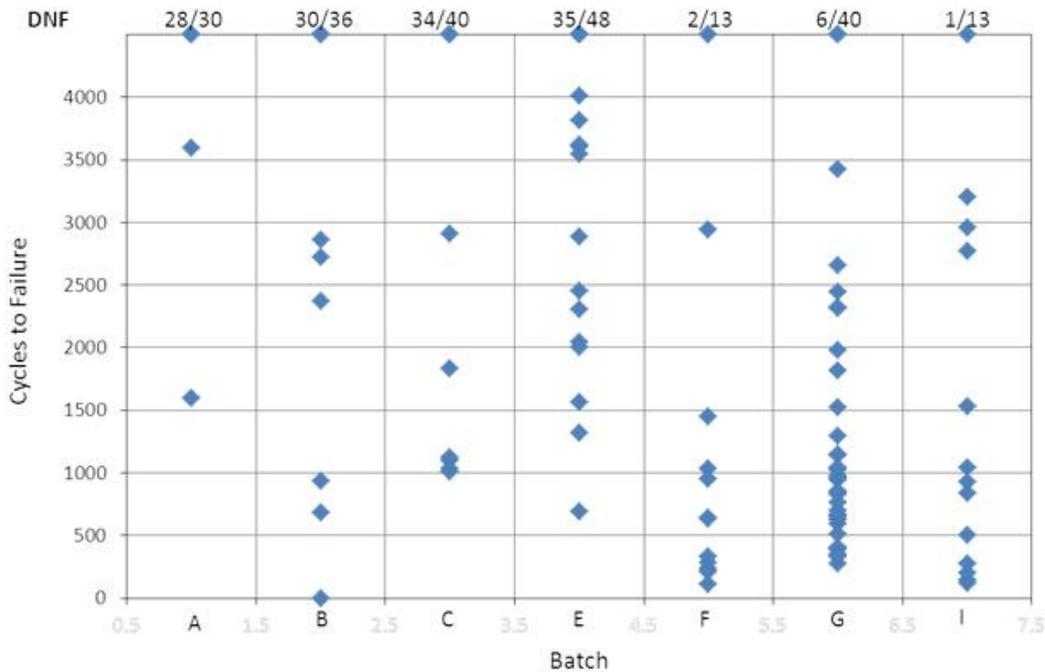
Figure 187 - Cycles to failure agglomerated for all as-manufactured PDIP's as a function of production batch showing a faster rate of failure for batches F, G, and I.

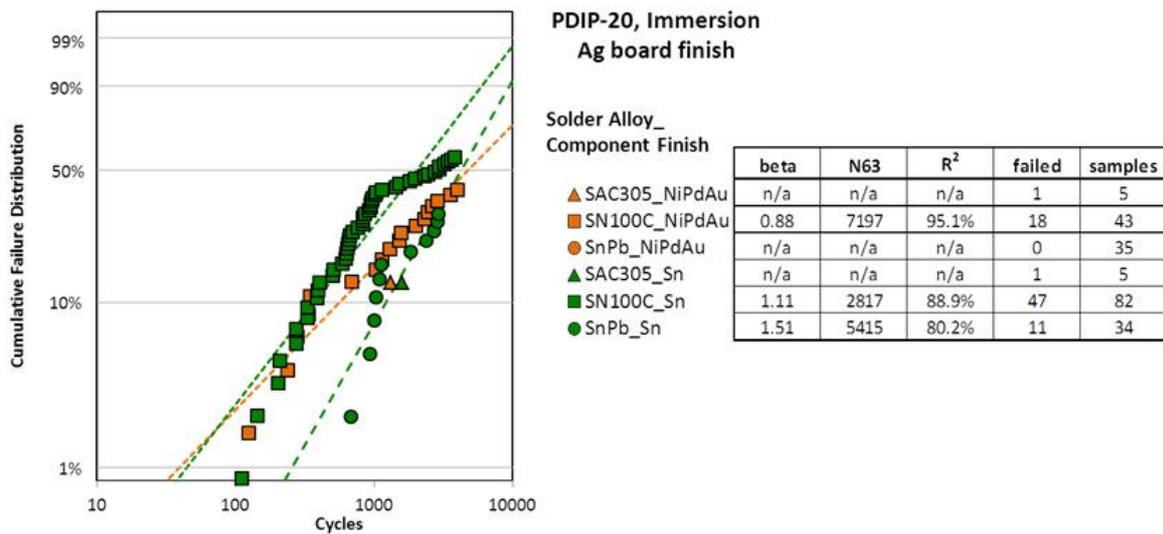
Figure 188 - PDIP-20 Weibull Plot for Immersion Silver PWB Finish

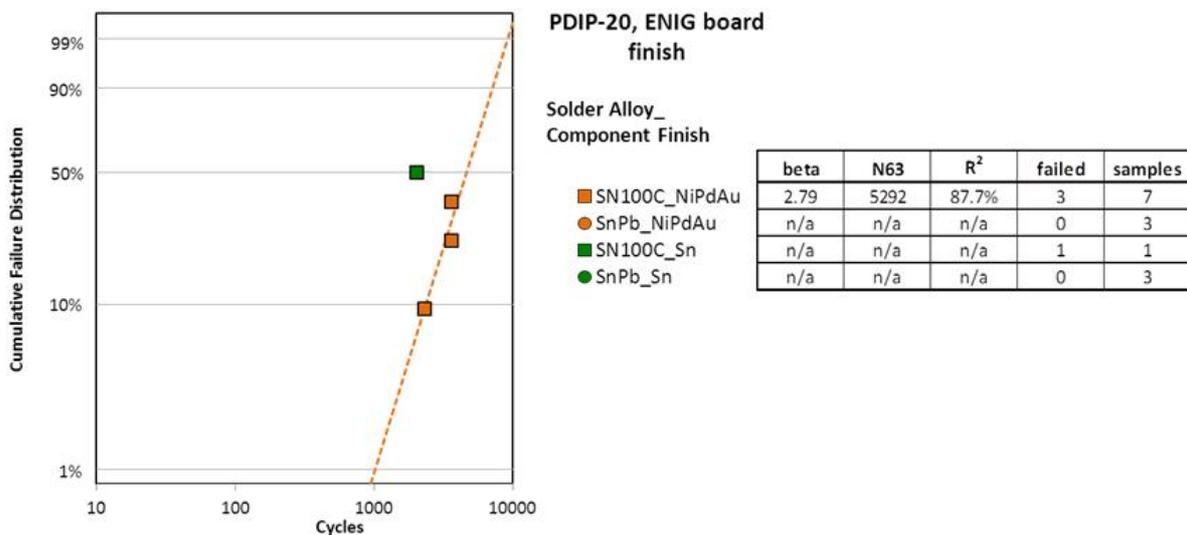
Figure 189 - PDIP-20 Weibull Plot for ENIG PWB Finish

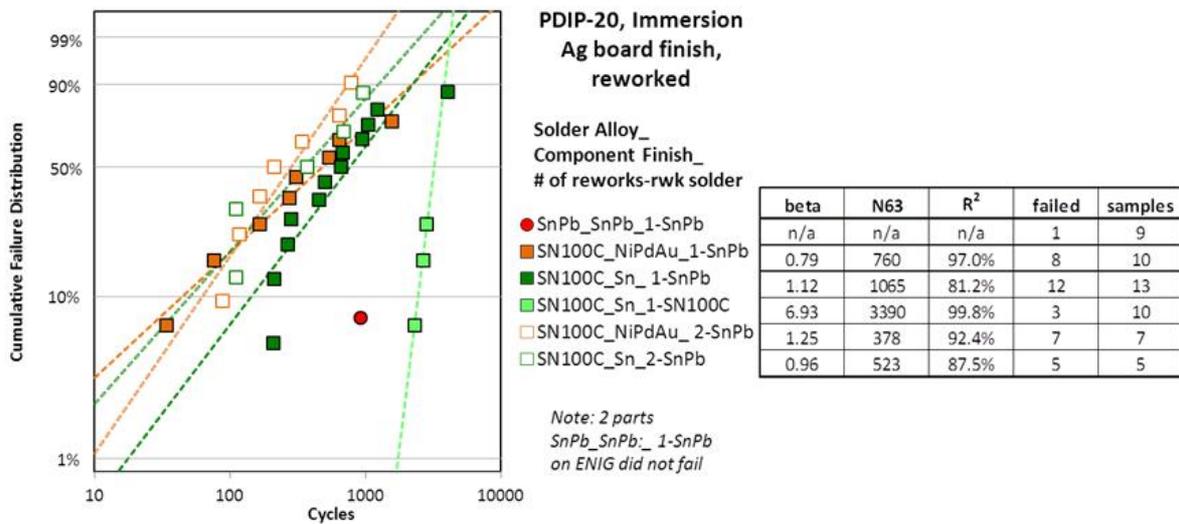
The reworked PDIP-20 components had accumulated 56% population failure after the completion of 4068 thermal cycles. The non- mixed metallurgy alloy/component finish combinations exhibited better thermal cycle performances than mixed metallurgy combination. The reworked PDIP-20 components with mixed metallurgy combinations showed the same thermal cycle results trends as the mixed metallurgy PBGA-225 alloy/component finish combinations despite being two completely different component technologies (Plated-Through-

Figure 190 - Reworked PDIP-20 Weibull Plot

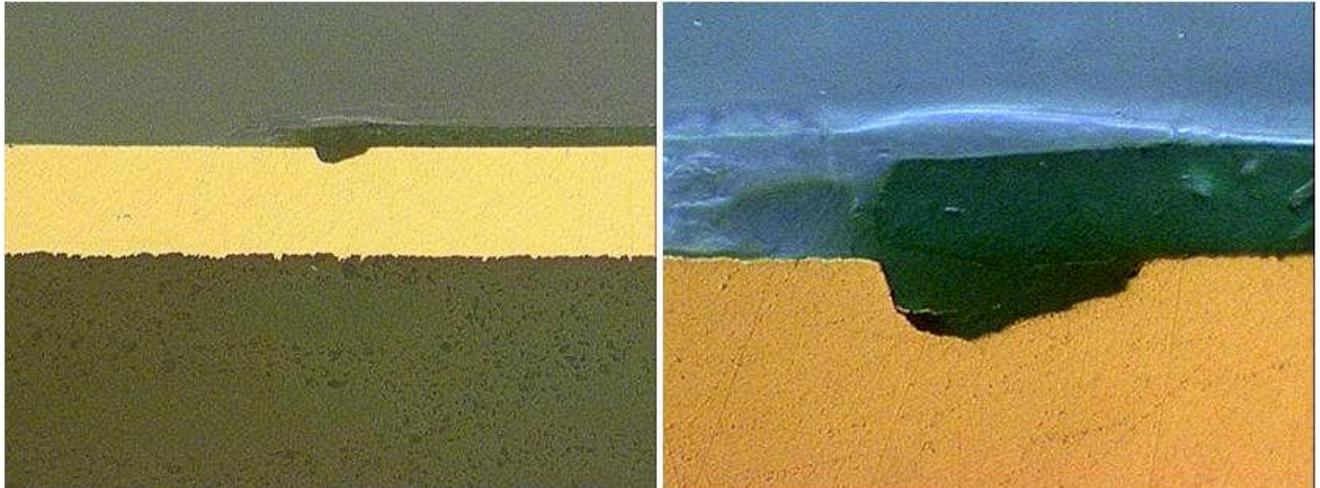
Metallographic cross-sectional analysis was conducted on the PDIP-20 components to document the solder joint failure location, crack morphology and solder joint microstructure. One of the issues observed during the NASA DoD testing program was the significant solder joint integrity difference in the PDIP-20 components in comparison with the JCCA/JGGP testing program results. Failure analysis reviewed a fabrication defect in the test vehicle associated with the surface traces for the PDIP-20 components. Poor cleaning/entrapment of fabrication chemistry resulted in the removal of copper beneath the soldermask. Figure 191 and Figure 192 shows a cross-sectional view of the fabrication defect in the test vehicle at the PDIP-20 locations. Fabrication chemistry was trapped under the soldermask edge along the PDIP-20 pads resulting in a reduction of the copper trace thickness.

Figure 191 - Cross-sectional Views of the Fabrication Defect in the Test Vehicle at the PDIP-20 Locations (Left – Macro View, Right – Magnified View)

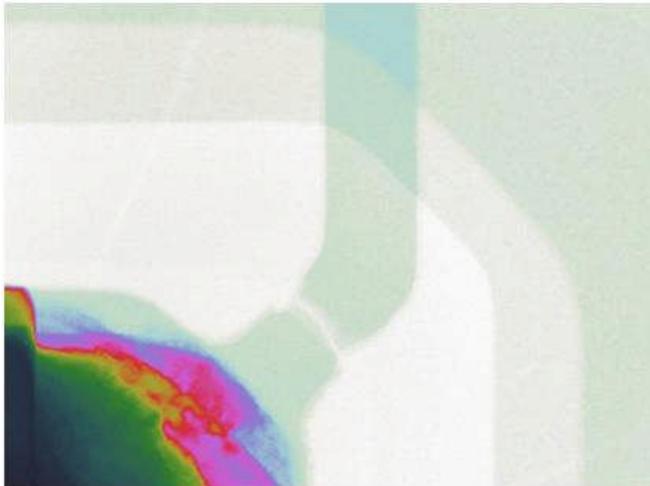
Figure 192 - Color X-ray Image of PDIP-20 Thermal Cycling Induced Cracked Trace

This “necked down” region of the trace cracked during thermal cycling. In addition, the lead-free solder alloys had additional trace integrity degradation due to their copper dissolution characteristics. Figure 193 illustrates the resulting trace cracks due to thermal cycle testing of a PDIP-20 component.

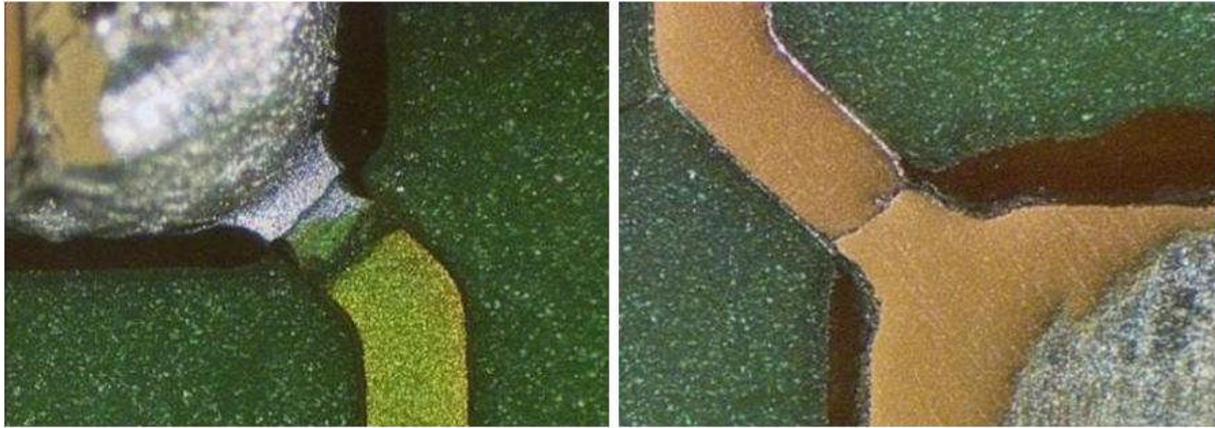
Figure 193 - PDIP-20 Thermal Cycling Induced Cracked Trace at Fabrication Defect Location

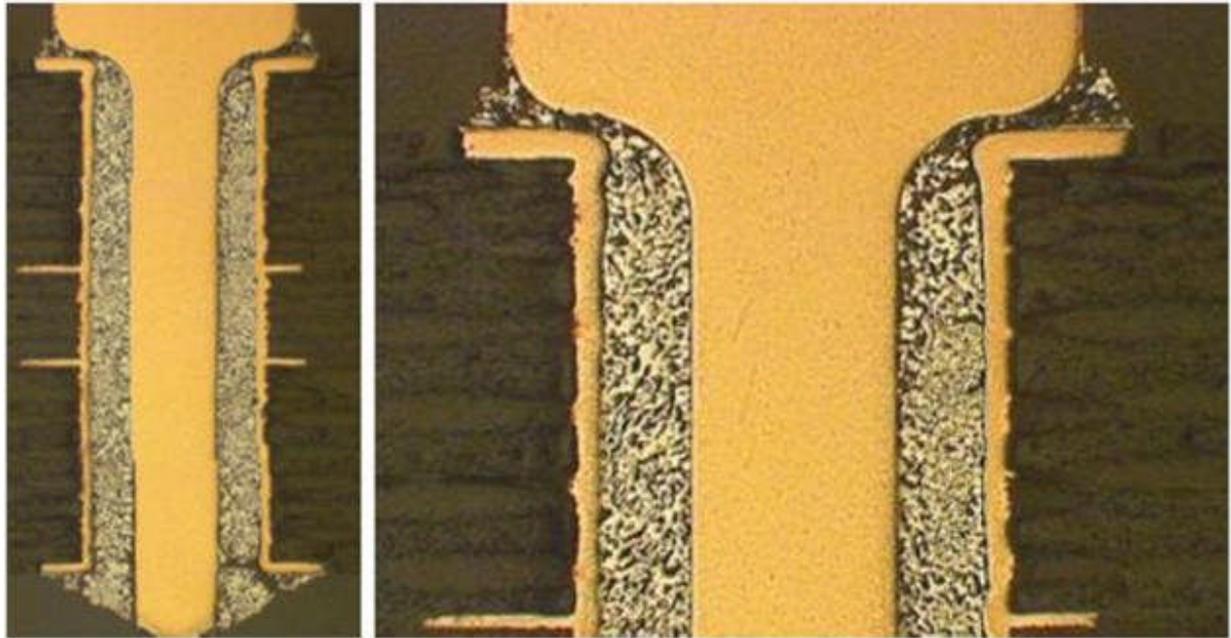
Figure 194 through Figure 196 illustrate the typical TSOP-50 solder joint failures. Note that the “failed cycle” value is when the copper trace broke and not a failure of the solder joint in these figures.

Figure 194 - PDIP-20 Solder Joints, Board 124, Component U23, SnPb/NiPdAu, DNF

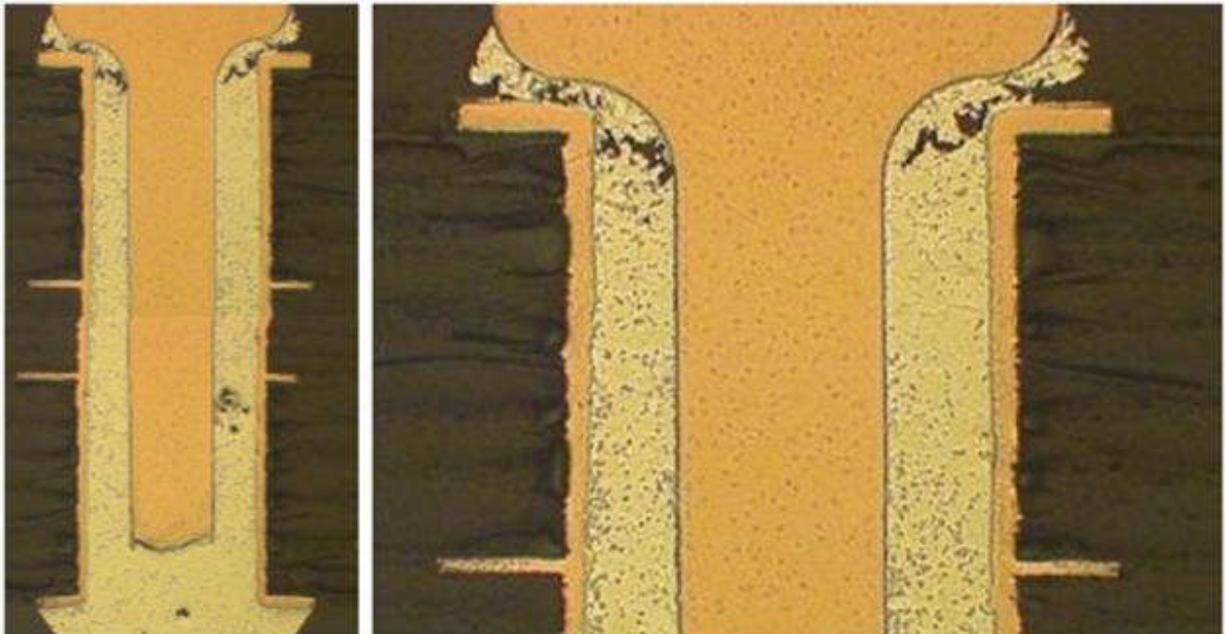
Figure 195 - PDIP-20 Solder Joints, Board 43, Component U8, SN100C/NiPdAu, DNF

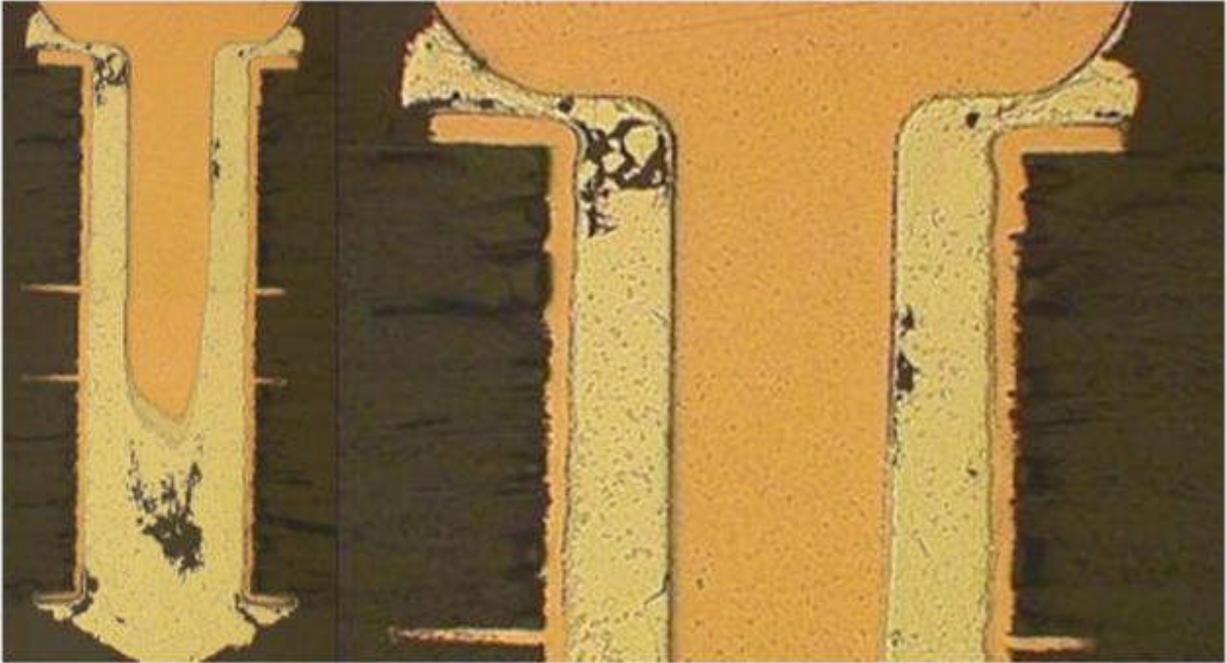
Figure 196 - PDIP-20 Solder Joints, Board 168, Component U49, SN100C/Sn, DNF

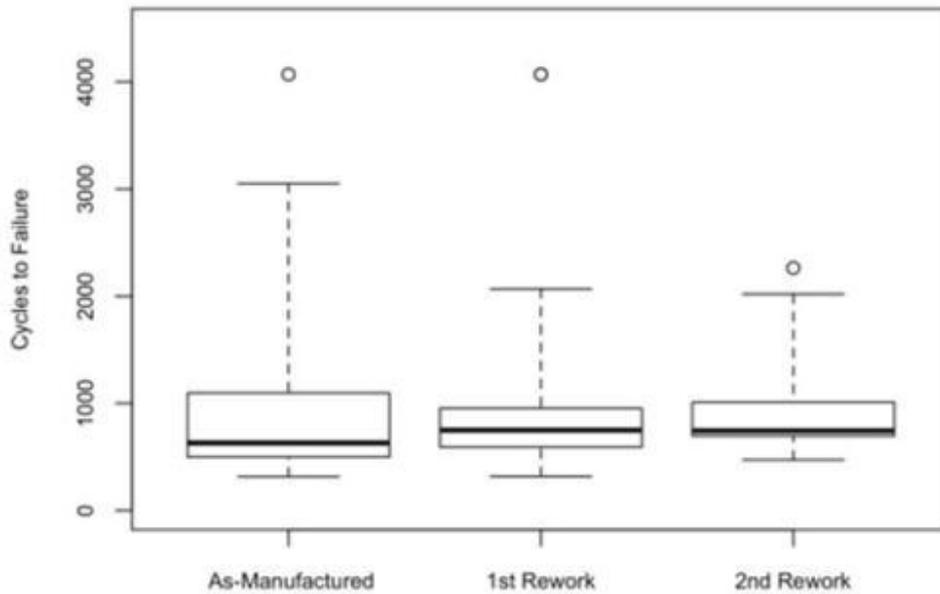
Both rework scenarios resulted in reworked CLCC's with thermal cycles to failure comparable to the as-manufactured CLCC's. The p-values, shown in Table 34, were all greater than 0.05 and the percentages of components that failed during testing, shown in Table 33, were all within expected variation.

Figure 197 - Box and whisker plot comparing thermal cycles to failure for SAC305 finished CLCC's originally soldered with SAC305 and reworked 1 or 2 times with SAC305 finished CLCC's soldered with eutectic SnPb. No differences in cycles to failure were considered statistically significant.

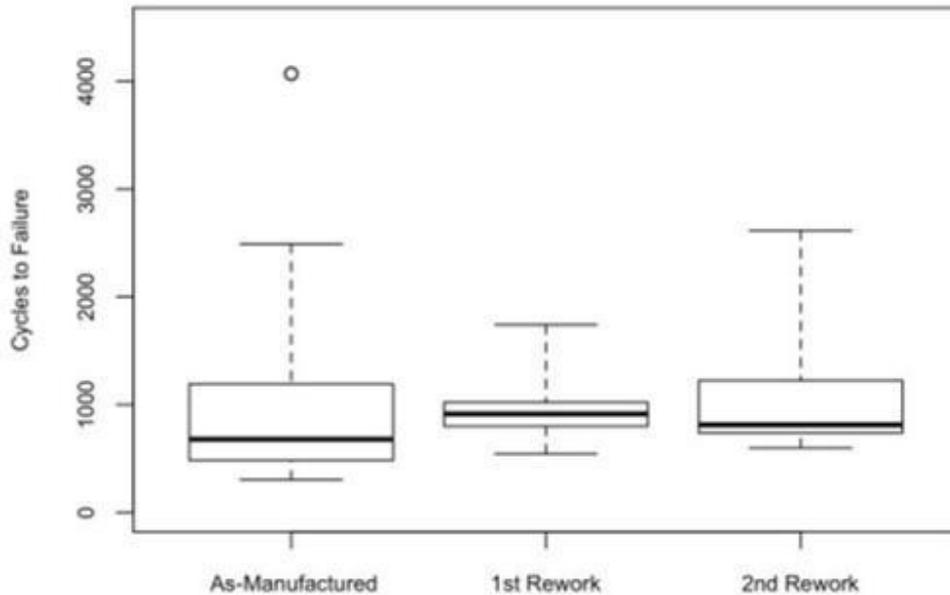
Figure 198 - Box and whisker plot comparing thermal cycles to failure for SAC305 finished CLCC's originally soldered with SN100C and reworked 1 or 2 times with SAC305 finished CLCC's soldered with eutectic SnPb. No differences in cycles to failure were considered statistically significant.

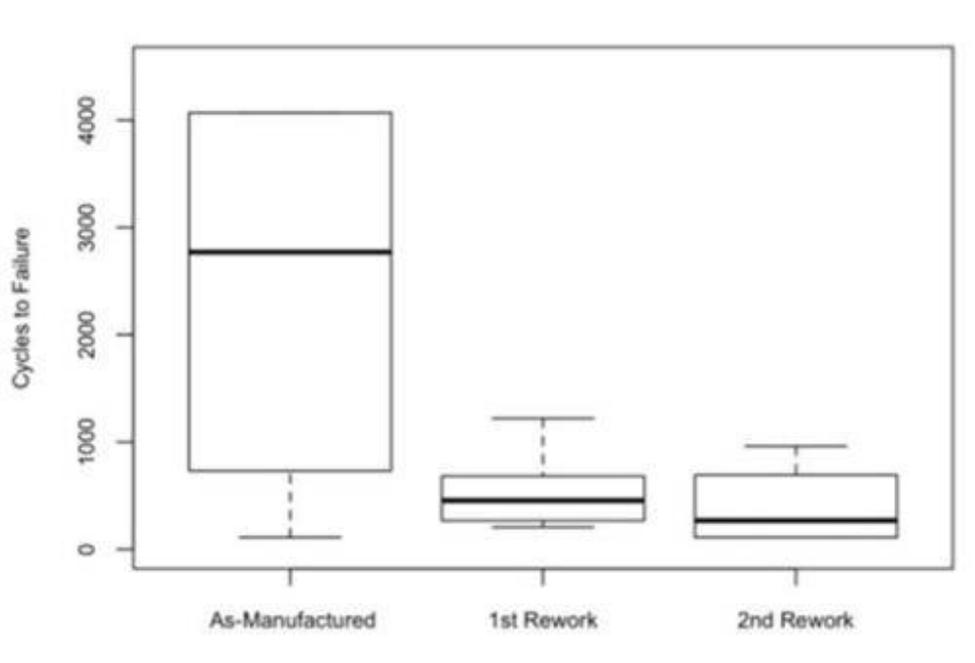
Figure 199 - Box and whisker plot comparing thermal cycles to failure for Sn finished PDIP's originally soldered with SN100C and reworked 1 or 2 times with Sn finished PDIP's soldered with eutectic SnPb. The decrease in cycles to failure for both reworks was considered statistically significant.

Overall, it is difficult to determine the true effect of reworking PDIP's on the thermal cycles to failure. There is a significant decrease in cycles to failure for reworked PDIP's compared to the as-manufactured PDIP's. However, a production issue affecting reworked PDIPS's convoluted the results. Further testing is required to determine the effect of rework on PDIP's.

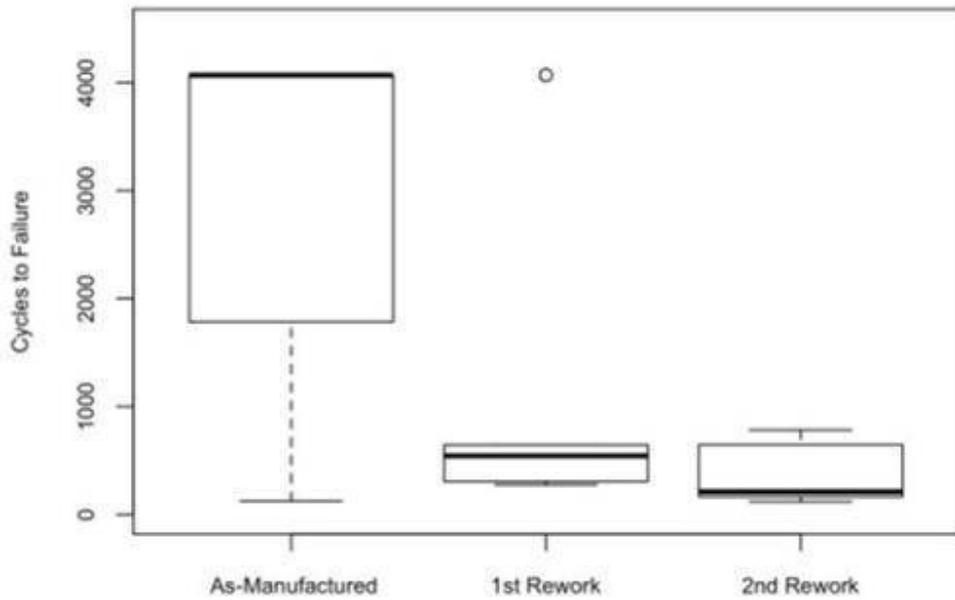
Figure 200 - Box and whisker plot comparing thermal cycles to failure for NiPdAu finished PDIP's originally soldered with SN100C and reworked 1 or 2 times with Sn finished PDIP's soldered with eutectic SnPb. The decrease in cycles to failure for the second rework was considered statistically significant.

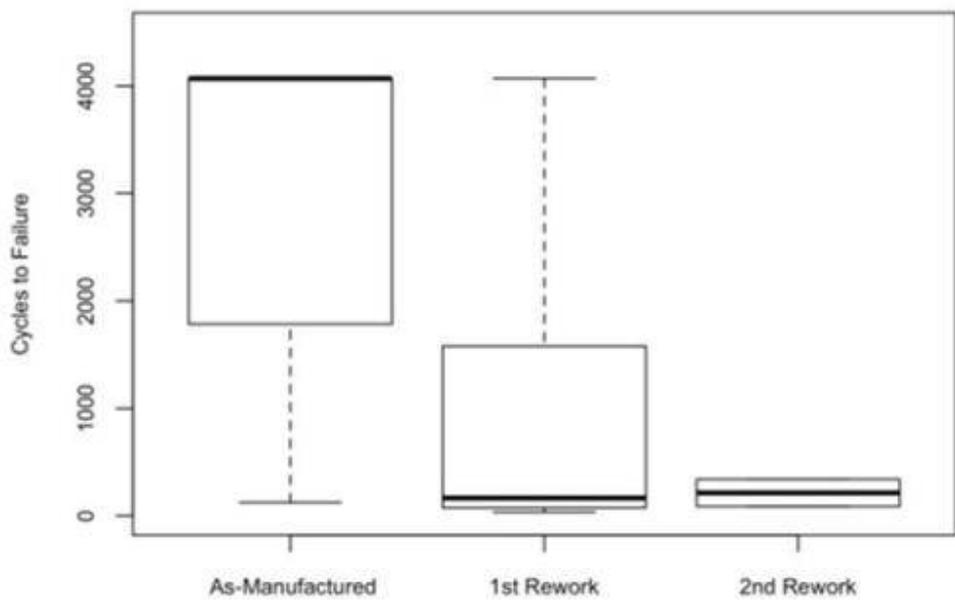
Figure 201 - Box and whisker plot comparing thermal cycles to failure for NiPdAu finished PDIP's originally soldered with SN100C and reworked 1 or 2 times with NiPdAu finished PDIP's soldered with eutectic SnPb. The decrease in cycles to failure for the second rework was considered statistically significant.

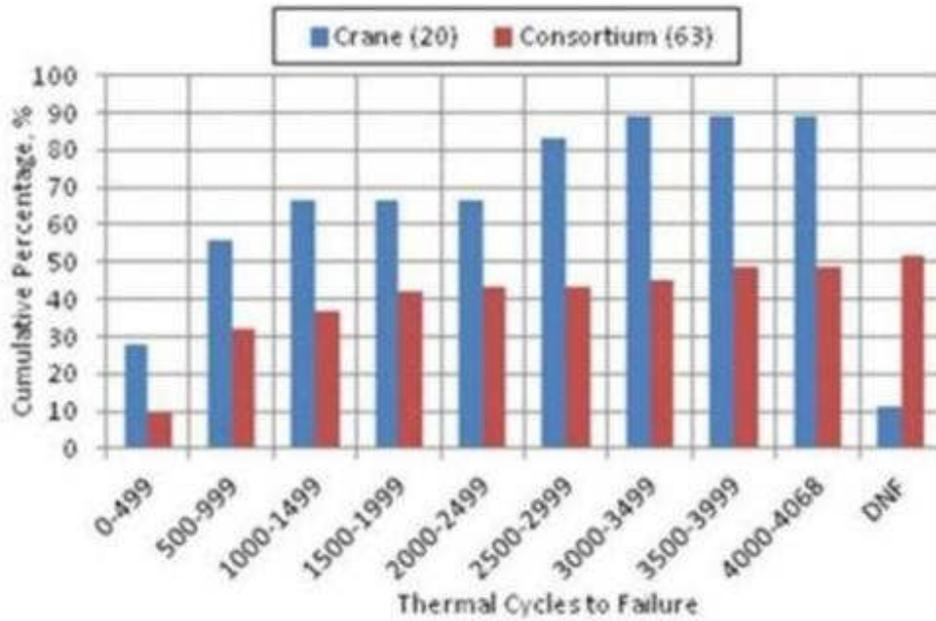
All reworked PDIP's came from batches F and I. As previously discussed in section 3.1, a production issue resulted in PDIP's from both of these batches and batch G being less reliable than PDIP's from batches A, B, C, and E. The increased rate of failure is illustrated in Figure 202 and Figure 203 and shown in Table 35. This production issue convolutes the meaning of both the percent of components that failed during testing, shown in Table 33 and the p-values, shown in Table 34.

Figure 202 - Cumulative Percentage of failures for as-manufactured Sn finished PDIP's soldered with SN100C showing a faster rate of failure and higher overall rate of failure for PDIP's on Crane test vehicles vs. other test vehicles in the consortium. There were 20 Crane specific PDIPs vs. 63 general to the consortium.

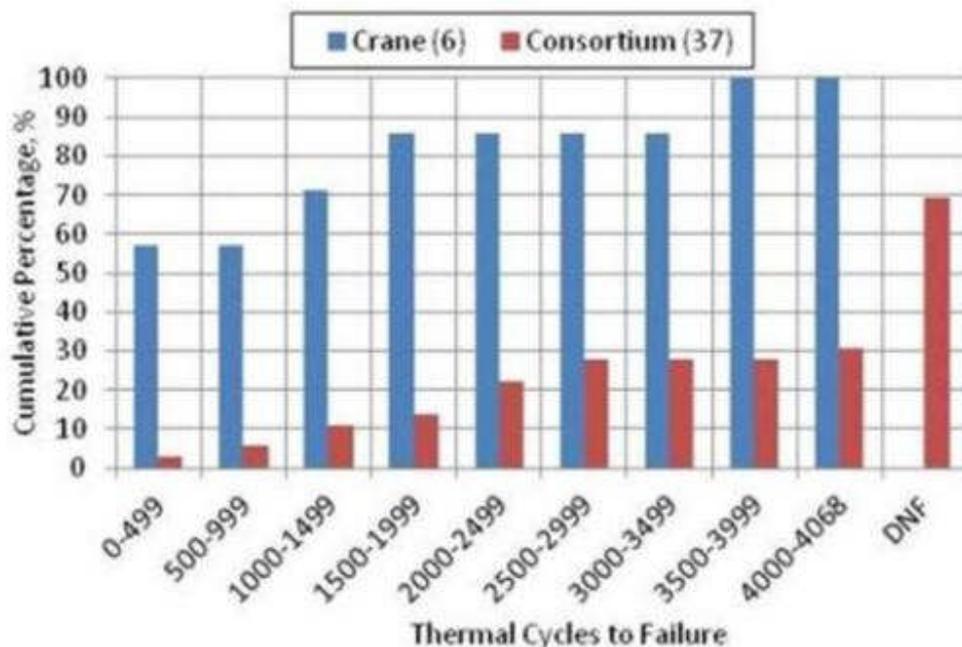
Figure 203 - Cumulative Percentage of failures for as-manufactured NiPdAu finished PDIP's soldered with SN100C showing a faster rate of failure and higher overall rate of failure for PDIP's on Crane test vehicles vs. other test vehicles in the consortium. There were 6 Crane specific PDIPs vs. 37 general to the consortium.

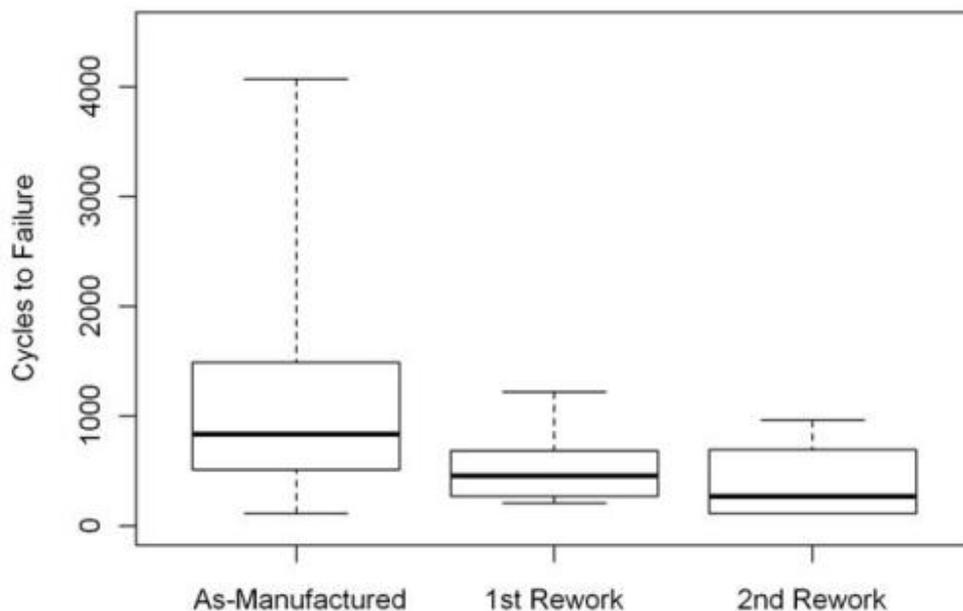
A repeat analysis of the PDIP cycles to failure was performed, only considering PDIP's from batches F, G, and I. All differences that were previously statistically significant were still determined to be statistically significant. However, the average cycles to failure for Sn finished PDIP's soldered with SN100C decreased from 2398 cycles to 1228 cycles; the average cycles to failure for NiPdAu finished PDIP's soldered with SN100C decreased from 3027 cycles to 2120 cycles. An example of the change in the box and whisker plot for Sn finished PDIP's soldered with SN100C is shown in Figure 204; and example of the change in the box and whisker plot for NiPdAu finished PDIP's soldered with SN100C is shown in Figure 205.

Figure 204 - Recreated box and whisker plot comparing thermal cycles to failure for Sn finished PDIP's originally soldered with SN100C and reworked 1 or 2 times with Sn finished PDIP's soldered with eutectic SnPb showing the effect of only considering times to failure from batches F, G, and I.

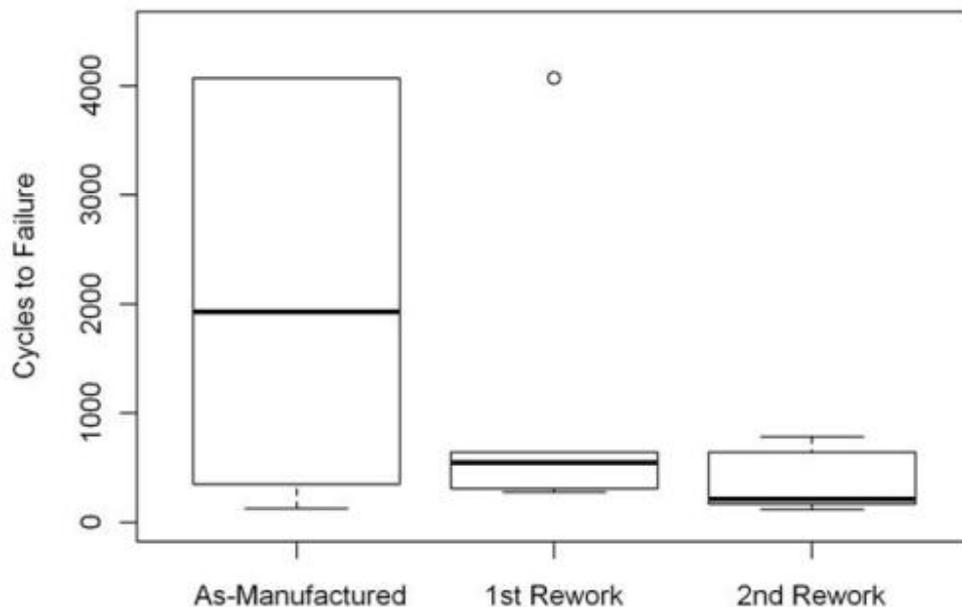
Figure 205 - Recreated box and whisker plot comparing thermal cycles to failure for NiPdAu finished PDIP's originally soldered with SN100C and reworked 1 or 2 times with Sn finished PDIP's soldered with eutectic SnPb showing the effect of only considering times to failure from batches F, G, and I.
