**Technology Evaluation for Environmental Risk
Mitigation Principal Center**

NASA-DoD Lead-Free Electronics Project

Joint Test Report - Final

December 2011

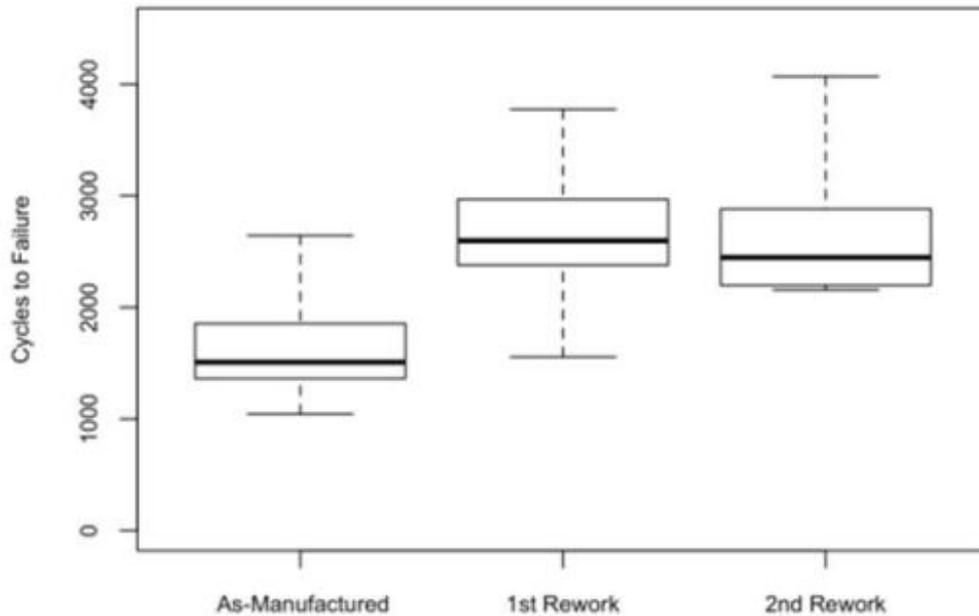
Both rework scenarios resulted in reworked TQFP's with a statistically significant increase in thermal cycles to failure comparable to the as-manufactured TQFP's. Reworking Sn finished TQFP's originally soldered with SAC305 resulted in an increase in cycles to failure from 1630 cycles to 2677 cycles after one rework and 2705 cycles after two reworks; reworking Sn finished TQFP's originally soldered with SN100C resulted in an increase in cycles to failure from 1634 cycles to 2436 cycles after one rework and 2697 cycles after two reworks. The p-values, shown in Table 34, were all less than 0.05. The percentages of components that failed during testing, shown in Table 33, were all within expected variation.

Figure 206 - Box and whisker plot comparing thermal cycles to failure for Sn finished TQFP's originally soldered with SAC305 and reworked 1 or 2 times with Sn finished TQFP's soldered with eutectic SnPb. The increase in cycles to failure for both reworks was considered statistically significant.

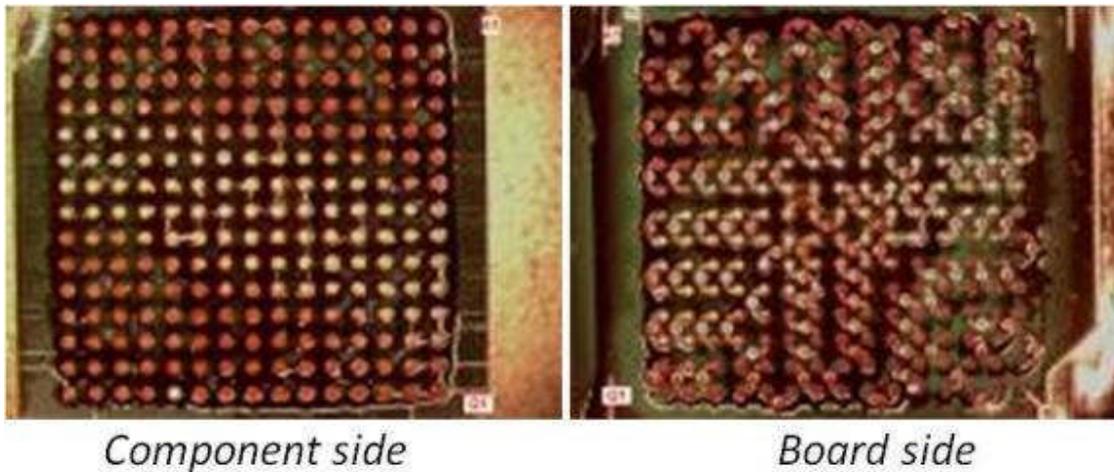
The main focus of the NASA drop test failure analysis was the 225 I/O plastic BGAs. This was because the vast majority of electrical failures on the test vehicle were these larger PBGAs. All CSPs electrically passed drop testing. For the PBGAs there was a wide range in number of drops until failure: 40% failed electrically within less than 6 drops and 99% failed electrically by 20 drops. Less than 1% of non-BGA components electrically failed after 20 drops. Pad cratering was the predominant failure mode for all samples destructively analyzed. Dye-and-pry and cross-sections of failed joints are shown below; Figure 213 and Figure 214.

Figure 213 - Typical Pad Cratering seen on BGA225 after Dye-and-Pry

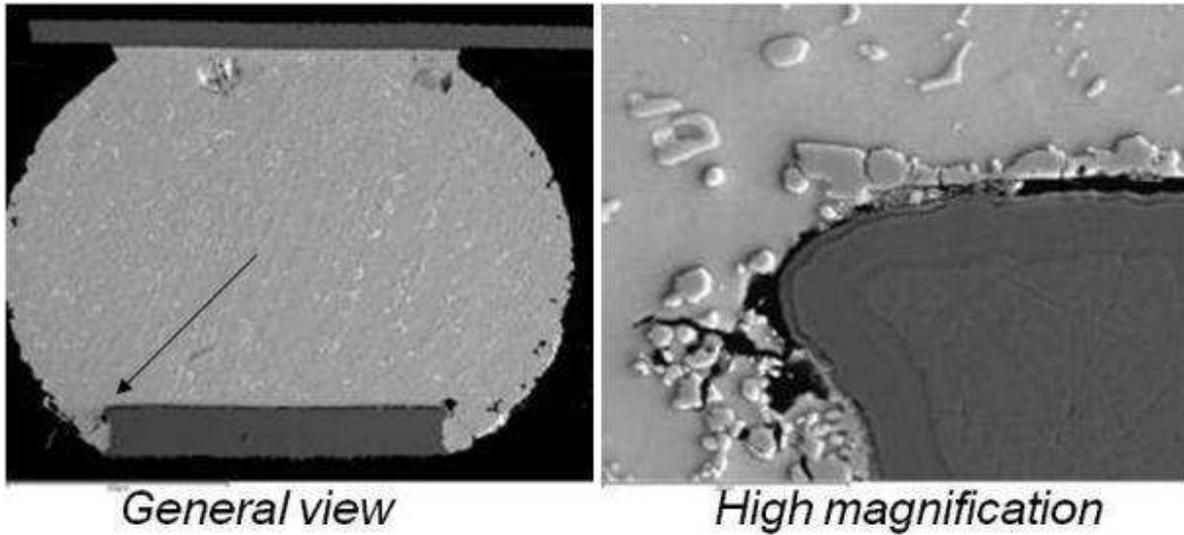
An additional mechanism that caused electrical failure in mixed solder joints was crack propagation through a low melting $\text{Sn}+\text{Pb}+\text{Ag}_3\text{Sn}$ ternary and/or $\text{Sn}+\text{Pb}+\text{Ag}_3\text{Sn} + \text{Cu}_6\text{Sn}_5$ quaternary eutectic accumulation layer at the board or component interface depending on sample history. In as-assembled condition the crack grew between the intermetallic layer and the bulk solder at the board side and after rework the more susceptible location was the interface between the intermetallic layer and the bulk solder at the component side; Figure 215. For the ENIG finished boards the predominant failure modes were brittle intermetallic cracking on both board and component sides.

Figure 215 - SEM of Brittle Intermetallic Failure on BGA225

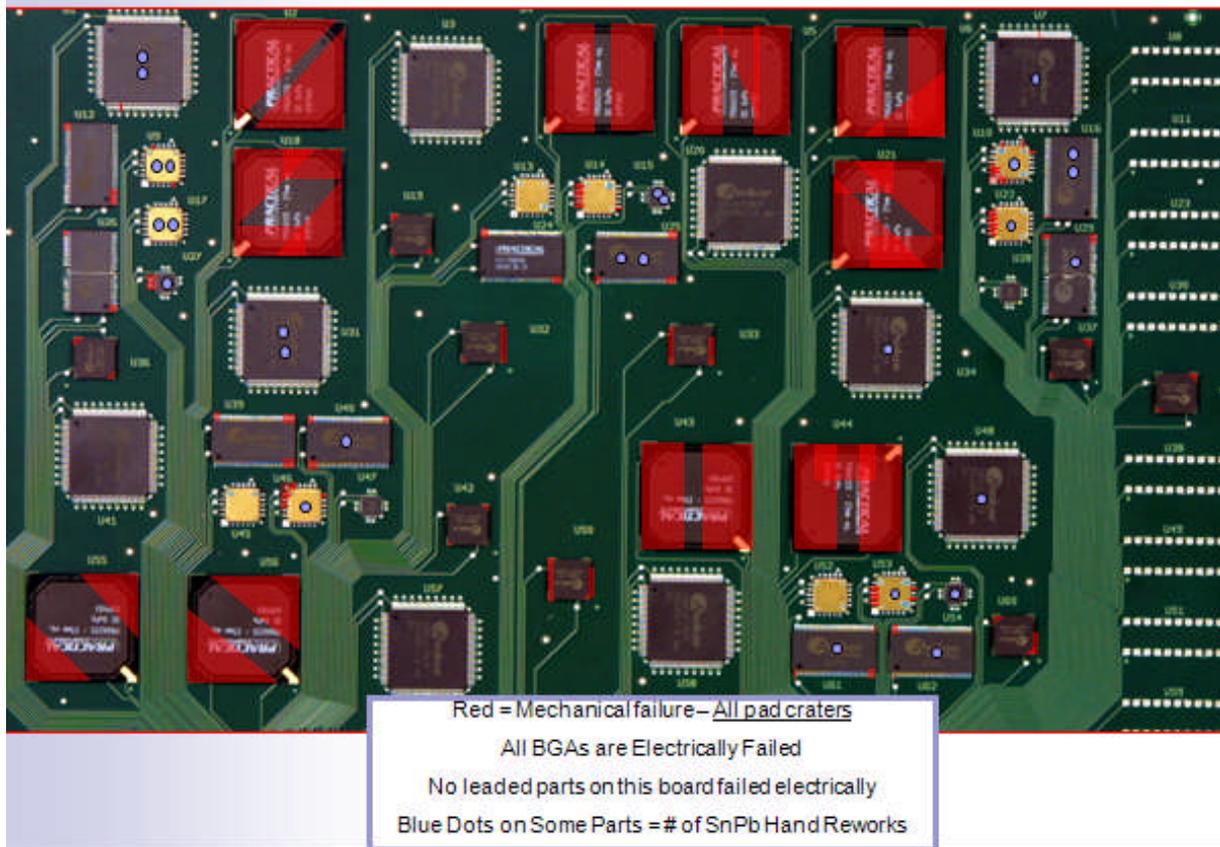
One of the cards tested, which had no electrically failing leaded parts, was chosen for dye & pry of all 63 parts in order to map the mechanical damage. Figure 216 summarizes the mechanical failure (red overlay) of one board after 20 drops at 500G. In-situ electrical data on BGAs showed that some PBGAs failed after as little as 5 drops – this implies that mechanical failure may have occurred after even fewer drops. Interesting to note that the board was held by posts in the 4 corners and as such the strain is not symmetrical across the card.

Figure 216 – Mechanical Failure Mapping

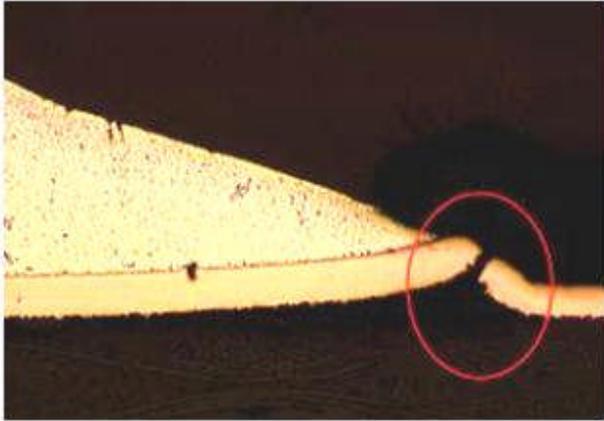
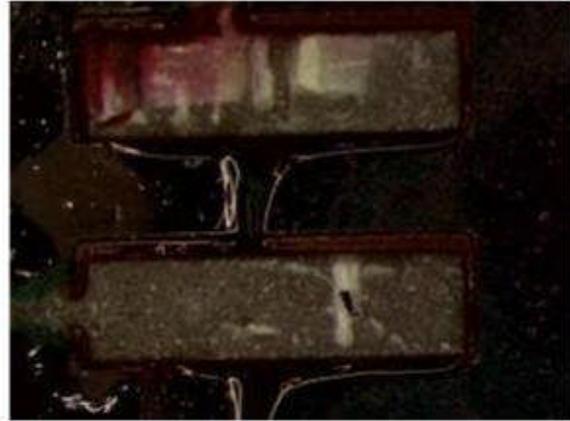
Pad cratering was the predominant failure mechanism in all components, as observed through both dye-and-pry and cross sectioning; Figure 217. In two cases the pad cratering was significant enough to break the trace and cause an electrical failure. However in most cases the trace remained intact and therefore no electrical failure was detected.

Figure 217 - Pad Cratering seen on CLCC-20

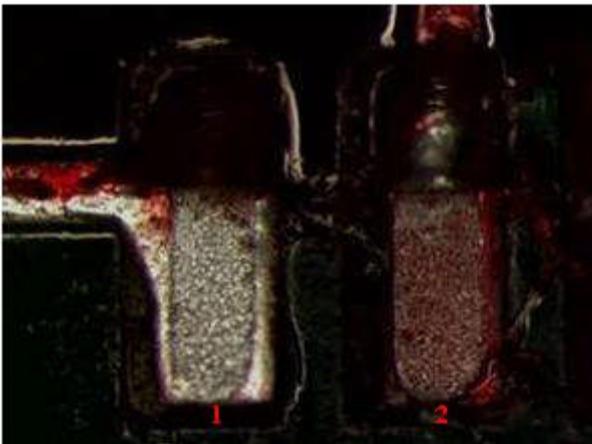
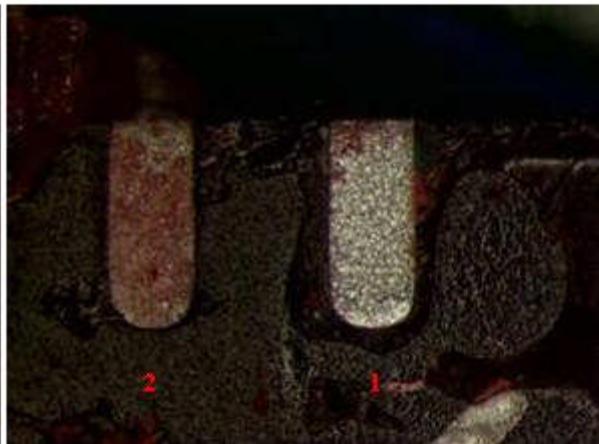
A small number of the analyzed solder joints had signs of solder fracture; however only in one case did this lead to an electrical failure; Figure 218. This indicates that, for the most part, the solder fractures did not penetrate through the entire solder joint.

Figure 218 - Dye and Pry of a QFN-20 showing dye penetration through the bulk solder

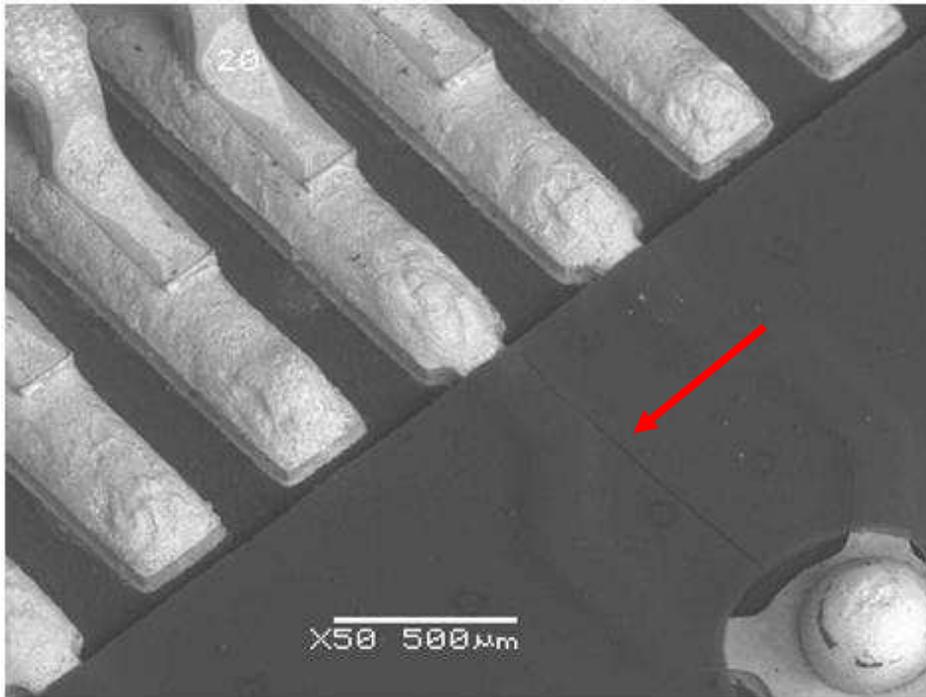
- Solder mask cracking found on test vehicle 21, TQFP components U34 (Figure 220) and U57 (Figure 221).
- Coplanarity issue causing open contacts on test vehicle 21, TQFP components U34 (Figure 222) and U57 (Figure 223).

Figure 220 - U34 TQFP, SEM Image, Solder Mask Crack near Lead 20 (X50)

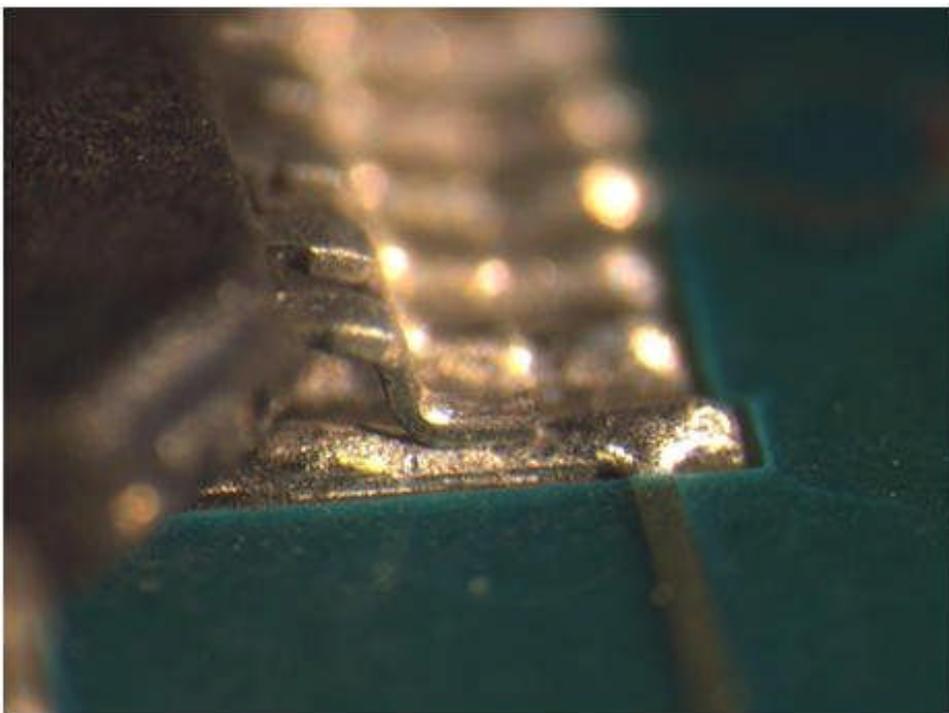
Figure 223 - U57 TQFP, No Solder Contact to Lead 1 (X49); Open due to Non Coplanarity

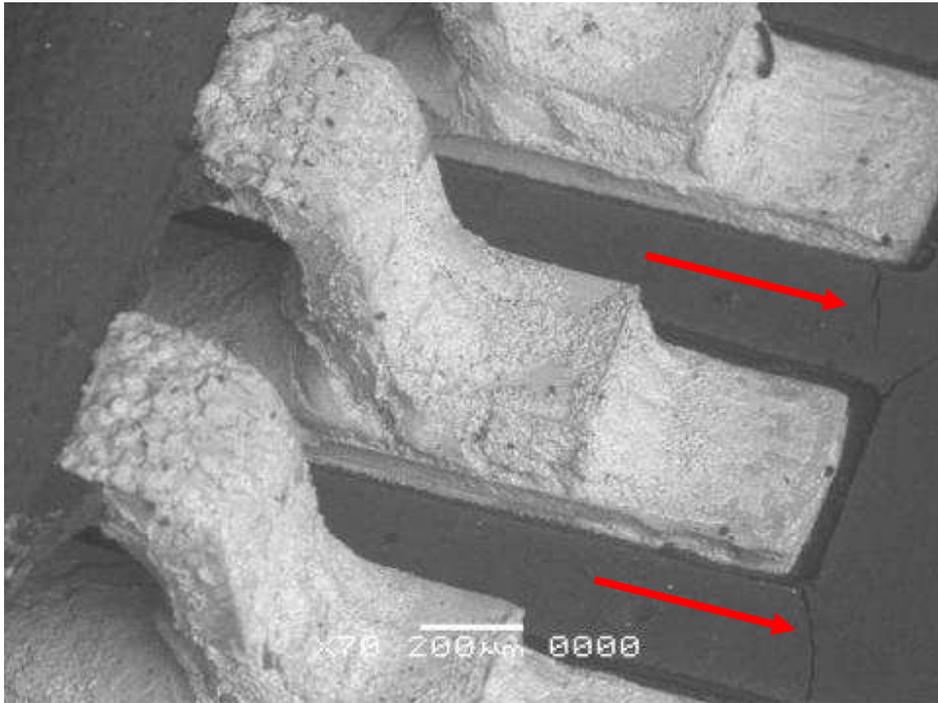
- Solder mask cracking found on test vehicle 119, TSOP component U39 (Figure 224).
- Solder mask cracking found on test vehicle 181, TSOP component U25 (Figure 225).
- Voids in solder joints, test vehicle 119, TSOP component U39 (Figure 226)
- Solder in the upper bend area of test vehicle 119, TSOP component U39 (Figure 227) and test vehicle 181, TSOP component U25 (Figure 228).
- Presence of Pb phase in the vicinity and along the cracks on both parts; test vehicle 119, TSOP component U39 and test vehicle 181, TSOP component U25.

Figure 225 - U25 TSOP, SEM Image, Lead 2 in Center, Lead 1 Left (X70)

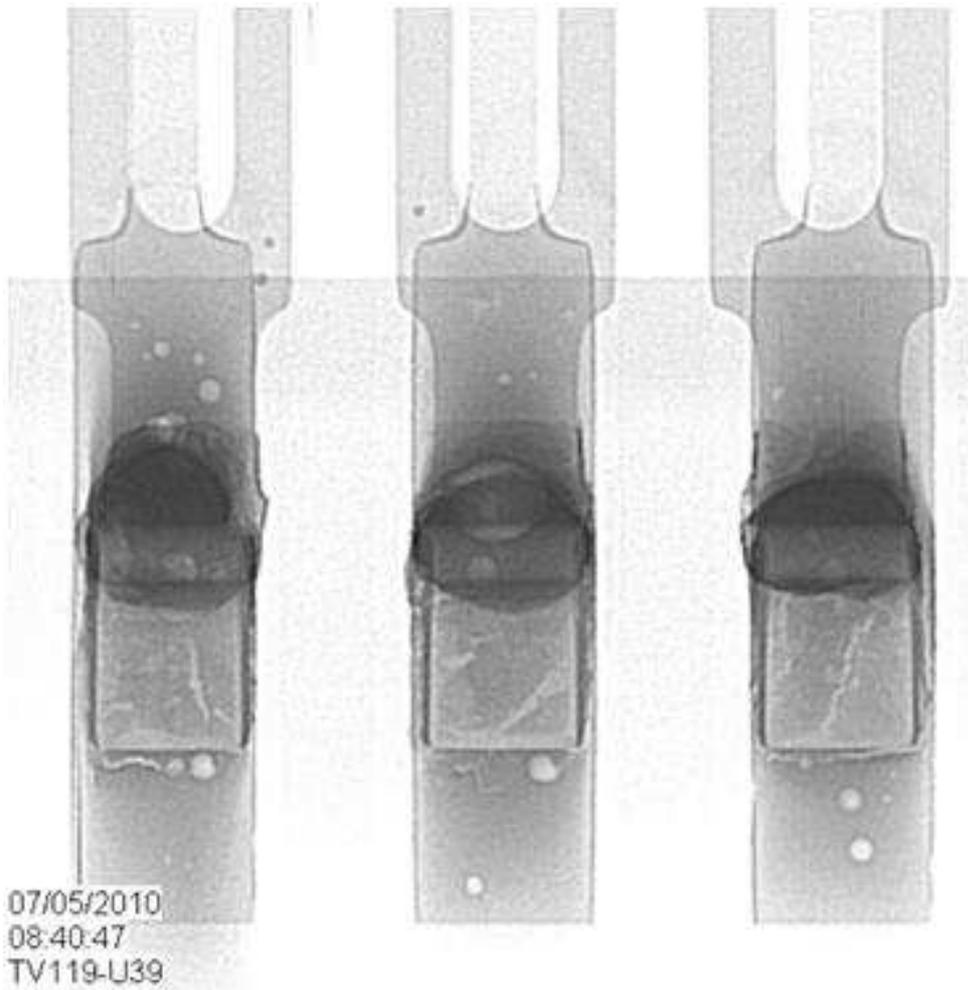
Figure 226 - U39 TSOP, X-ray Image, Leads 1-3, Voids in Solder Joints

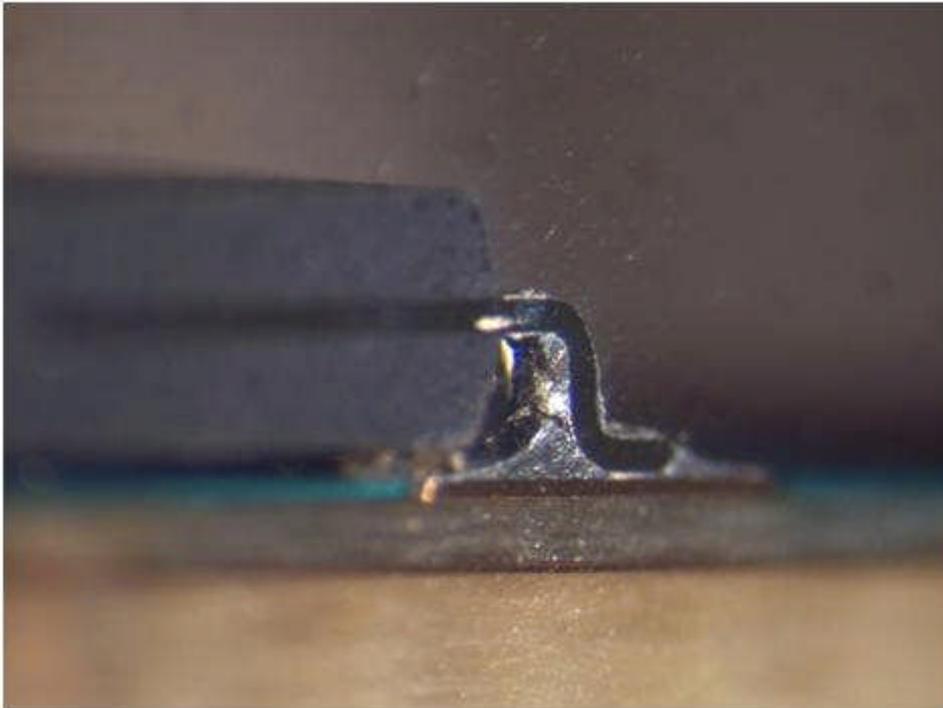
Figure 227 – U39 TSOP, Cross Sectional View of Lead 1, Solder (X49)

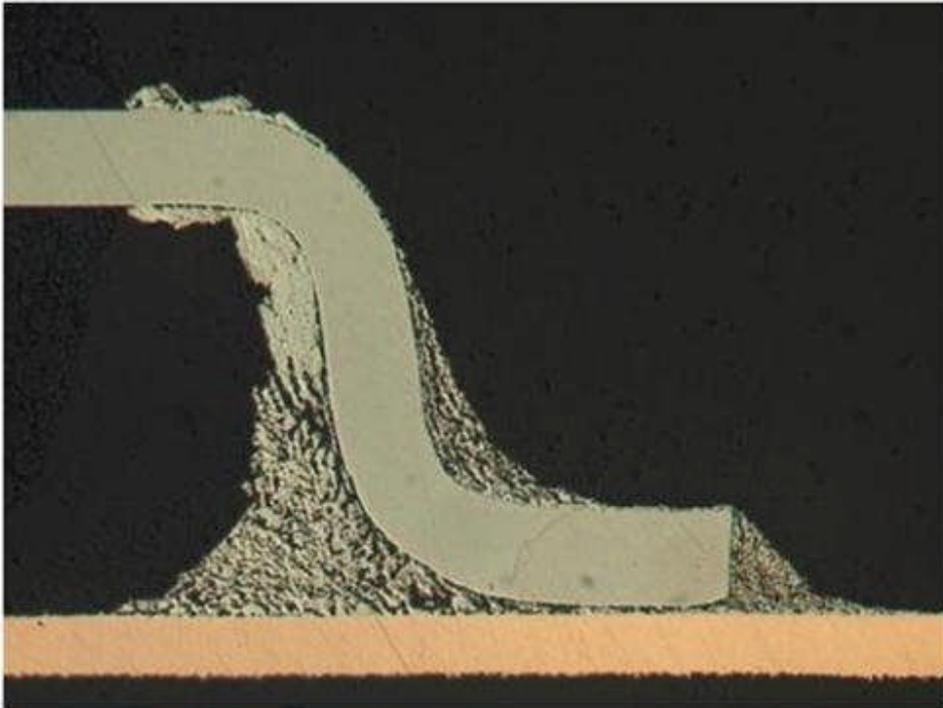
Figure 228 – U25 TSOP, Cross Sectional View of Lead 2, Solder (X136)

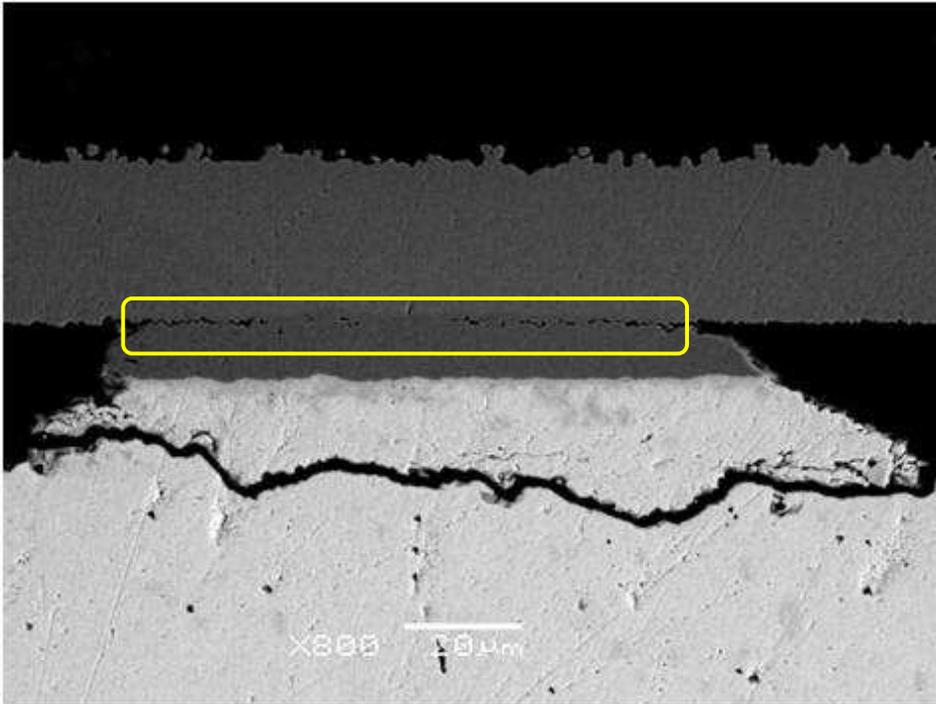
- Solder mask cracking found on test vehicle 119, CSP component U36 (Figure 229).
- Cracks developed at SnCu phase, PCB interface; test vehicle 119, CSP component U36 (Figure 230).
- Cracks developed at Sn rich phase adjacent to Ni barrier; test vehicle 119, CSP component U36 (Figure 231).

Figure 231 - U36 CSP, SEM image of Ball A2, Component Side (X800)

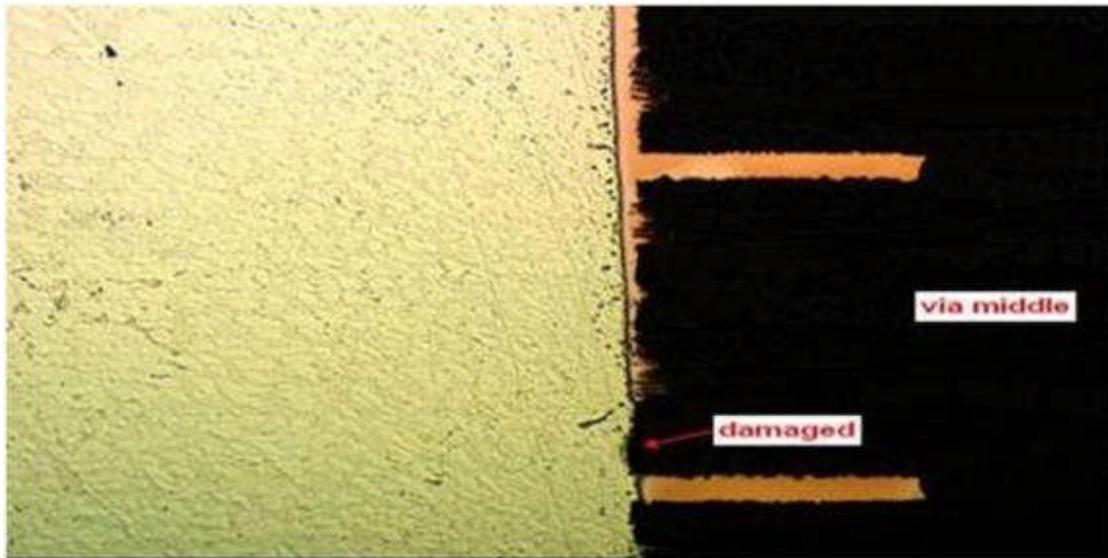
Figure 253 shows a trace that is disconnected from the PTH barrel and therefore represents a board defect resulting from excessive copper dissolution. DfX rules could redirect the location of these signal connections within the barrel towards the upper layers to minimize the risk of an interconnection failure in the product. Figure 254 illustrates a 0.036" PTH that was subjected to a total of 240 seconds of wave solder exposure. The PTH copper has been completely dissolved in the wave soldering process to nearly 30% of the plated-through-hole copper height.

Figure 253 - Damage example – PTH trace disconnected from PTH barrel

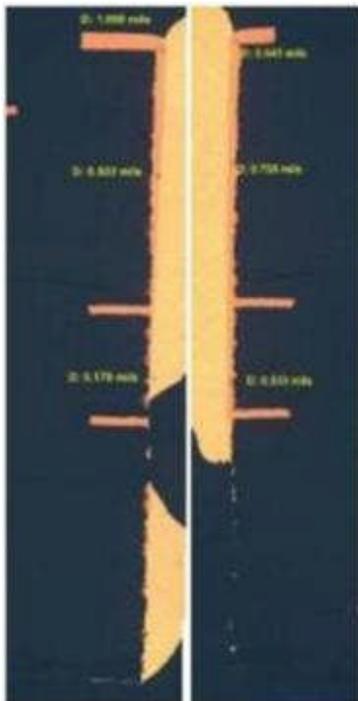
Figure 254 - SN100C Cross-section of 0.036" PTH with 240 Seconds Exposure

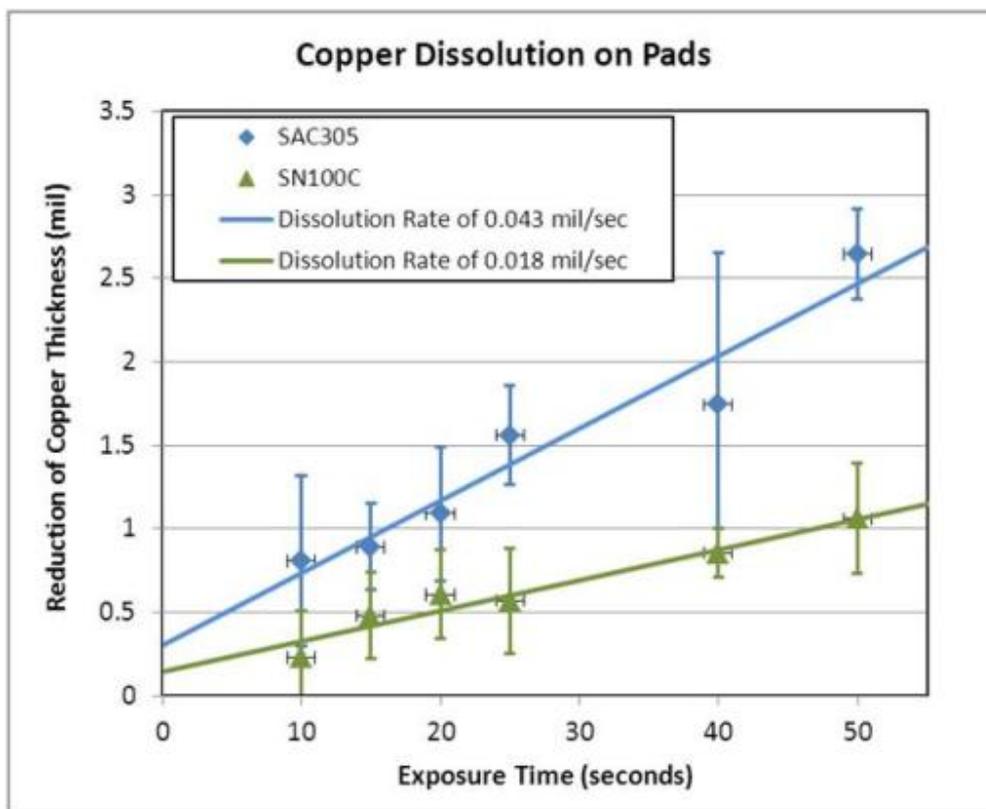
Figure 256 - SAC305 and SN100C Copper Dissolution Results for SMT QFP

Figure 256 illustrates the differences in copper dissolution rates for the SAC305 and SN100C alloys for the SMT QFP pad feature. The results shown in Figure 256 are in good agreement with the industry literature, with the SAC305 solder alloy having a higher copper dissolution rate than the SN100C solder alloy.

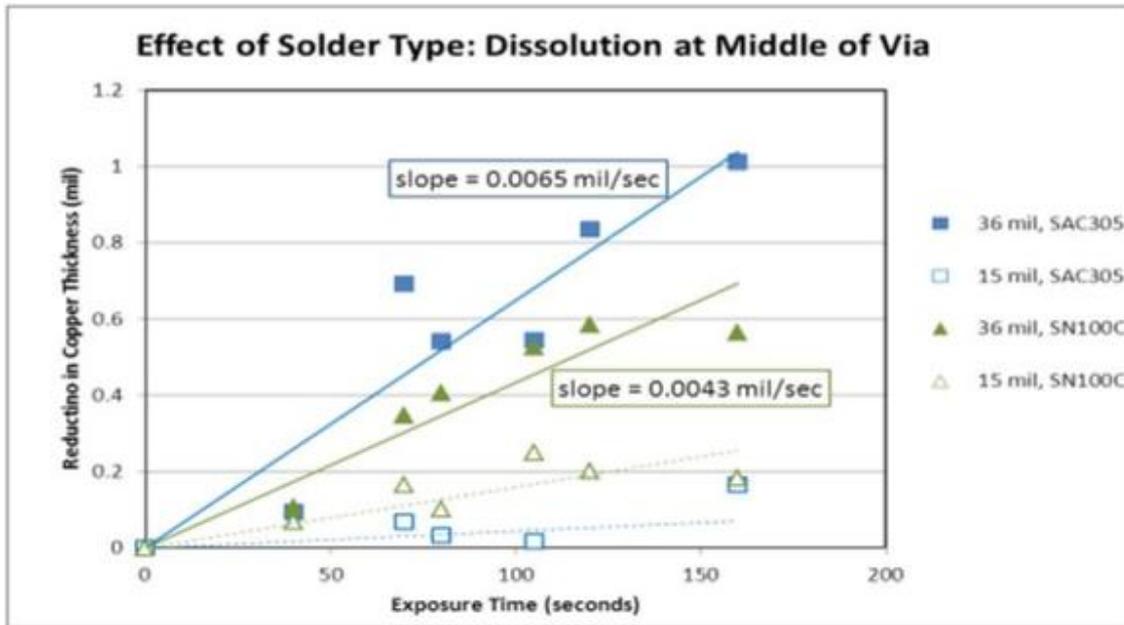
Figure 257 - SAC305 and SN100C Copper Dissolution Results for PTH DIP at Middle Via Measurement Location

Figure 257 illustrates the differences in copper dissolution rates for the SAC305 and SN100C alloys for the PTH DIP via feature. This figure shows the rates of copper dissolution of the midpoint of the 36 mil and 15 mil vias for both types of solder alloys tested. Similarly to the SMT QFP pad results, the SAC305 solder alloy has a higher copper dissolution rate than the SN100C solder alloy for the 36 mil via size. The influence of the plated through via feature is illustrated in Figure 257 as the copper dissolution rates for the SAC305 and SN100C alloys are very similar for the 15 mil via size. The geometry of the 15 mil via reduces the molten solder contact exposure, which reduces the effective copper dissolution rates. This influence of the plated through via size can be potentially be used as a design advantage for copper dissolution concerns dependent upon necessary via functionality. For lead-free alloys, it has been shown that larger hole to pin ratios are required (12). This larger hole requirement to enhance the via fill and resulting solder joint is inversely related to the copper dissolution interaction. Design considerations for lead-free products must take into account and balance the risks between copper dissolution and PTH solder hole fill.

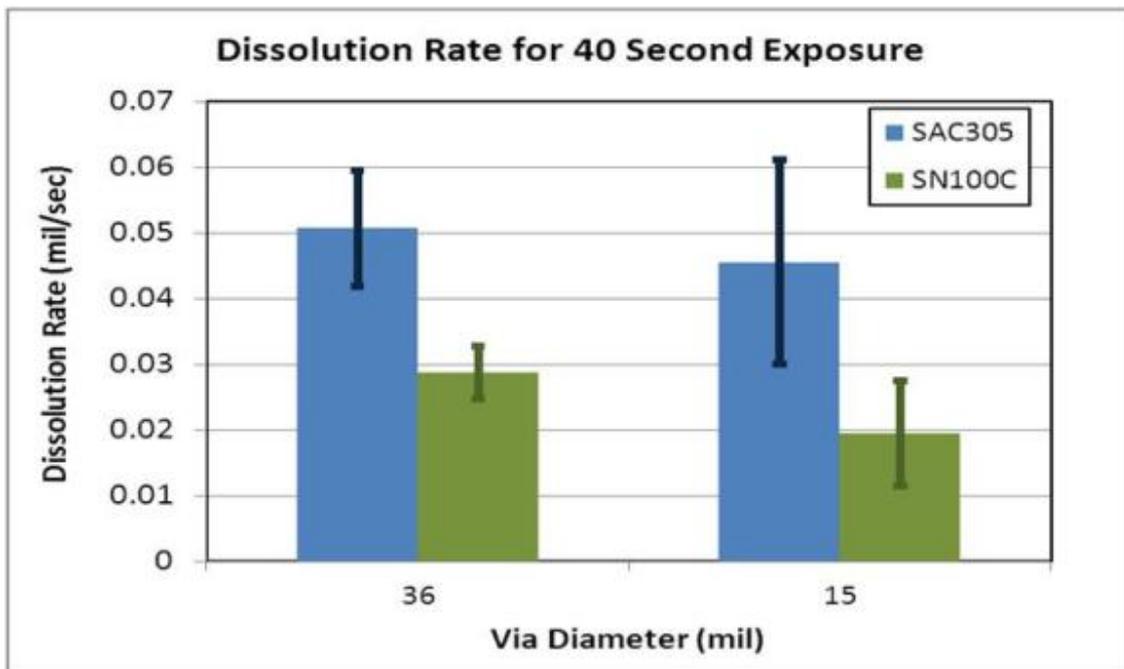
Figure 258 - SAC305 and SN100C Copper Dissolution Rate Comparison for 40 Second Exposure

Figure 258 illustrates the slight differences in the average copper dissolution rates between the 36 mil and 15 mil via sizes for both solders that were evaluated. The error bars on this figure represent one standard deviation of the data.

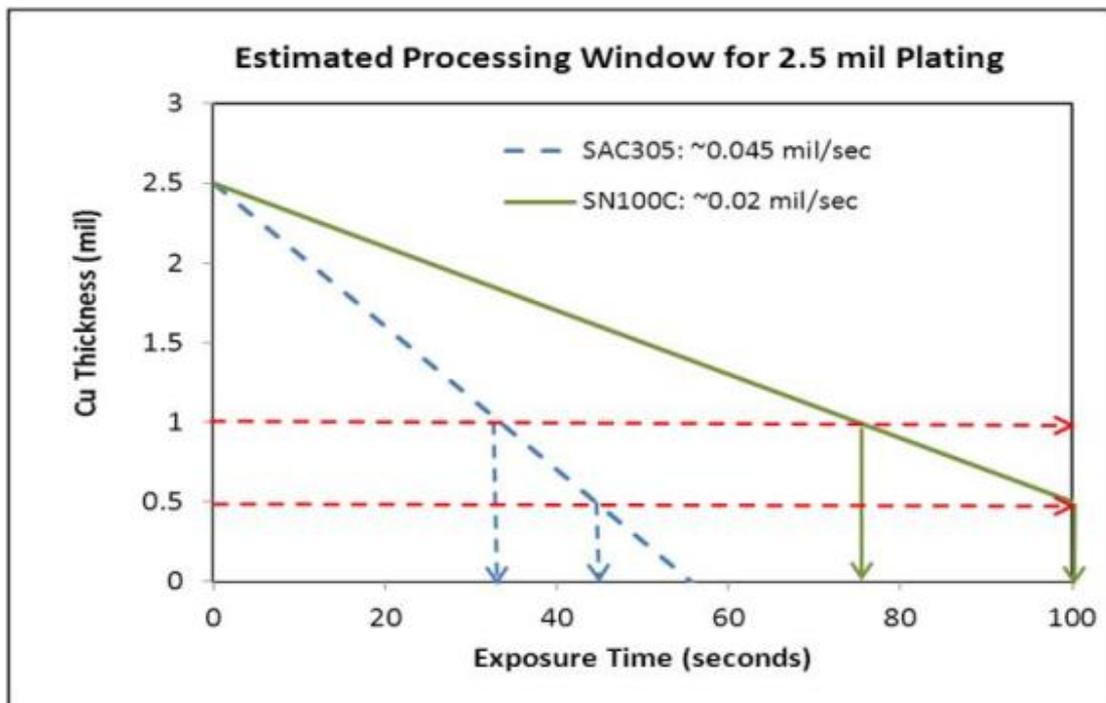
Figure 259 - Mini Wave Soldering Processing Window Estimation

Since the dissolution of a plated through via knee is not readily detectible using typical assembly product stress screening, strict assembly process control limits are necessary to yield acceptable product reliability. Figure 259 shows soldering process windows for the SAC305 and SN100C solder alloys for two classes of electronic products. The dissolution rates used to define the process window values correlate to the test results plotted in Figure 258. The minimum copper plating thickness required for Class 3 products is 1 mil and for Class 2 products is 0.5 mils.

Based on the investigation data, the Figure 259 graph shows that the acceptable process window, i.e. cumulative wave solder exposure time is:

- ~77 seconds for SN100C and ~35 seconds for SAC305 in Class 3 products
- ~100 seconds for SN100C and ~44 seconds for SAC305 in Class 2 products

The selection of a particular lead-free soldering alloy significantly impacts the allowable assembly process window. Some product designs that had adequate process windows using tin/lead solder would be impossible to process using some lead-free solder alloys, since the time required to remove and replace a component would result in copper plating thickness falling below the required Class 2 or 3 minimum values.

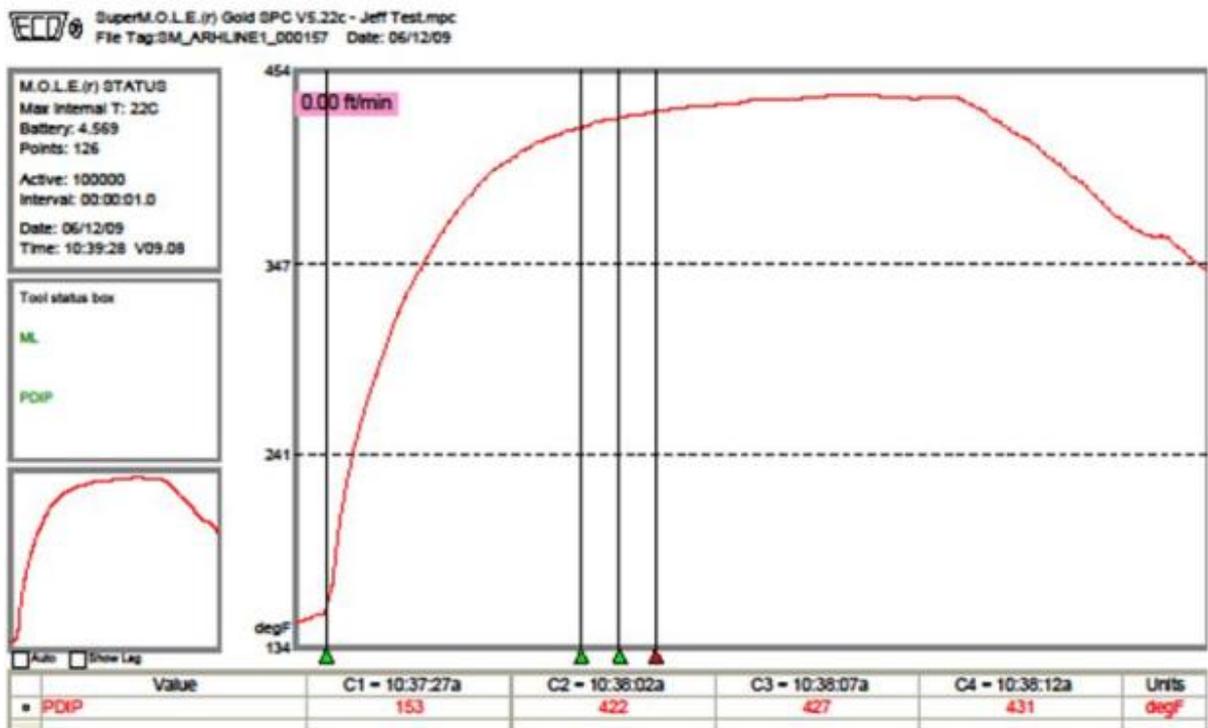
Figure 260 - Rework Temperature Profile

The profile in Figure 260 shows how the hole typically heats up during the mini-pot wave rework cycle/exposure. This data shows that it requires 25 to 30 seconds for the top of the hole to reach the melting point.

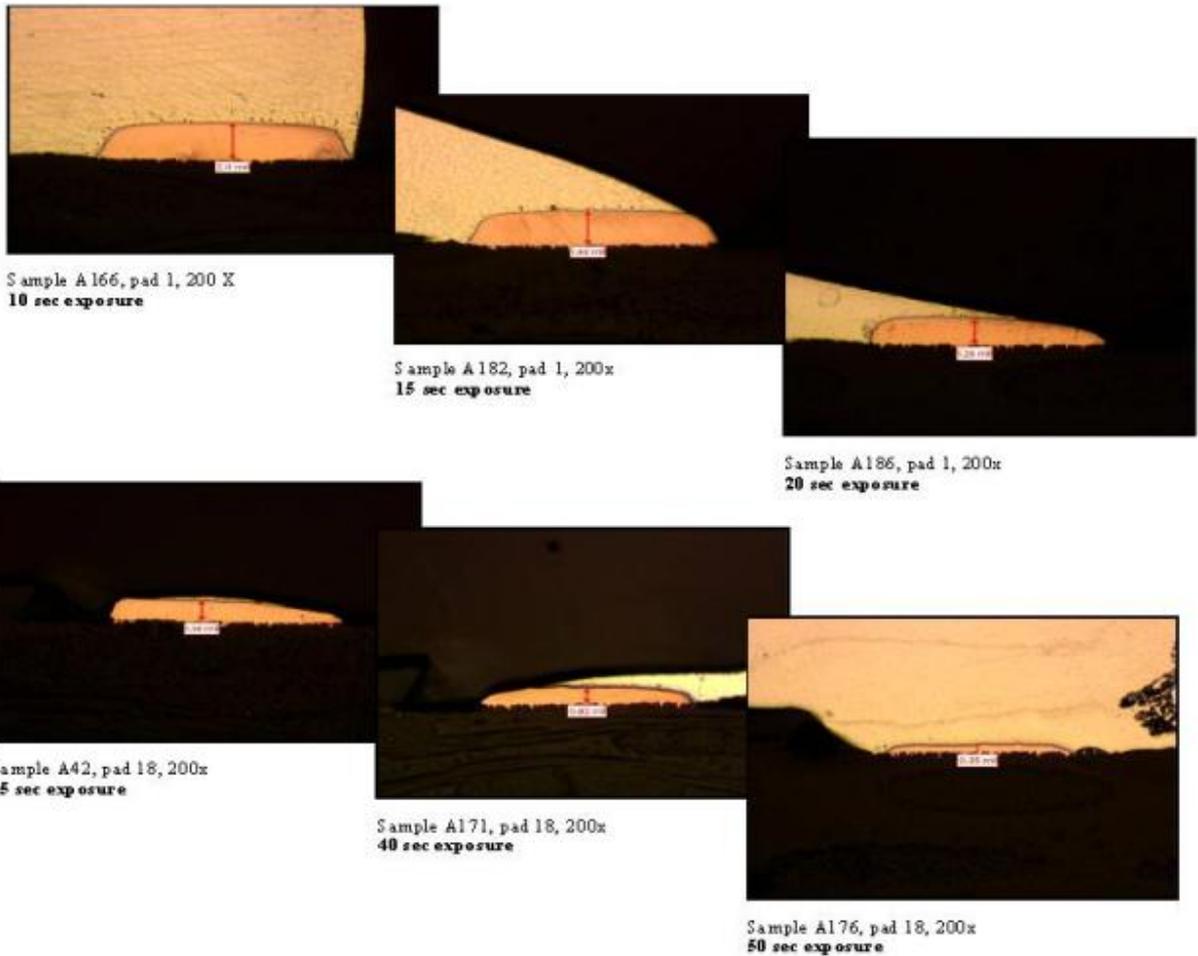
Figure 262 - Sequence of Pad Copper Dissolution by Exposure Time

Figure 262 shows the sequence of pad foil copper dissolution over a period of time. The slope, i.e. the copper dissolution rate, was found to be approximately 0.04 mils/second. This is very similar to the rate of copper dissolution determined at the knee of the DIP PTH for SAC305.

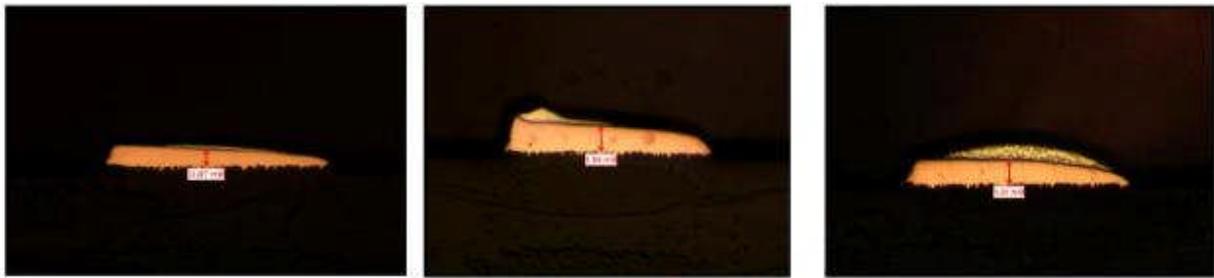
Figure 263 - Illustration of Copper Dissolution Rate Variance for A Specific Exposure Time

Figure 263 shows an example of the copper dissolution variance within a specific exposure time. The dynamic nature of the molten wave as it interacts with the plated through via or surface mount pad results in variation of remaining copper plating thickness, despite using tightly controlled test parameters and procedures. It should be noted that the copper dissolution rate for the SMT pads is not much different that of the PTH. This indicates that foil copper dissolves at nearly the same rate as the plated PTH copper.

Sample A185, pad 9, 200x

Sample A186, pad 9, 200x

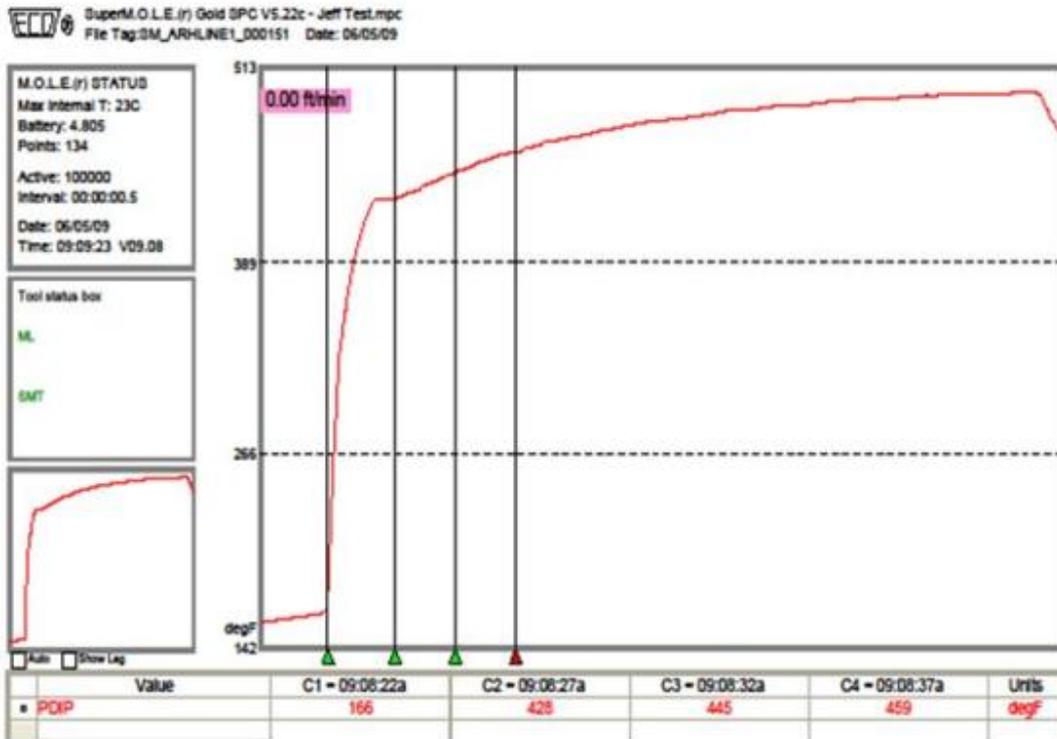
Figure 264 - SMT QFP Pad Thermal Profile

Figure 264 illustrates a temperature profile that shows the SMT QFP pads reaching reflow temperature within 5 seconds. The copper is exposed to molten alloy from the moment of contact, so the effect of the copper dissolution reaction is more damaging than in a plated PTH barrel. Typically, the surface mount pads would start with a lower copper thickness than those of a PTH barrel on the same circuit card assembly (depending on whether it is pattern plated or panel plated) so those features would be more severely impacted if they were in the vicinity of a PTH connection that is exposed to the rework process.

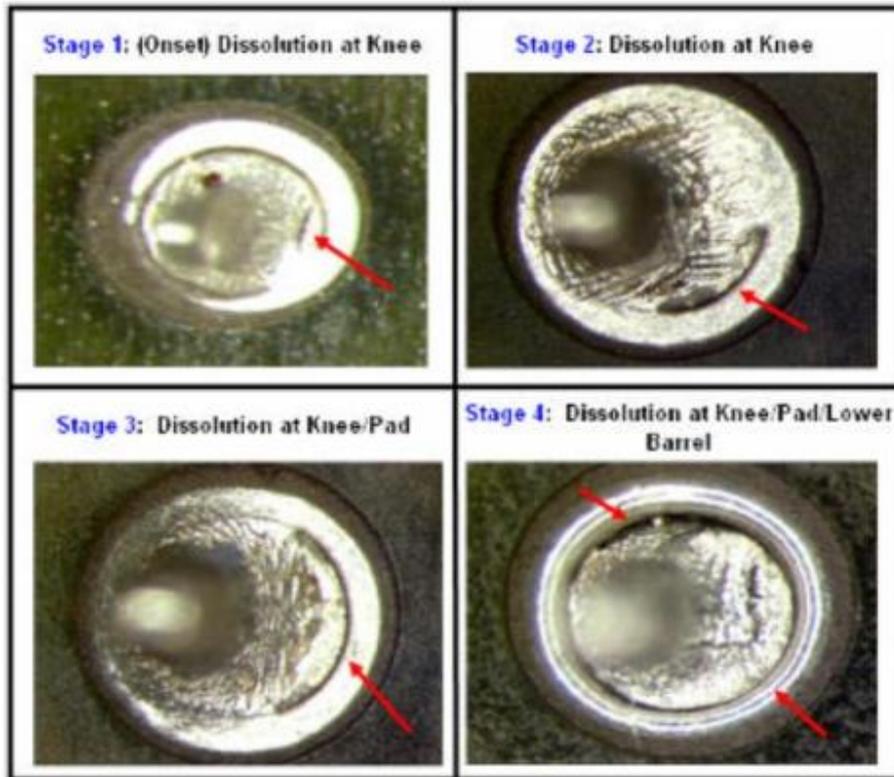
Figure 265 - Visual Indicators of Copper Dissolution(13): Knee- Pad- Barrel for Location of Copper Reduction Sequence

Visual inspection confirmed that the PTH catch pad and the knee of the PTH solder joint were the most susceptible locations for copper dissolution. The rate of copper dissolution is greater at this surface as compared to the inner barrel wall. Fillets at the knee may indicate a discontinuity at the location and may be a visual indicator for possible partial void/disconnection location. These visual indicators, illustrated in Figure 265 can be used by the operator to determine if there is an out-of-control process.

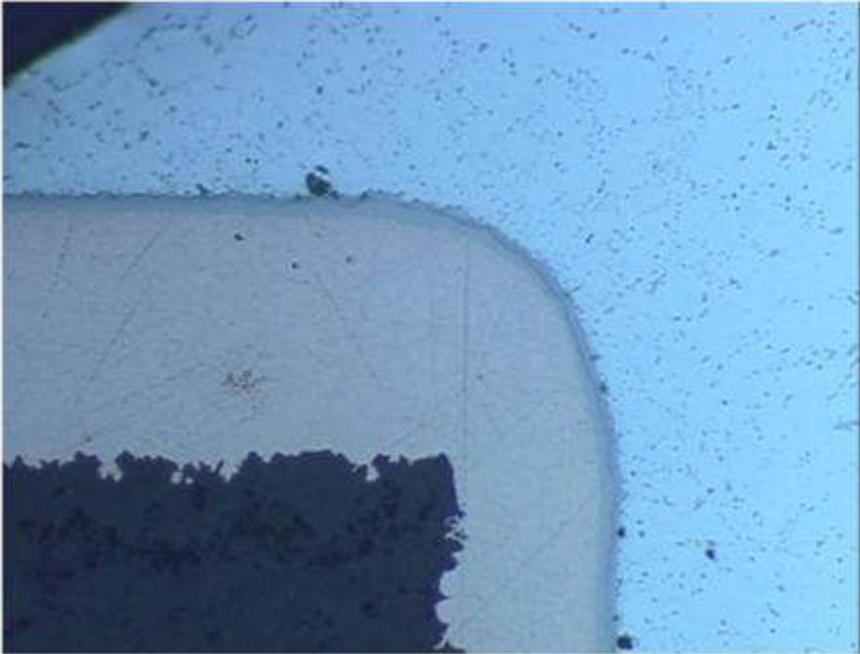
Figure 267 - Impact of PWB Surface Finish on Copper Dissolution; ENIG

- The use of alternative printed wiring board surface finishes
The characteristics of some printed wiring assemblies, such as the number of copper layers and/or how the plated-through-holes are connected, may make lead-free solder alloy rework/repair unachievable. Consideration of, and risk analysis for, the use of alternative printed wiring board surface finish such as electroless nickel/immersion gold (ENIG) that are plated directly on copper with no intermediary plating layer such as nickel may be necessary. Figure 267 and Figure 268 illustrates the difference between two surface finishes. ENIG nickel plating on the left hand side show that the nickel plating protects 0.0015” of copper plating from copper dissolution even after 60 seconds exposure in a SAC305 flowing solder pot. The immersion tin surface finish shown on the right hand side allowed nearly completed dissolution of the copper plating at the knee of the plated-through-hole for the same 60 second exposure time.
