# **Joint Test Report**

## **For Validation of Alternatives to Aliphatic Isocyanate Polyurethanes**

**NASA.PROJ.JTR.AIU.PL.08.31.07.F**

**August 31, 2007**

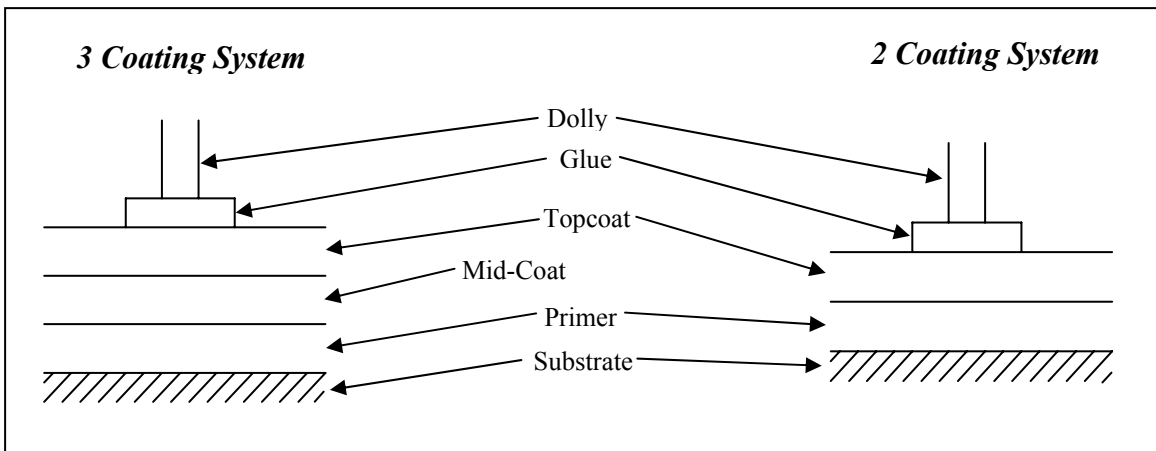
Figure 3-7 Coating System Interfaces

Measurements are limited by the strength of adhesion between the loading fixture and the specimen surface; or the cohesive strengths of the adhesive, coating layers, and substrate. The nature of the failure is reported as percentages of cohesive and adhesive failures of the respective interfaces (Figure 3-7).

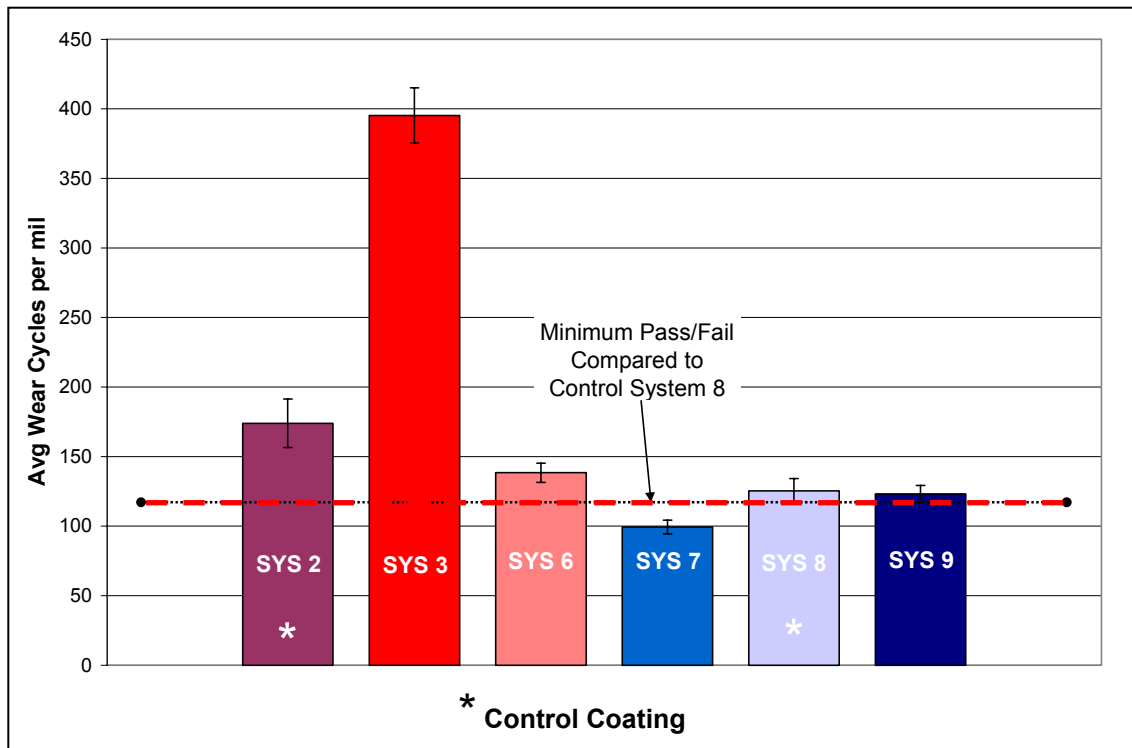
Figure 4-3 Taber Abrasion Wear Cycles per mil

From the data presented in Table 4-6, System -3 was the only coating system that survived the full 1000 cycles, far surpassing Control Systems -2 and -8. Systems -3, -6, and -9 performed equally well or better than Control System -8 (± 1 standard deviation), which was used for the low end pass/fail criteria (Figure 4-3).

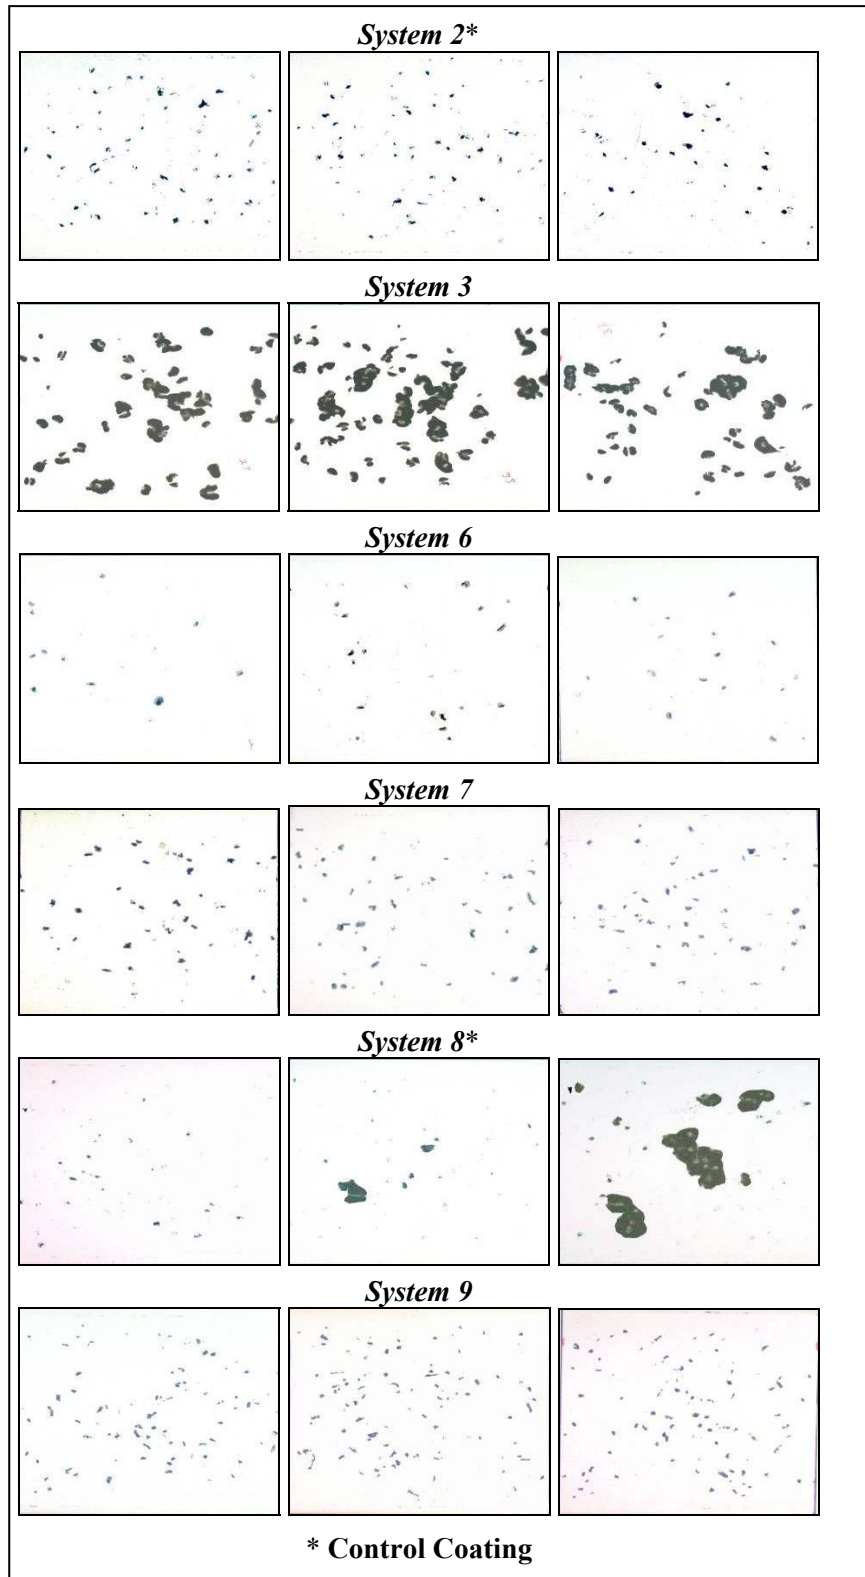
Figure 4-5 Gravelometer Chip Photographs

The resistance to chipping for Systems -3, -6, -7, and -9 was compared to the Control Systems -2 and -8. The coupons were photographed and are presented in Figure 4-5 to give a visual representation of the results. For all systems, adhesion failures predominated with disbondment occurring between the primer and topcoat.

The size and number of failures is noted in Table 4-9. Control System -8 proved to have the least number of chips (10 to 24), but the greatest chip size (>6 mm). A visual comparison indicates that all of the systems performed equal to or better than Control System -2, except for System -3 which experienced larger size chip damage. The photographs and tabulated results show System -6 exhibited the highest degree of performance, sustaining the smallest and fewest chipped regions.

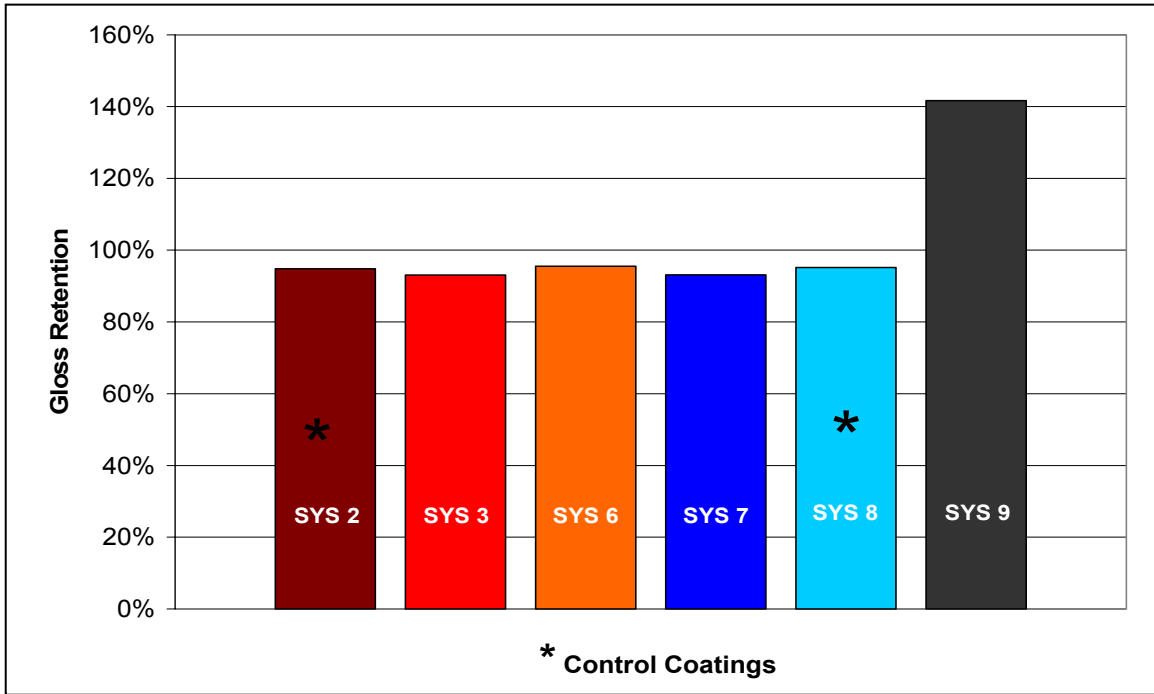
**Figure 4-8 Gloss Retention of Accelerated Weathering Coatings – 1000 hour Exposure**

Figure 4-8 shows the final gloss retention as a percentage of the initial GU measurements.

As indicated by the gloss retention values in Figure 4-7, accelerated weathering impacted gloss retention values on Systems -3, -6 and -7; in a manner similar to Control Systems -2 and -8. Calculated values of gloss retention ranged from 93.0% – 95.5%. The gloss retention for System -9 was the single exception to this trend, exhibiting a value of 141.7%. This behavior is inconsistent with the trend of decreasing gloss retention as a function of time at the KSC Beach Corrosion Test Site. The difference is understandable, however, considering that the panels at the beach were subject to much more corrosive conditions. As a result, the beach site panels showed a significant increase in corrosion products that had an obvious effect on the gloss readings.

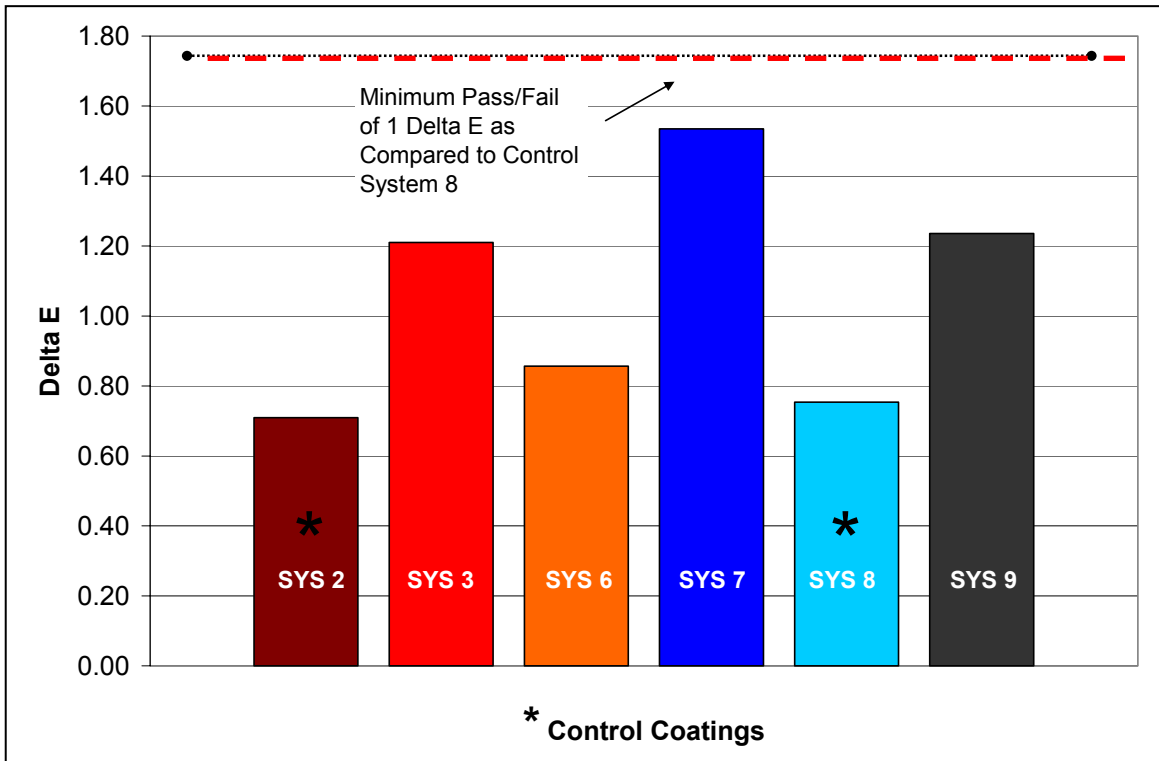
Figure 4-9 Delta E Color Difference – 1000 hour Exposure

As shown in Figure 4-9, all coating systems performed within 1 delta E of Control System -8. As a consequence, while all systems produced a very slight variation in color at the 1000 hour mark, no delta E values were exhibited by the candidate coatings that are indicative of a noticeably increased change in color as compared to Control System -8. In other words, no system changed by a degree which was noticeably different from the degree of change for Control System -8.

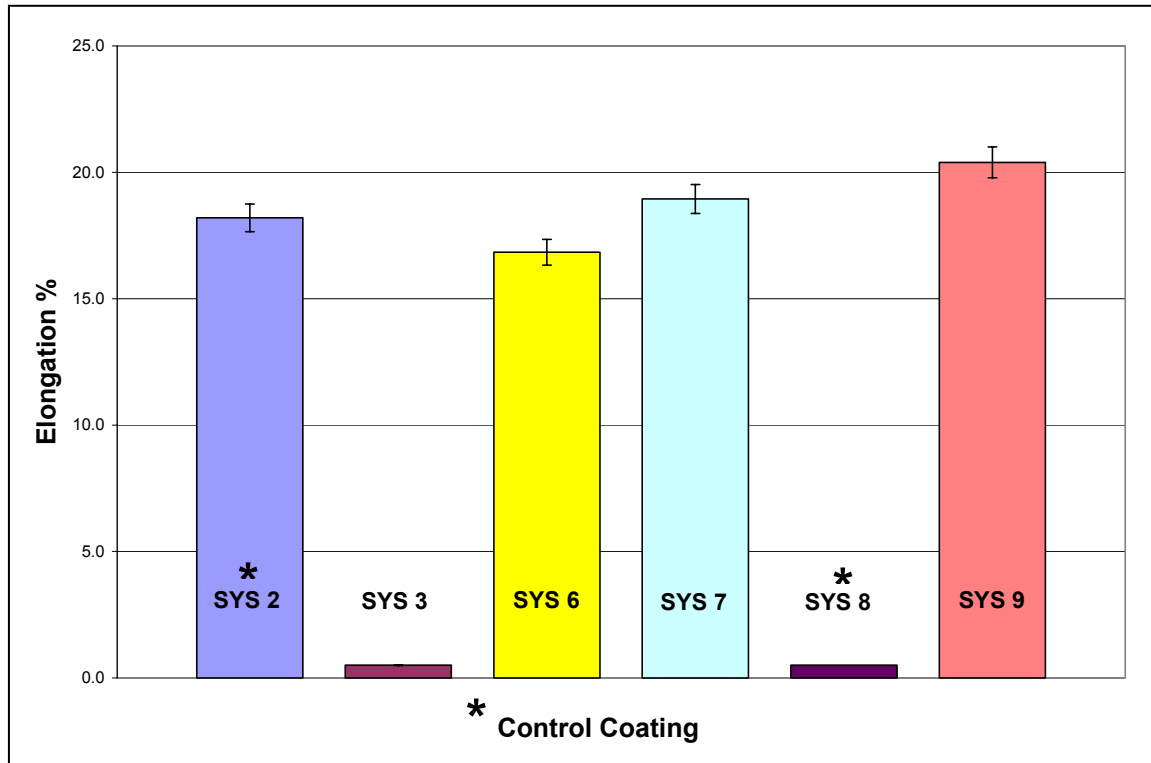
Figure 4-10 Coating Elongation from Mandrel Bend Test

Systems -6, -7, and -9 showed a similar or better degree of performance in relation to Control System -2 (Figure 4-10). Both Control System -8 and System -3 failed on the 1/4" mandrel. These systems were re-tested using a larger mandrel (1/2"), but still failed.

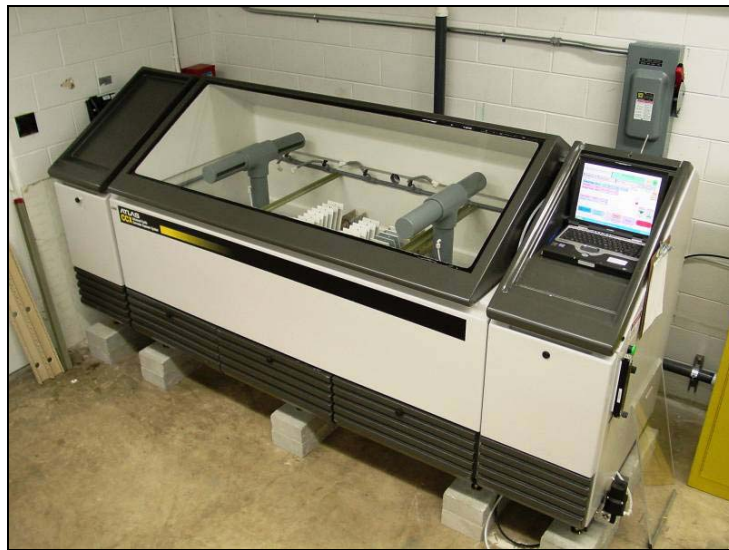
**Figure 4-11 Cyclic Corrosion Chamber**

The coupons were placed on non-conductive racks at a 30° angle in an Auto-Technology CCT-NC-40 programmable cyclic corrosion chamber (Figure 4-11).

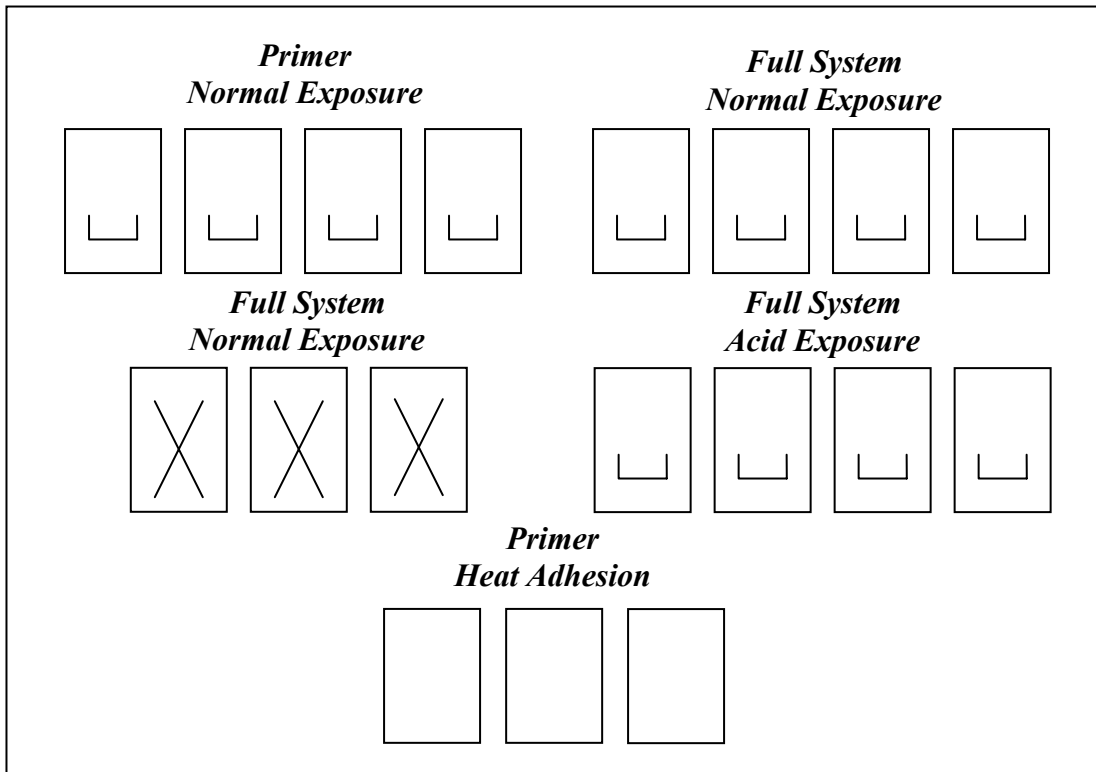
**Figure 4-13 Typical 18-Month Beach Exposure Coating System Coupon Matrix**

Each system consisted of a set of four primer-only composites, two sets of four composites with the full system, a set of three flat panels with the full system, and a set of three primer-only flat panels for heat adhesion (Figure 4-13).

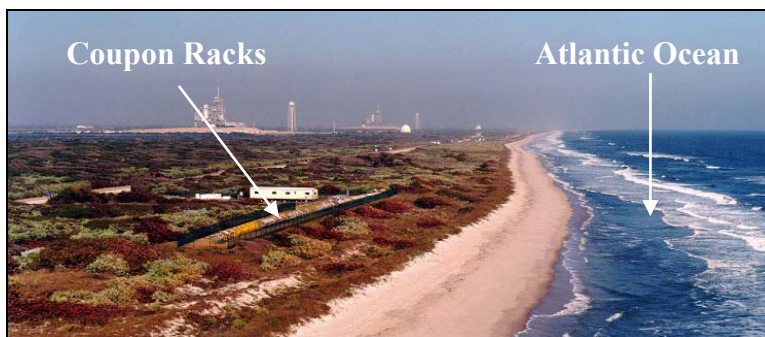
**Figure 4-14 Beach Corrosion Test Site at KSC**

The rating process consisted of adhesion testing of the primers, gloss measurements, and visual ASTM evaluations of the coated surfaces. Photographs were taken at the start of the 18-month exposure period. After all coating systems were applied and allowed to cure, the coupons were mounted on test racks and transported to the KSC Beach Corrosion Test Site stands. This site is located approximately 1.5 miles south of Launch Complex 39A at KSC (Figure 4-14). The coated test panels were installed on stainless steel racks that use porcelain insulators as standoffs. The racks were installed on galvanized pipe test stands which oriented the samples at a 30° angle facing the ocean. The distance of the test stands from the mean high-tide line is approximately 30 meters (100 feet) from the Atlantic Ocean.

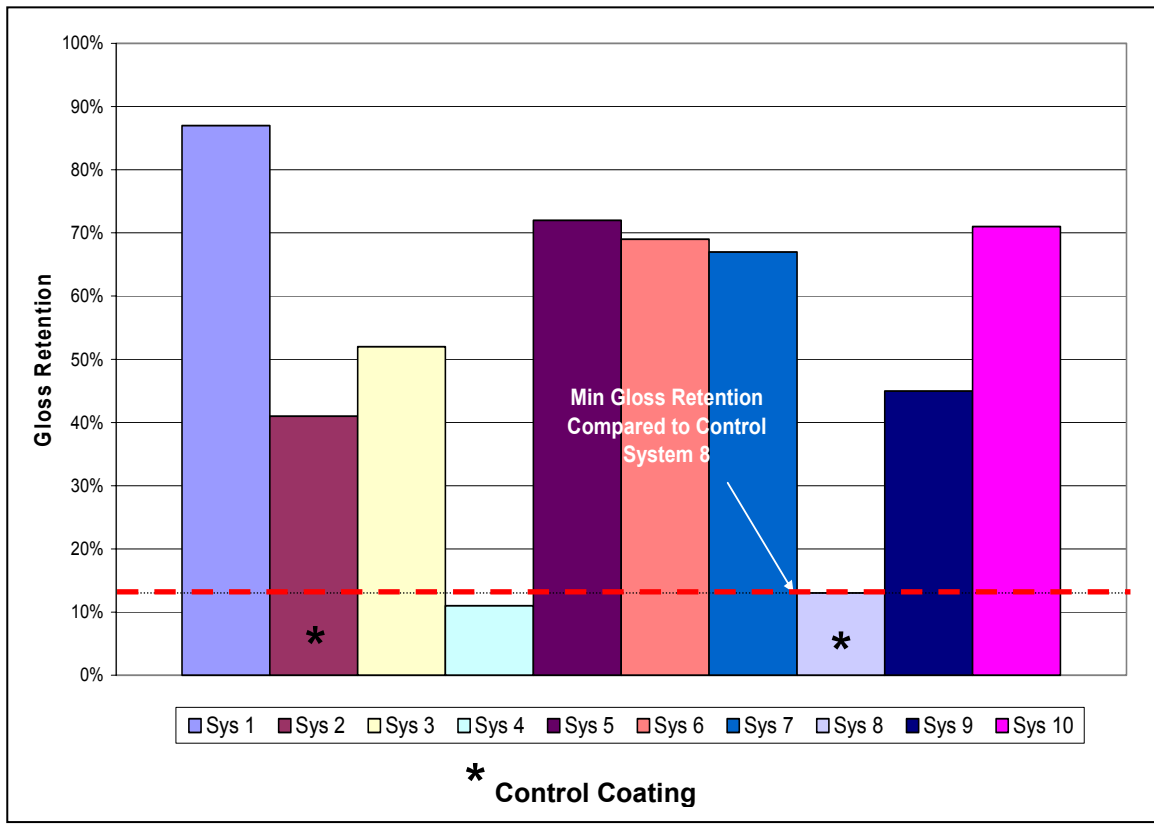
Figure 4-15 Results of 18-Month Marine Exposure Gloss Retention

As shown in Table 4-19, all of the coating systems exhibited significant drops in gloss. Compared to Control Systems -2 and -8, all of the coatings retained a higher percentage of gloss, except for System -4 which only retained 11%. System -1 performed the best with the highest gloss retention of 87% (Figure 4-15).

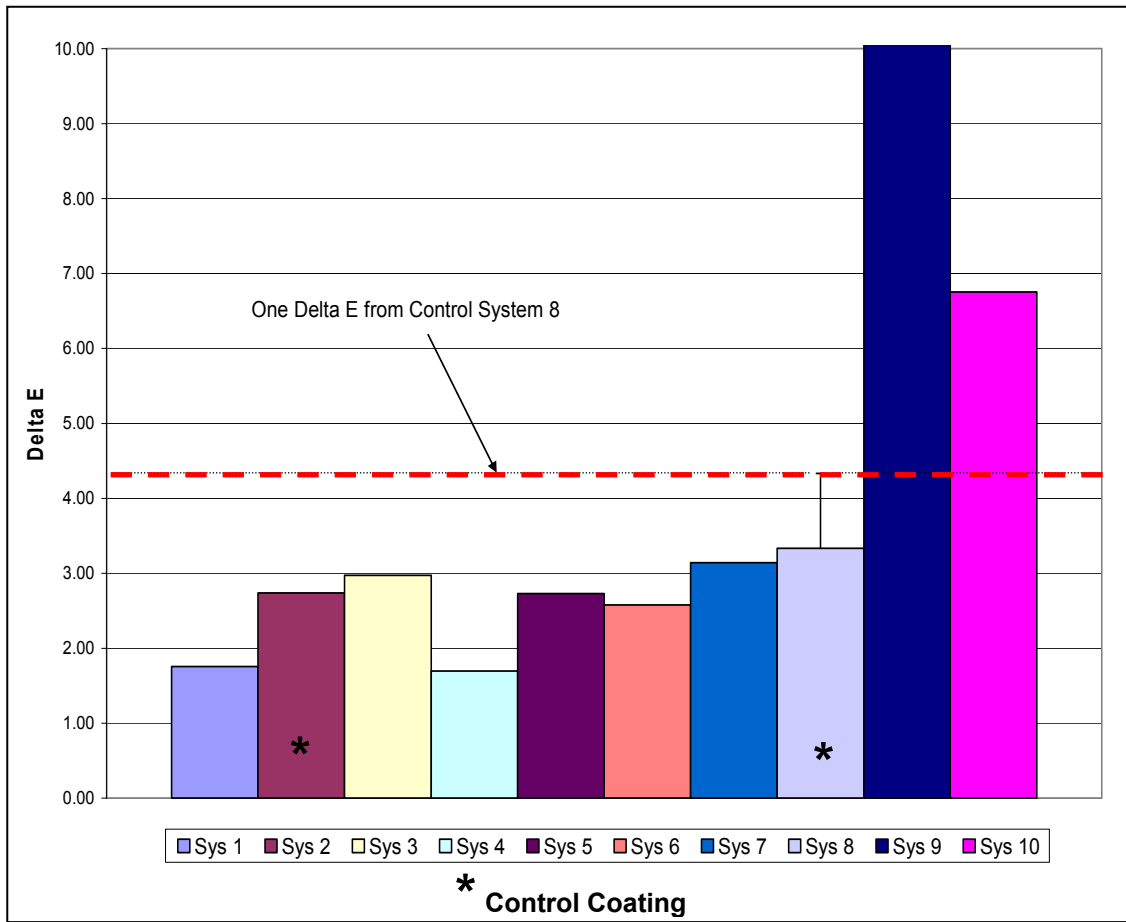
Figure 4-16 18-Month Marine Exposure Color Change Results

As shown in the table, all coating systems exhibited changes in color with values of delta E greater than 1 unit (Figure 4-16). Compared to Control Systems -2 and -8, all of the coatings' color retention properties were comparable to the control, except for Systems -9 and -10. System -1 and -4 provided the highest retention of color with delta E's of 1.74 and 1.70, respectively.

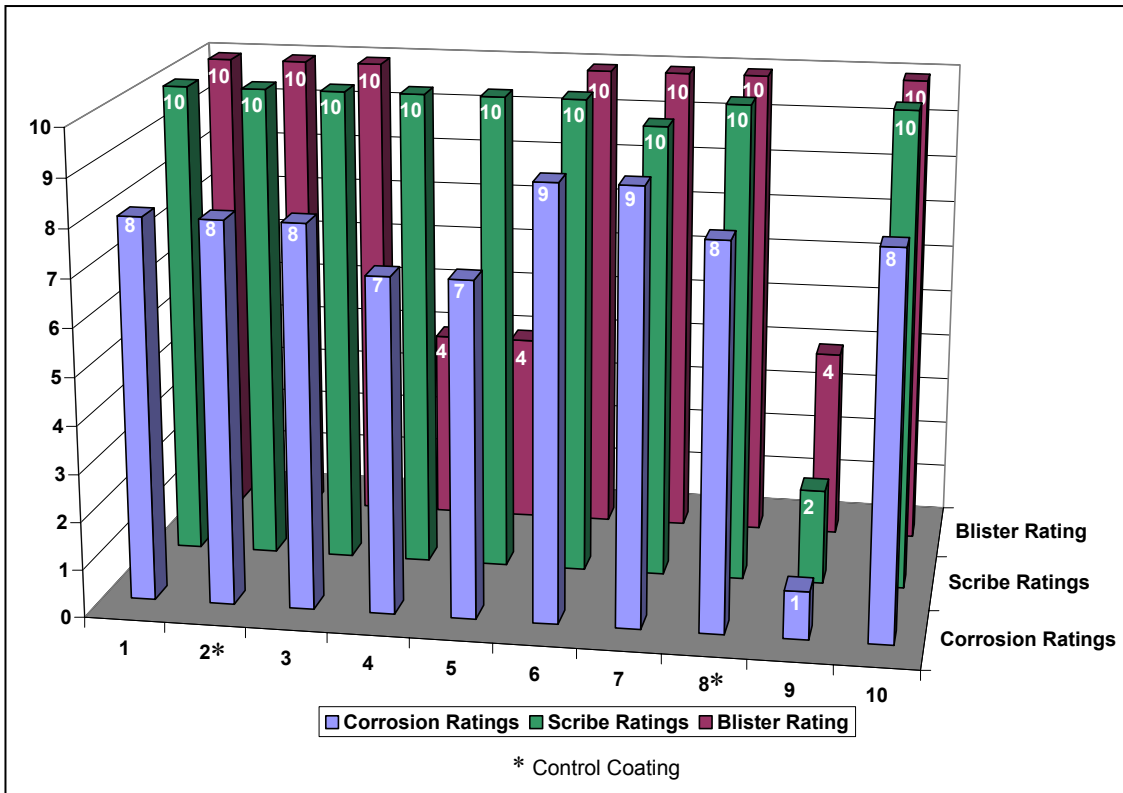
Figure 4-18 18-Month Beach Exposure Corrosion Ratings

performance according to the ASTM D 714 blister evaluation, with a rating of Blister Size 4 and frequencies of Medium, Medium, and Dense for the respective systems (Figure 4-18).

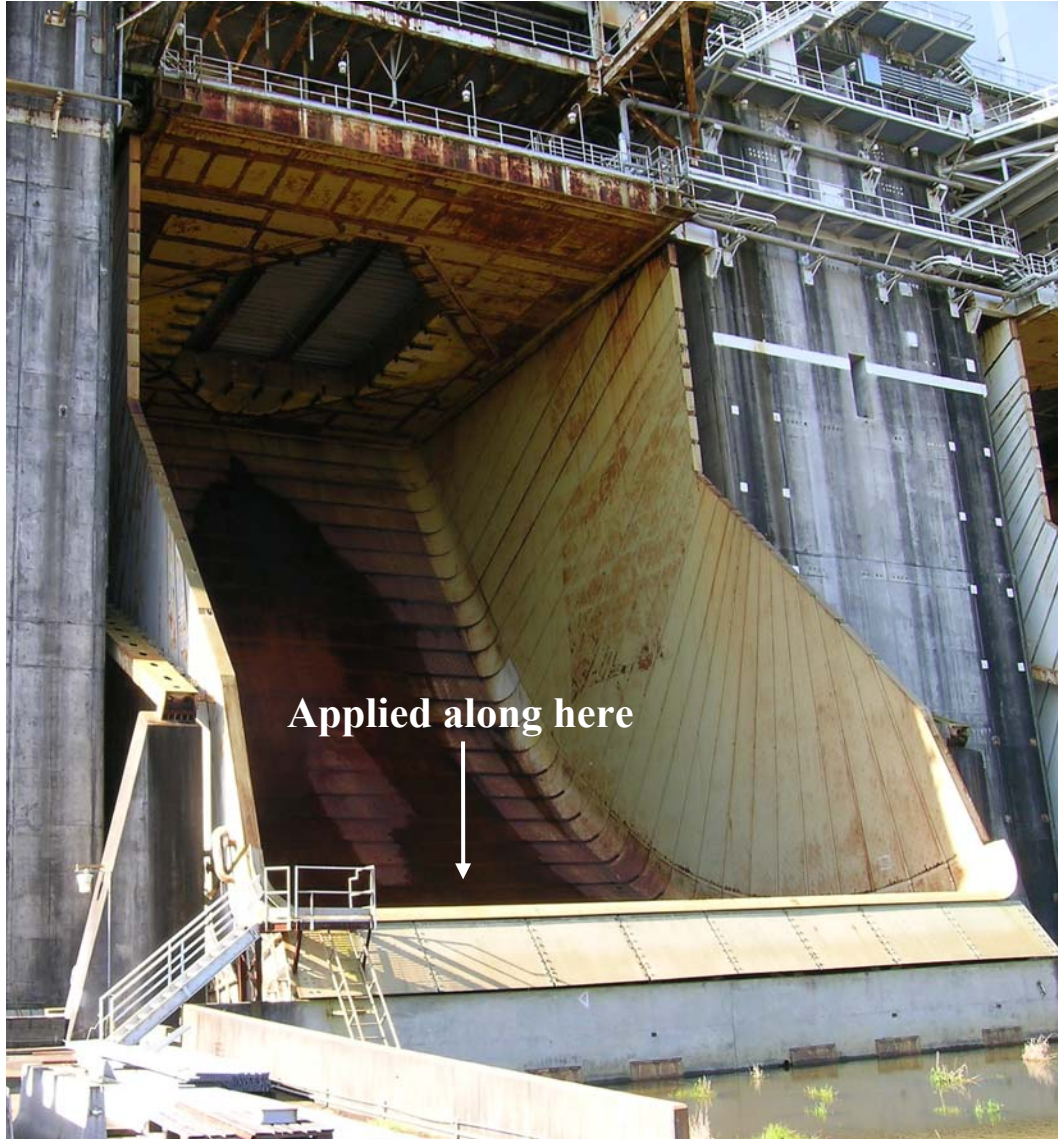
**Figure 5-1 Photograph of Field Application Site at SSC**

aluminum oxide to a *White Metal Blast Cleaning* condition (SSPC SP5) before masking 3'× 3' sections and applying the respective coating systems (Figures 5-1 and 5-2).

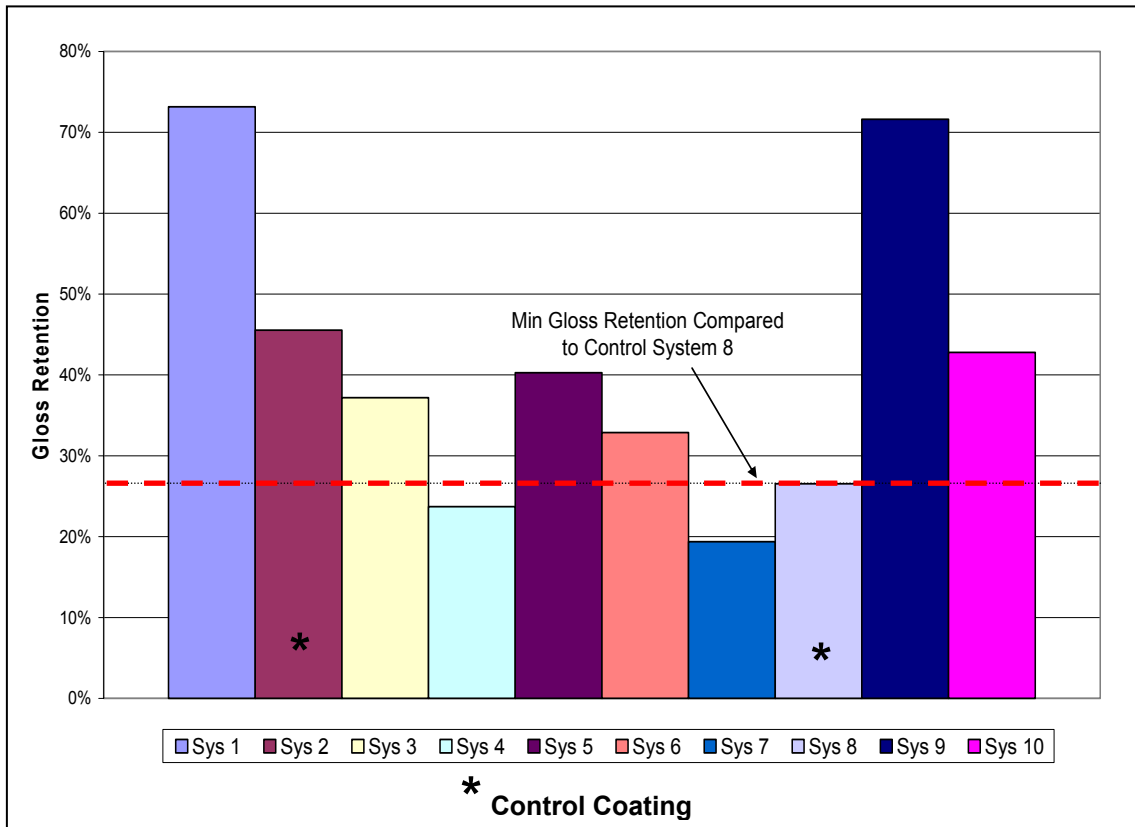
Figure 5-3 Results of Gloss Retention from SSC Field Testing

As shown in the table, all of the coating systems exhibited a significant reduction in gloss. Compared to Control System -2, only two of the coatings retained a higher percentage of gloss; Systems -1 and -9 retained the highest gloss of 73% and 72%, respectively. When compared to Control System -8, all the remaining coating systems met or exceeded the controls performance, except for Systems -4 and -7 which only retained 24% and 19% gloss, respectively, as shown in Figure 5-3.

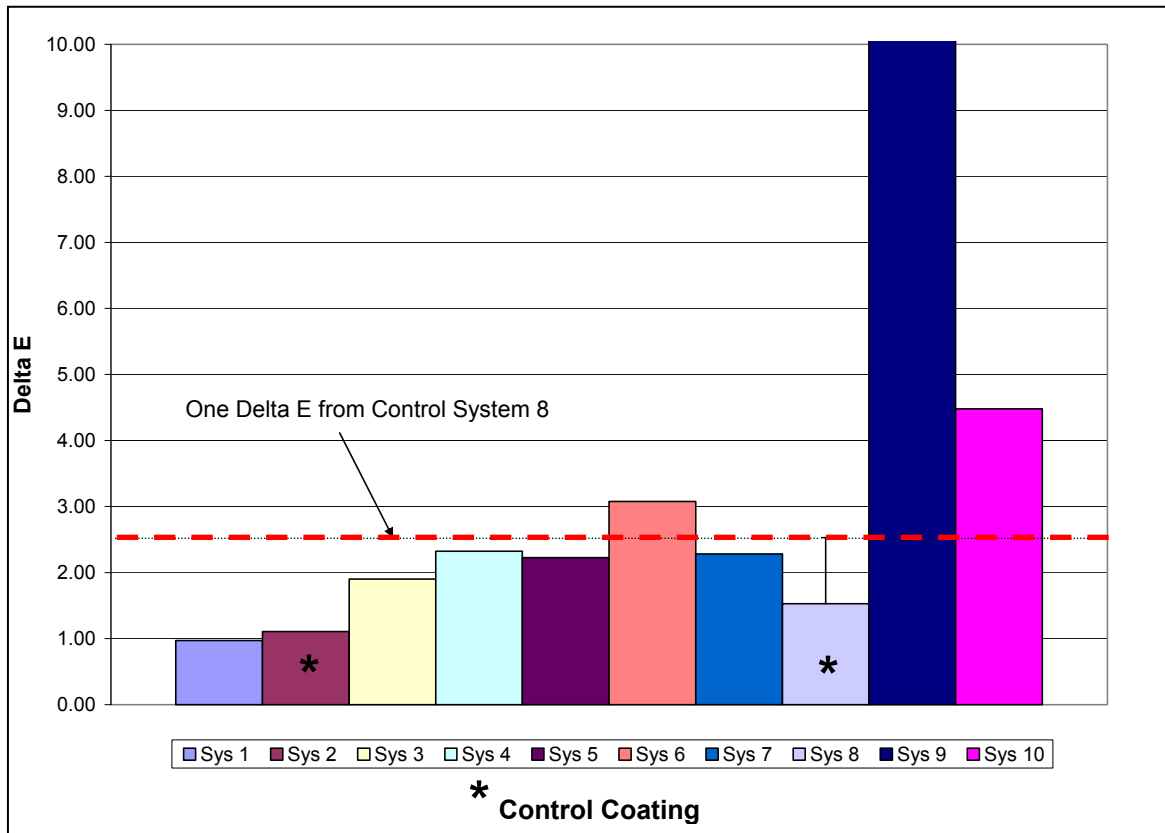
Figure 5-4 Results of Color Retention from SSC Field Testing

As shown in the table, all of the coating systems exhibited slight variations in color, except for System -9 which experienced the largest overall color change ( $\Delta E$ ) of 17.8 units. Control Systems -2 and -8 maintained their color properties with delta E values of 1.1 and 1.5, respectively. As shown in Figure 5-4, all remaining systems performed within one delta E of Control System -8, except for Systems -6 and -10, which were outside of this range. The field coatings color change properties showed similar performance characteristics to the laboratory findings for each system.
