CAPE CANAVERAL AIR FORCE STATION,
LAUNCH COMPLEX 39,
ROTATION PROCESSING & SURGE FACILITY
(John F. Kennedy Space Center)
Cape Canaveral
Brevard County
Florida

HAER FL-8-11-G

CAPE CANAVERAL AIR FORCE STATION,
LAUNCH COMPLEX 39,
ROTATION PROCESSING & SURGE FACILITY

HAER NO. FL-8-11-G

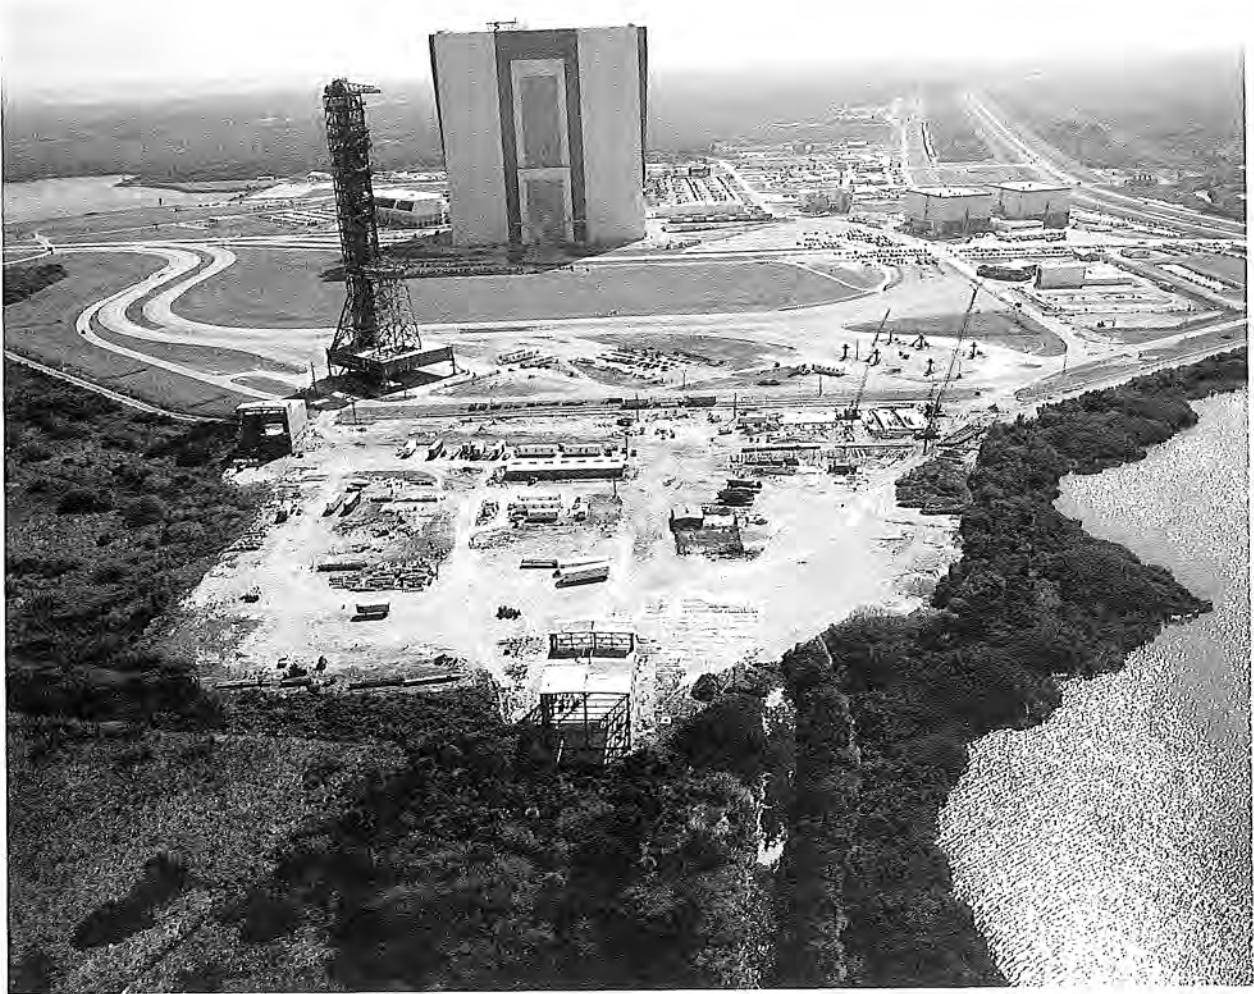
Aerial View of RPSF Complex Under Construction at Bottom of Photograph, View to South, February 8, 1983 (Courtesy of Kennedy Space Center, Negative 108-KSC-383C-267-20).

In the months that followed, the progress of the RPSF construction can be documented by a series of aerial photographs taken by NASA of the VAB area, dating from early February 1983, to June 1984. The aerial from February 8, 1983 illustrates the early progress made on the surge buildings. Their steel frames were standing and the roofs were in place, although the walls had not been installed. At the site of the main building, construction of the foundation was underway. Building K6-446, constructed prior to 1966, is standing in the middle of the site complex.³⁹

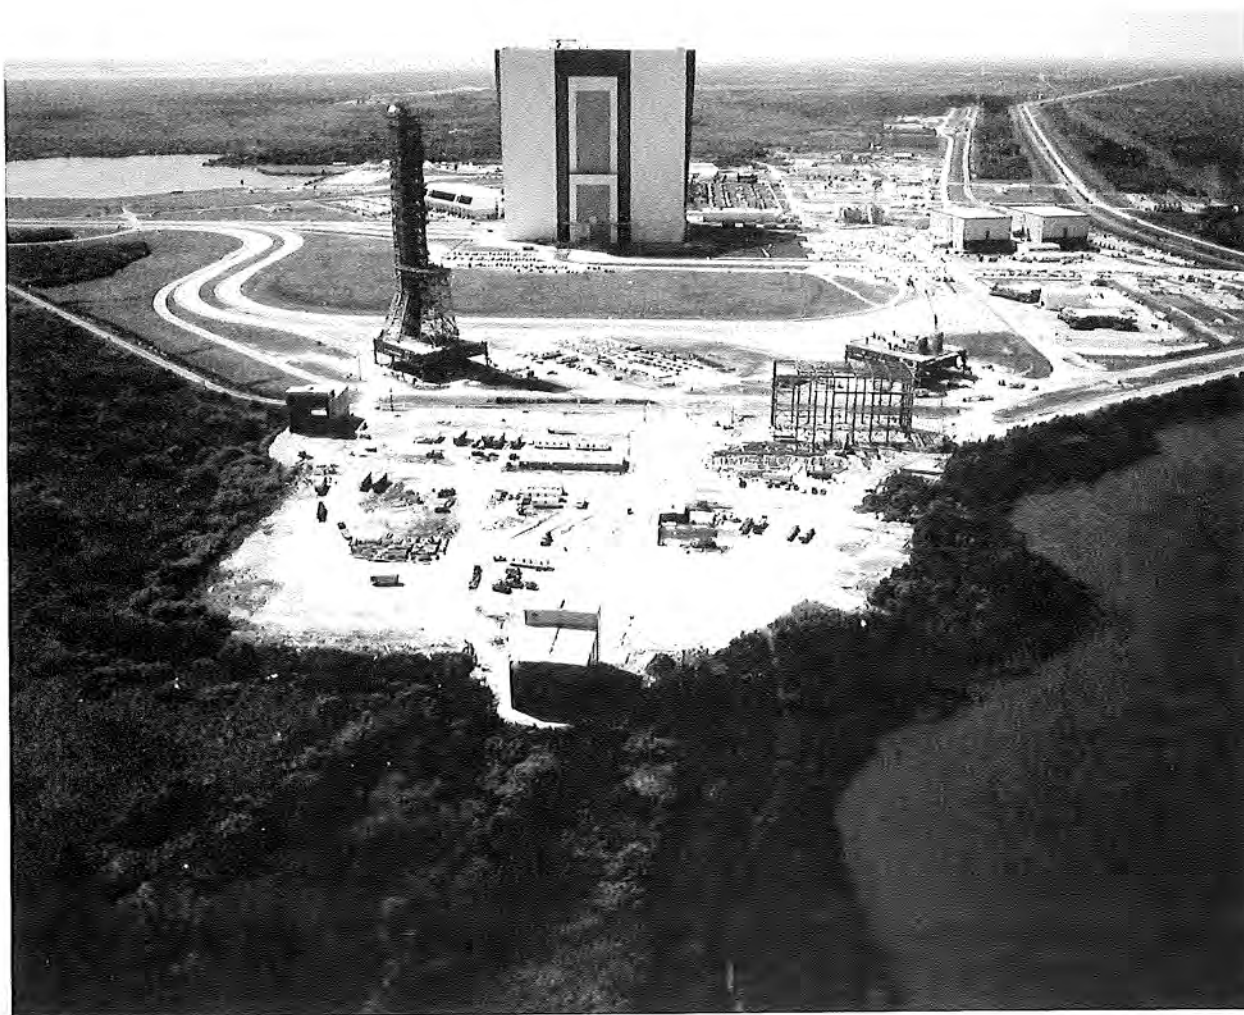
Aerial View of RPSF Complex Under Construction, Showing RPSF Steel Frame, View to South, April 21, 1983 (Courtesy of Kennedy Space Center, Negative 108-KSC-383C-1085-90).

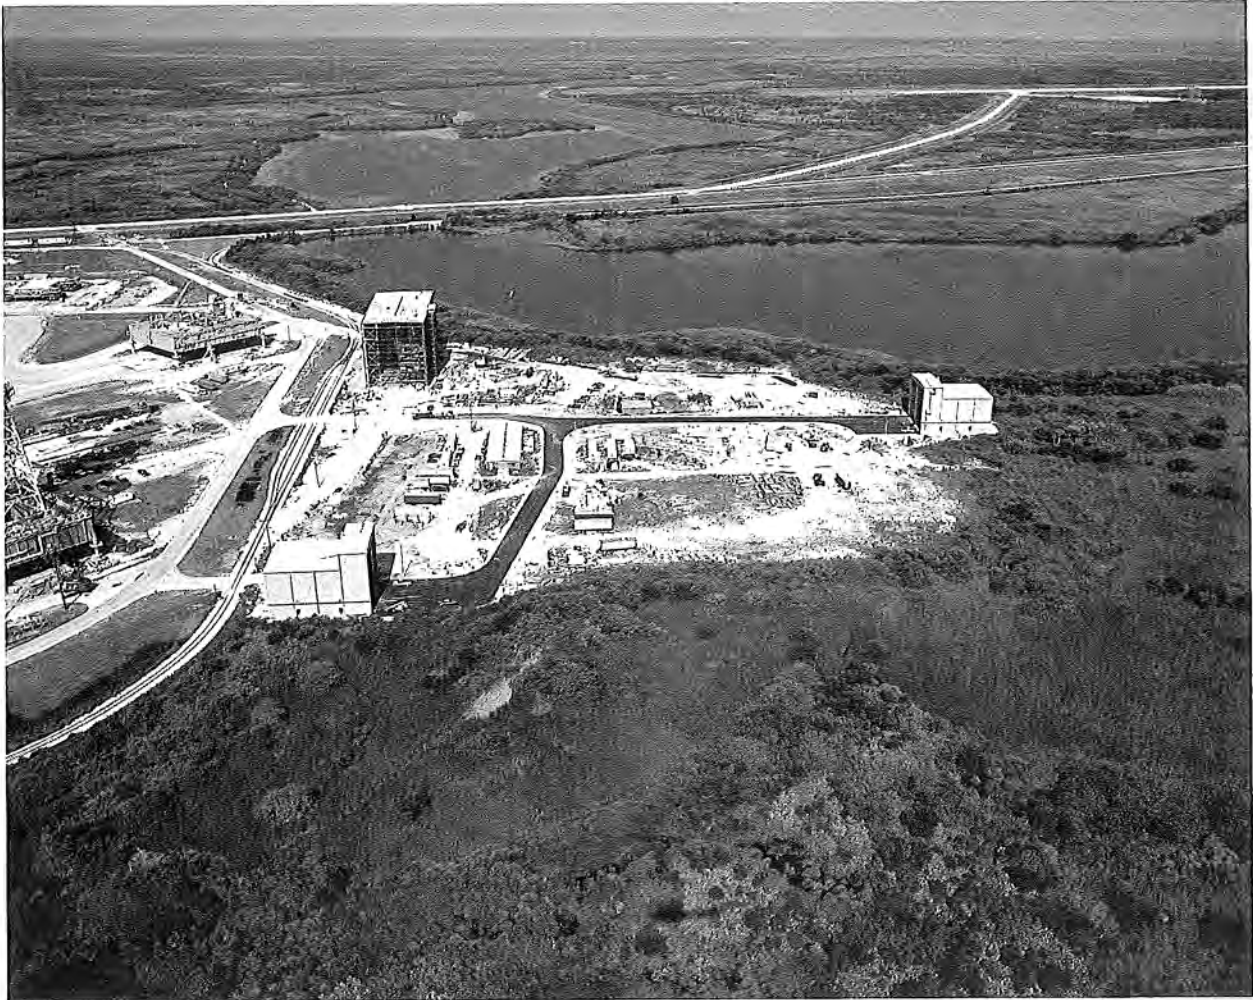
Aerial View of RPSF Complex Under Construction, View to West,
July 5, 1983 (Courtesy of Kennedy Space Center, Negative 108-
KSC-383C-2203-40).

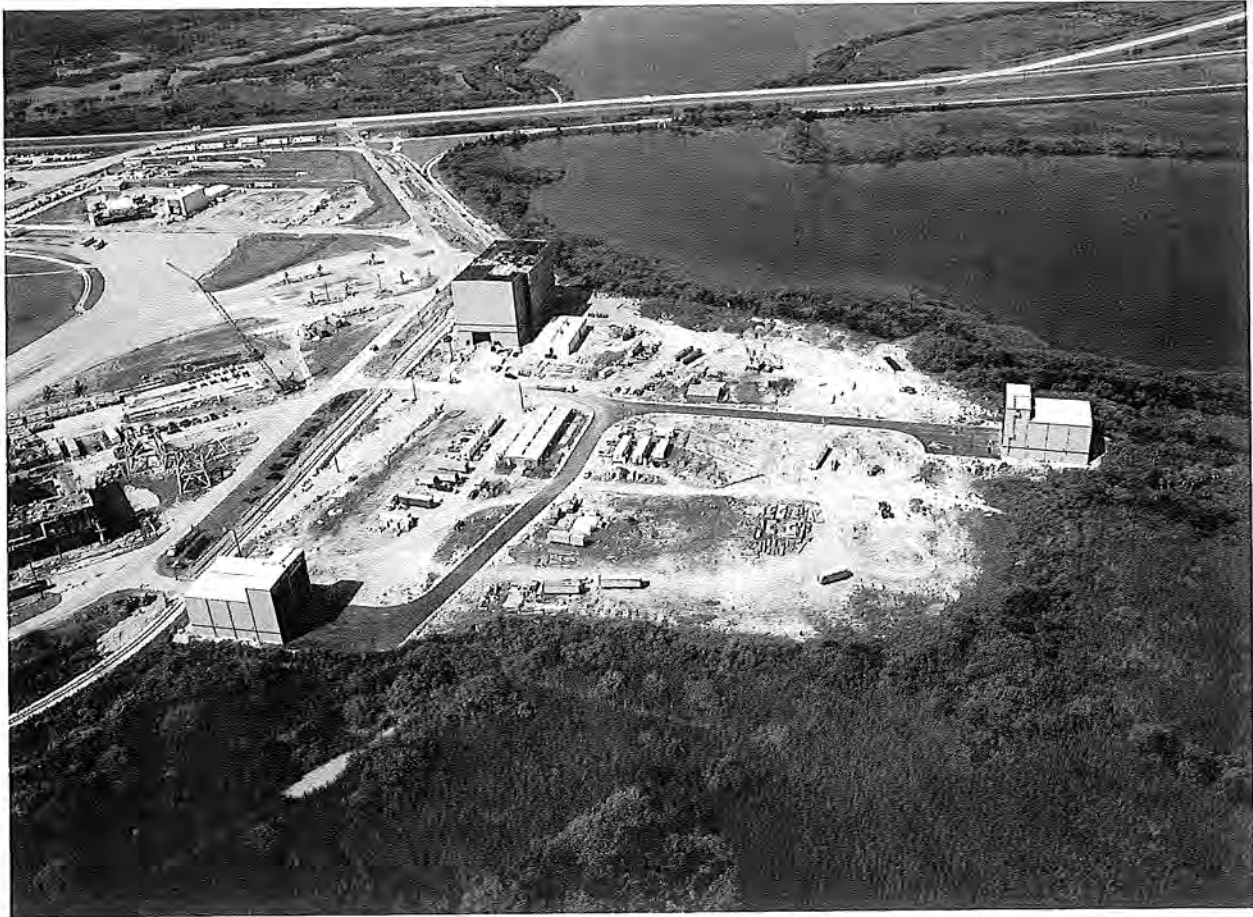
Aerial View of RPSF Complex Under Construction, View to West-Southwest, September 1, 1983 (Courtesy of Kennedy Space Center, Negative 116-KSC-383C-3090-30).

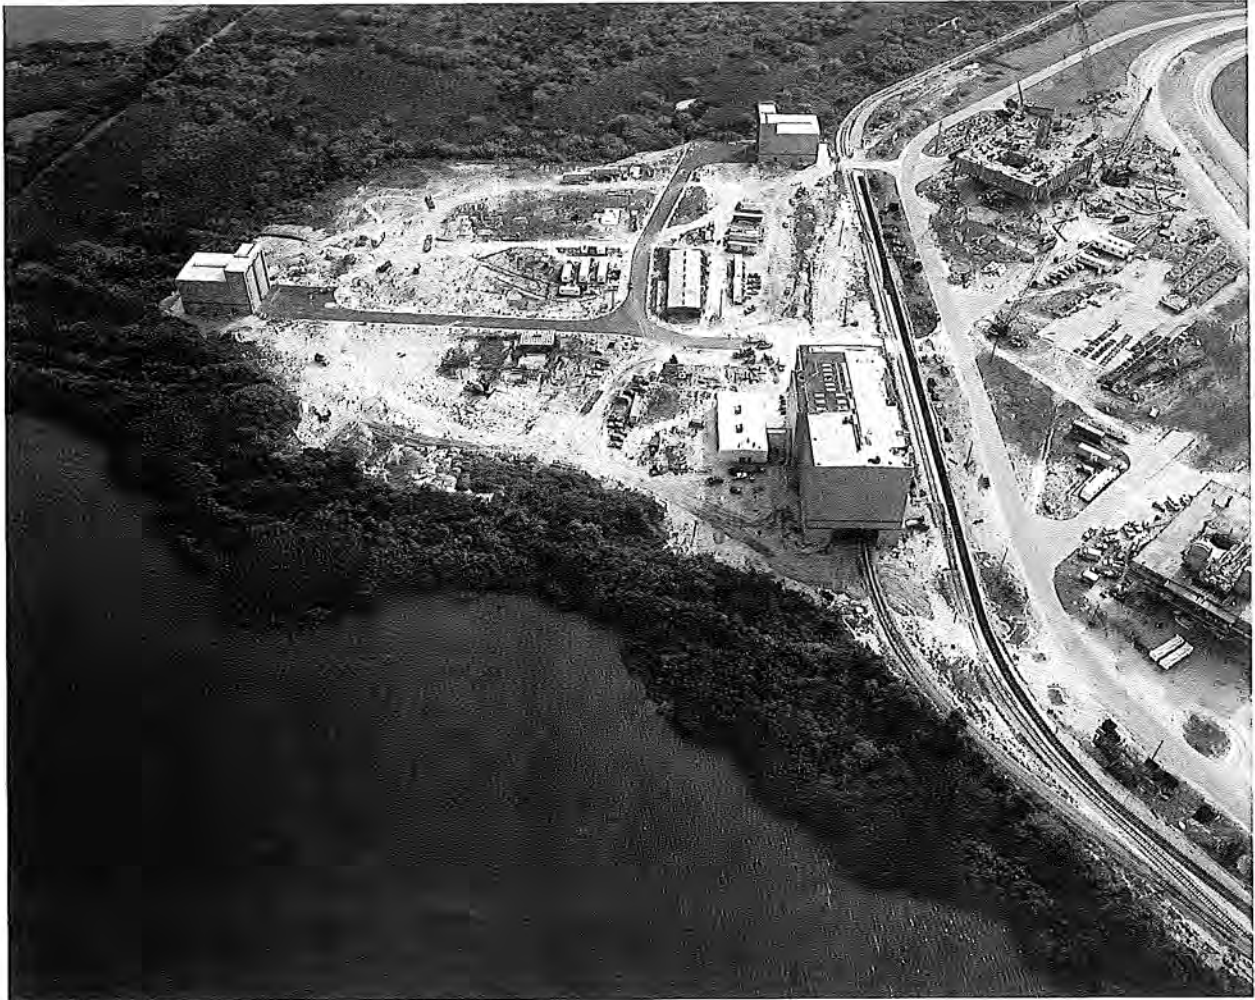
Aerial View of RPSF Complex Under Construction, View to East,
October 4, 1983 (Courtesy of Kennedy Space Center, Negative 116-
KSC-383C-3561-100).

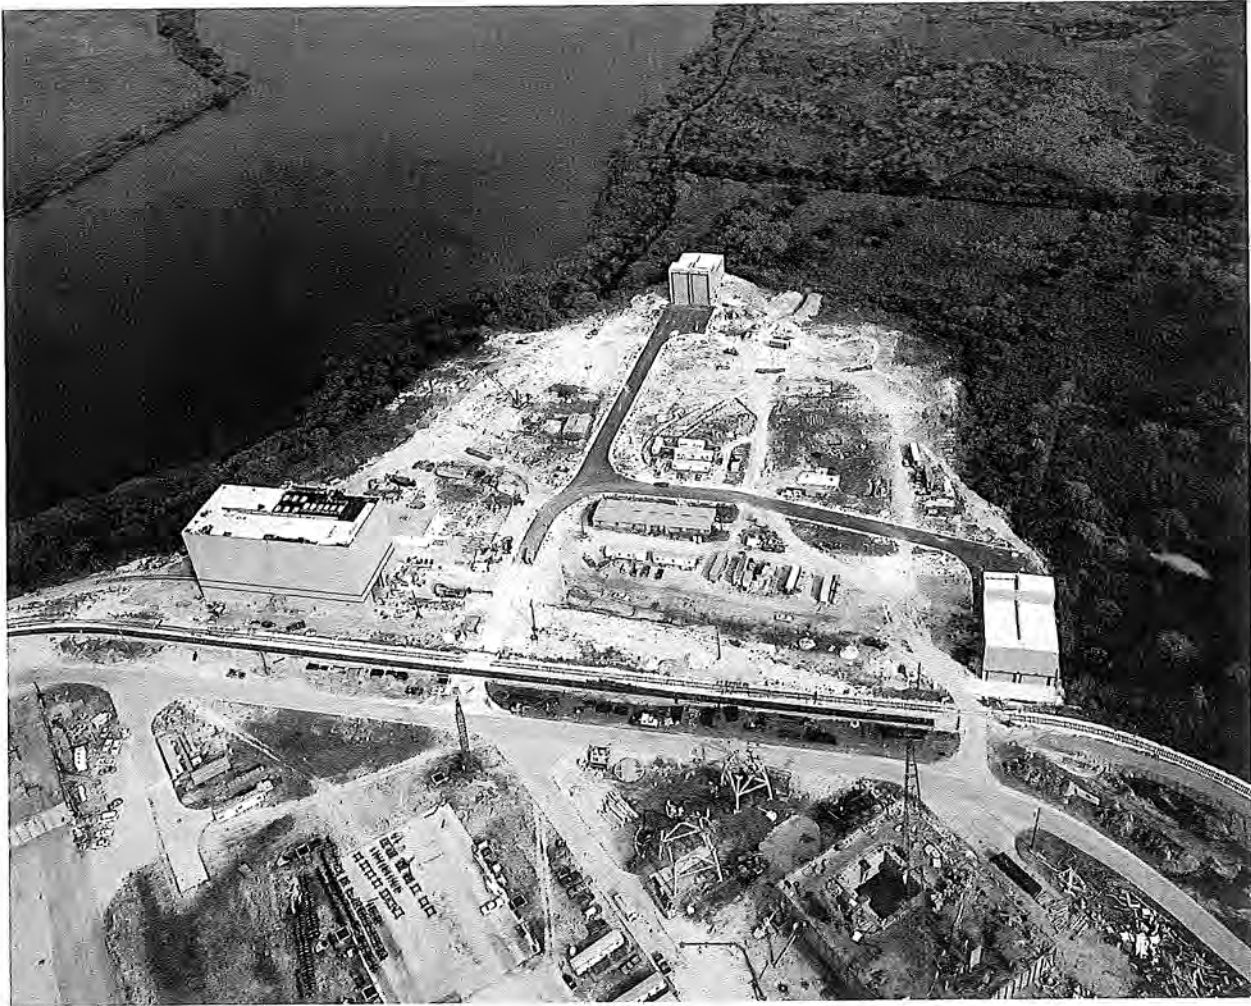
Aerial View of RPSF Complex Under Construction, View to North,
October 4, 1983 (Courtesy of Kennedy Space Center, Negative 116-
KSC-383C-3563-20).
